U. S. DEPARTMENT OF THE INTERIOR
ALASKA ROAD COMMISSION
Anchorage District

Item	FINAL CONSTRUCTION REPORT	Page Number
Location	EKLUTNA RIVER BRIDGE, MILE 25.9, GLENN HIGHWAY	
Description	Construction of Steel Arch Bridge	1
Contract Data	Contract No. I-arc-4299	2
Construction	Third Judicial Division, Territory of Alaska	3-8
Engineering		9-10
Laboratory Reports on Concrete Cylinder		11
Statistics of Contract Cost		12
Reasons for Overruns		13
Appendix (Photographs)

This report covers the construction of the Eklutna River Bridge, Project I-arc-4299, at Mile 25.9, Glenn Highway, Section A of the Third Judicial District.

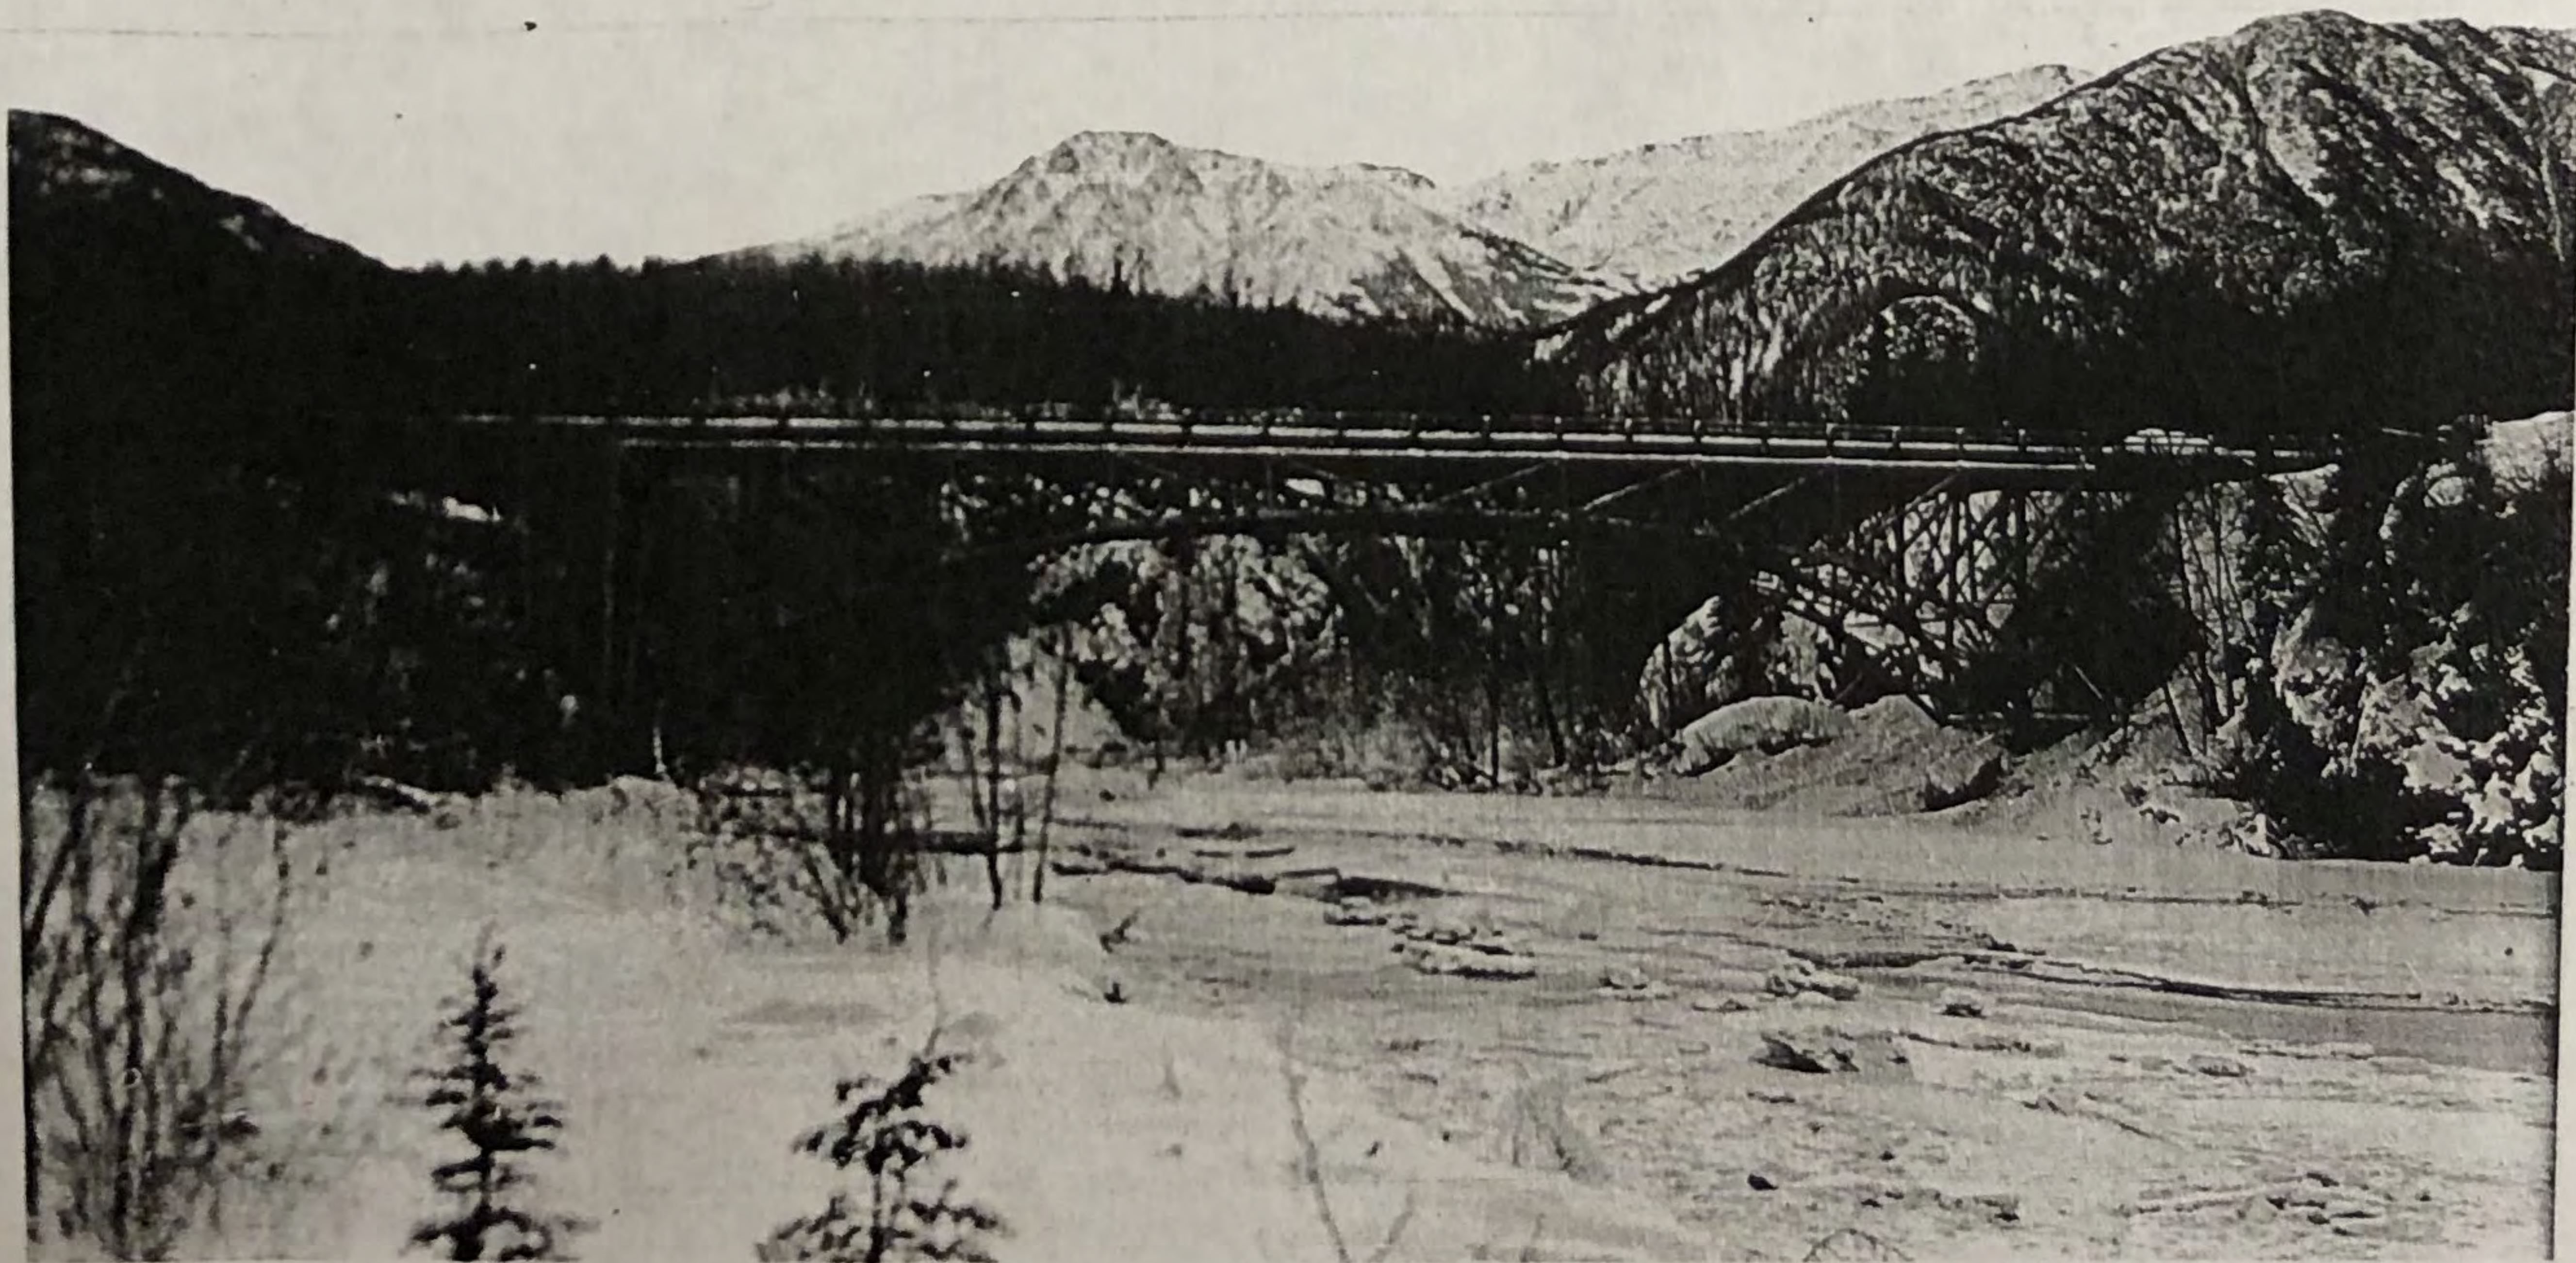
[RG 30-1948]

Status of Eklutna River Bridge March 1952

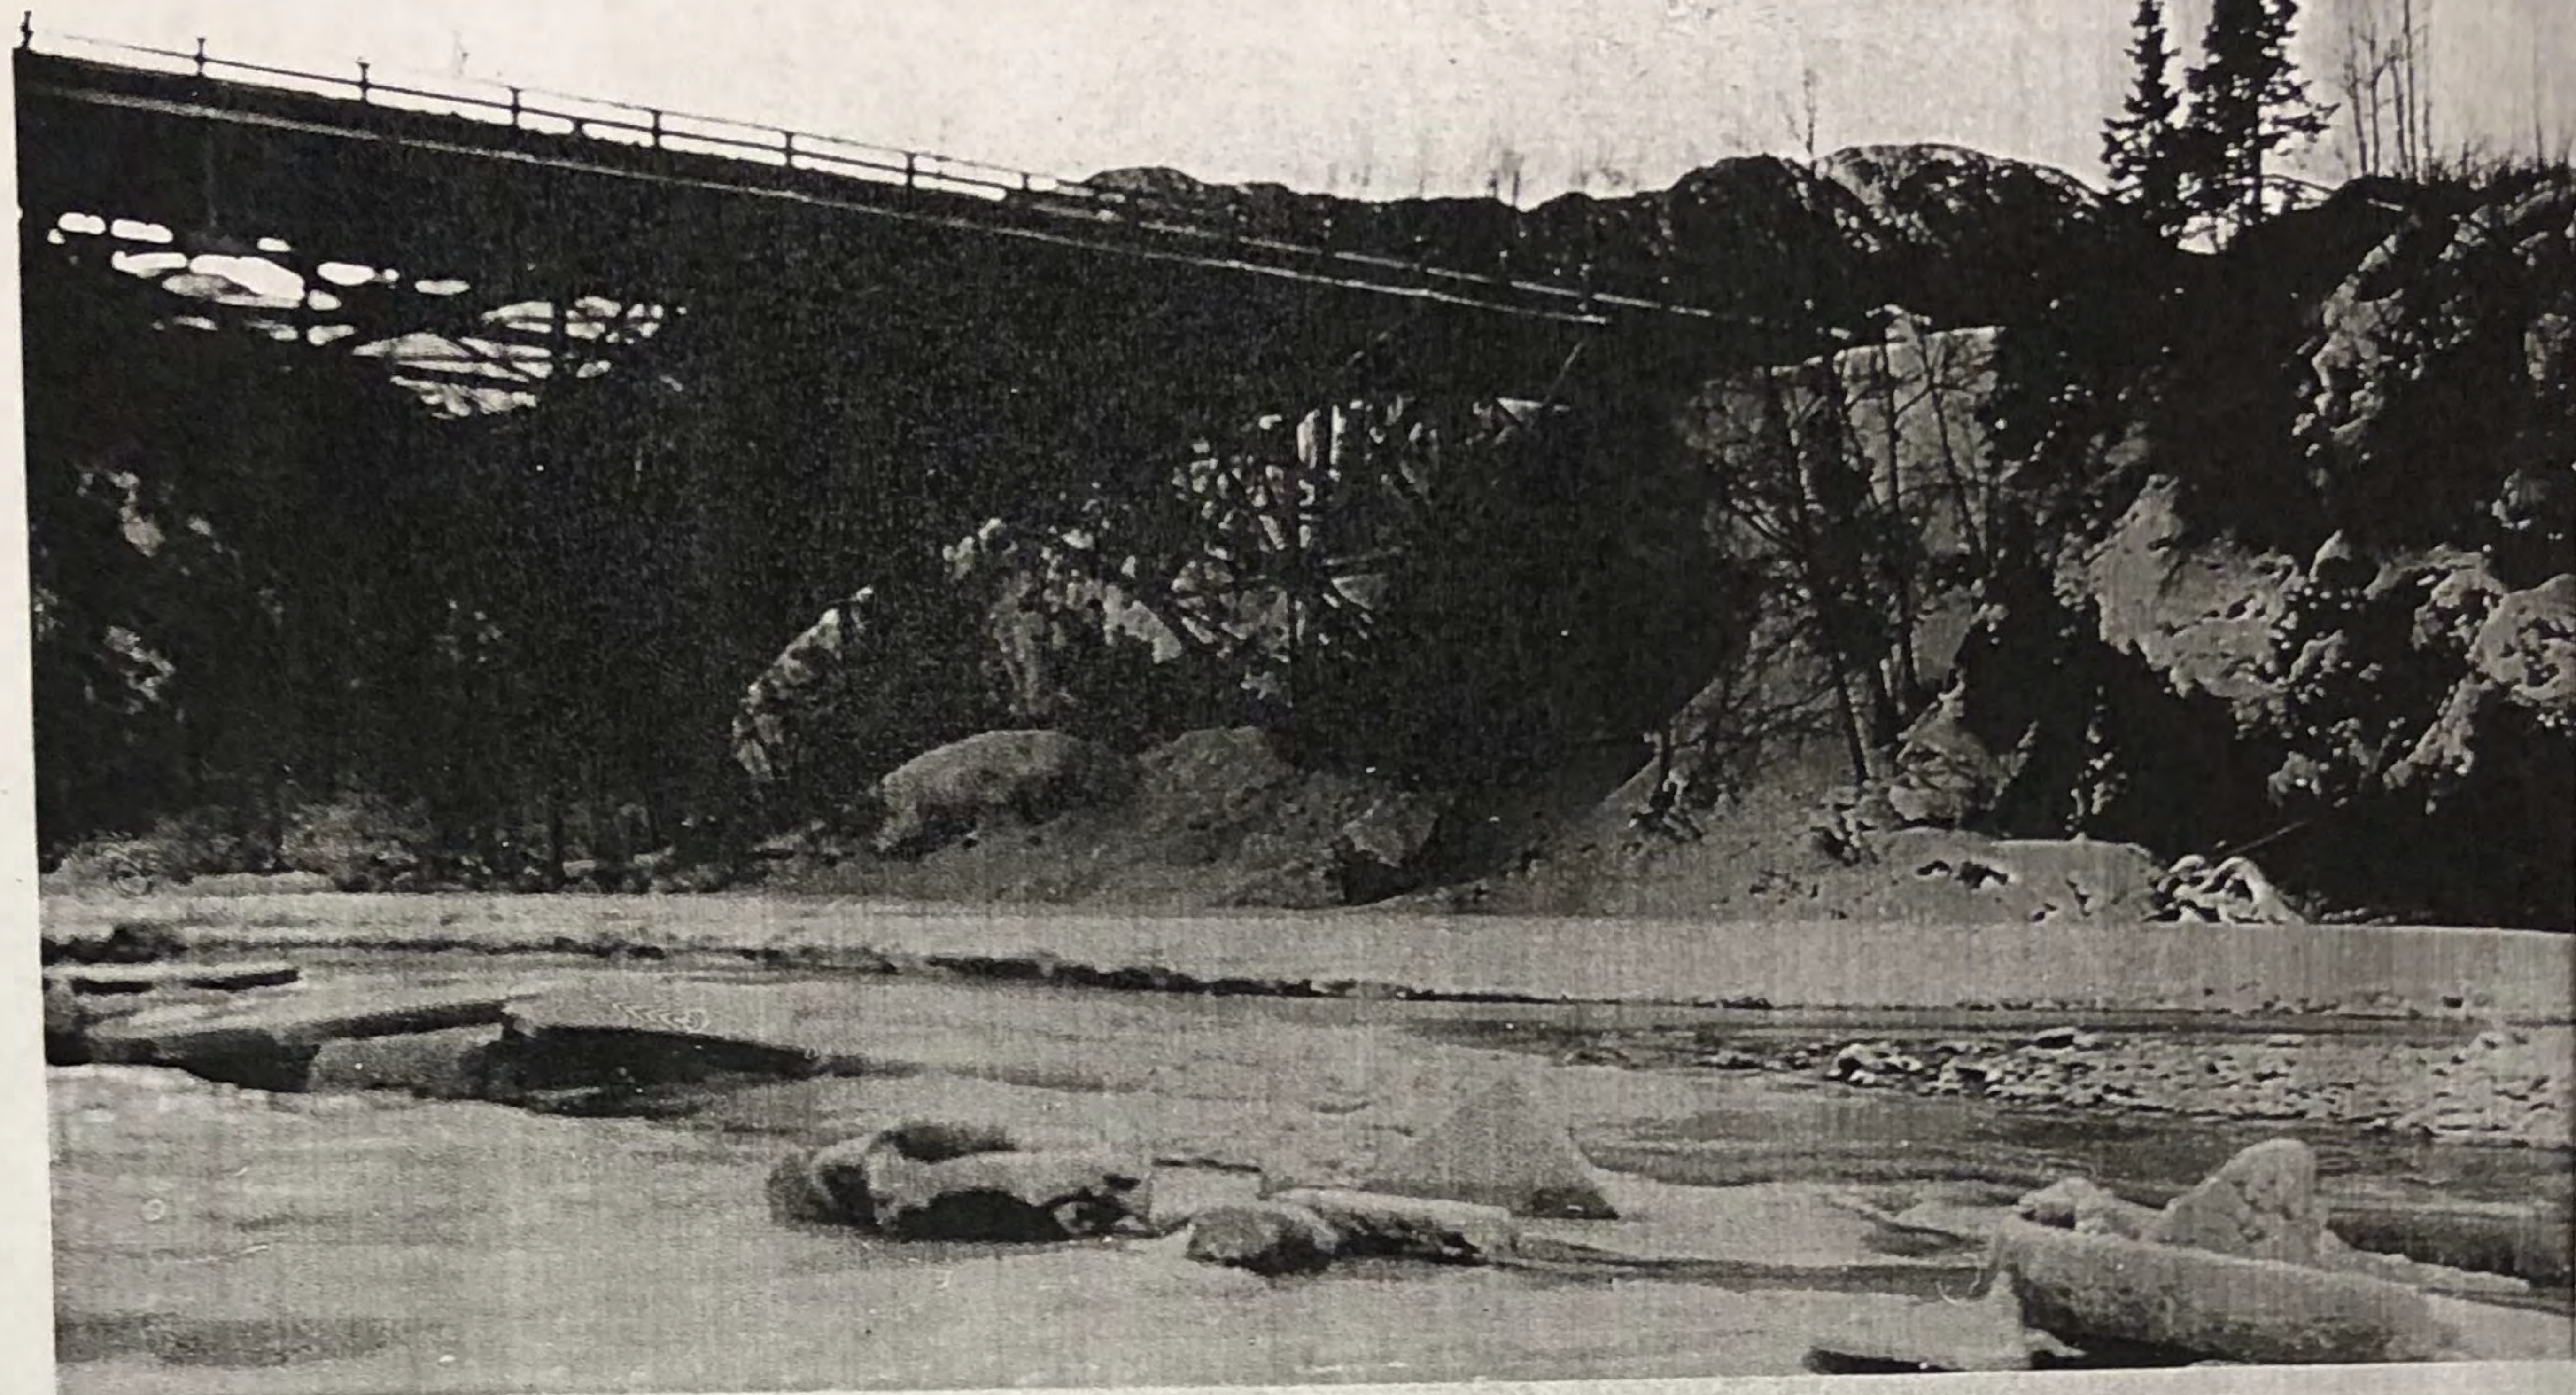
[RG 30-1949]

Completed Bridge (Picture taken January 21, 1954)

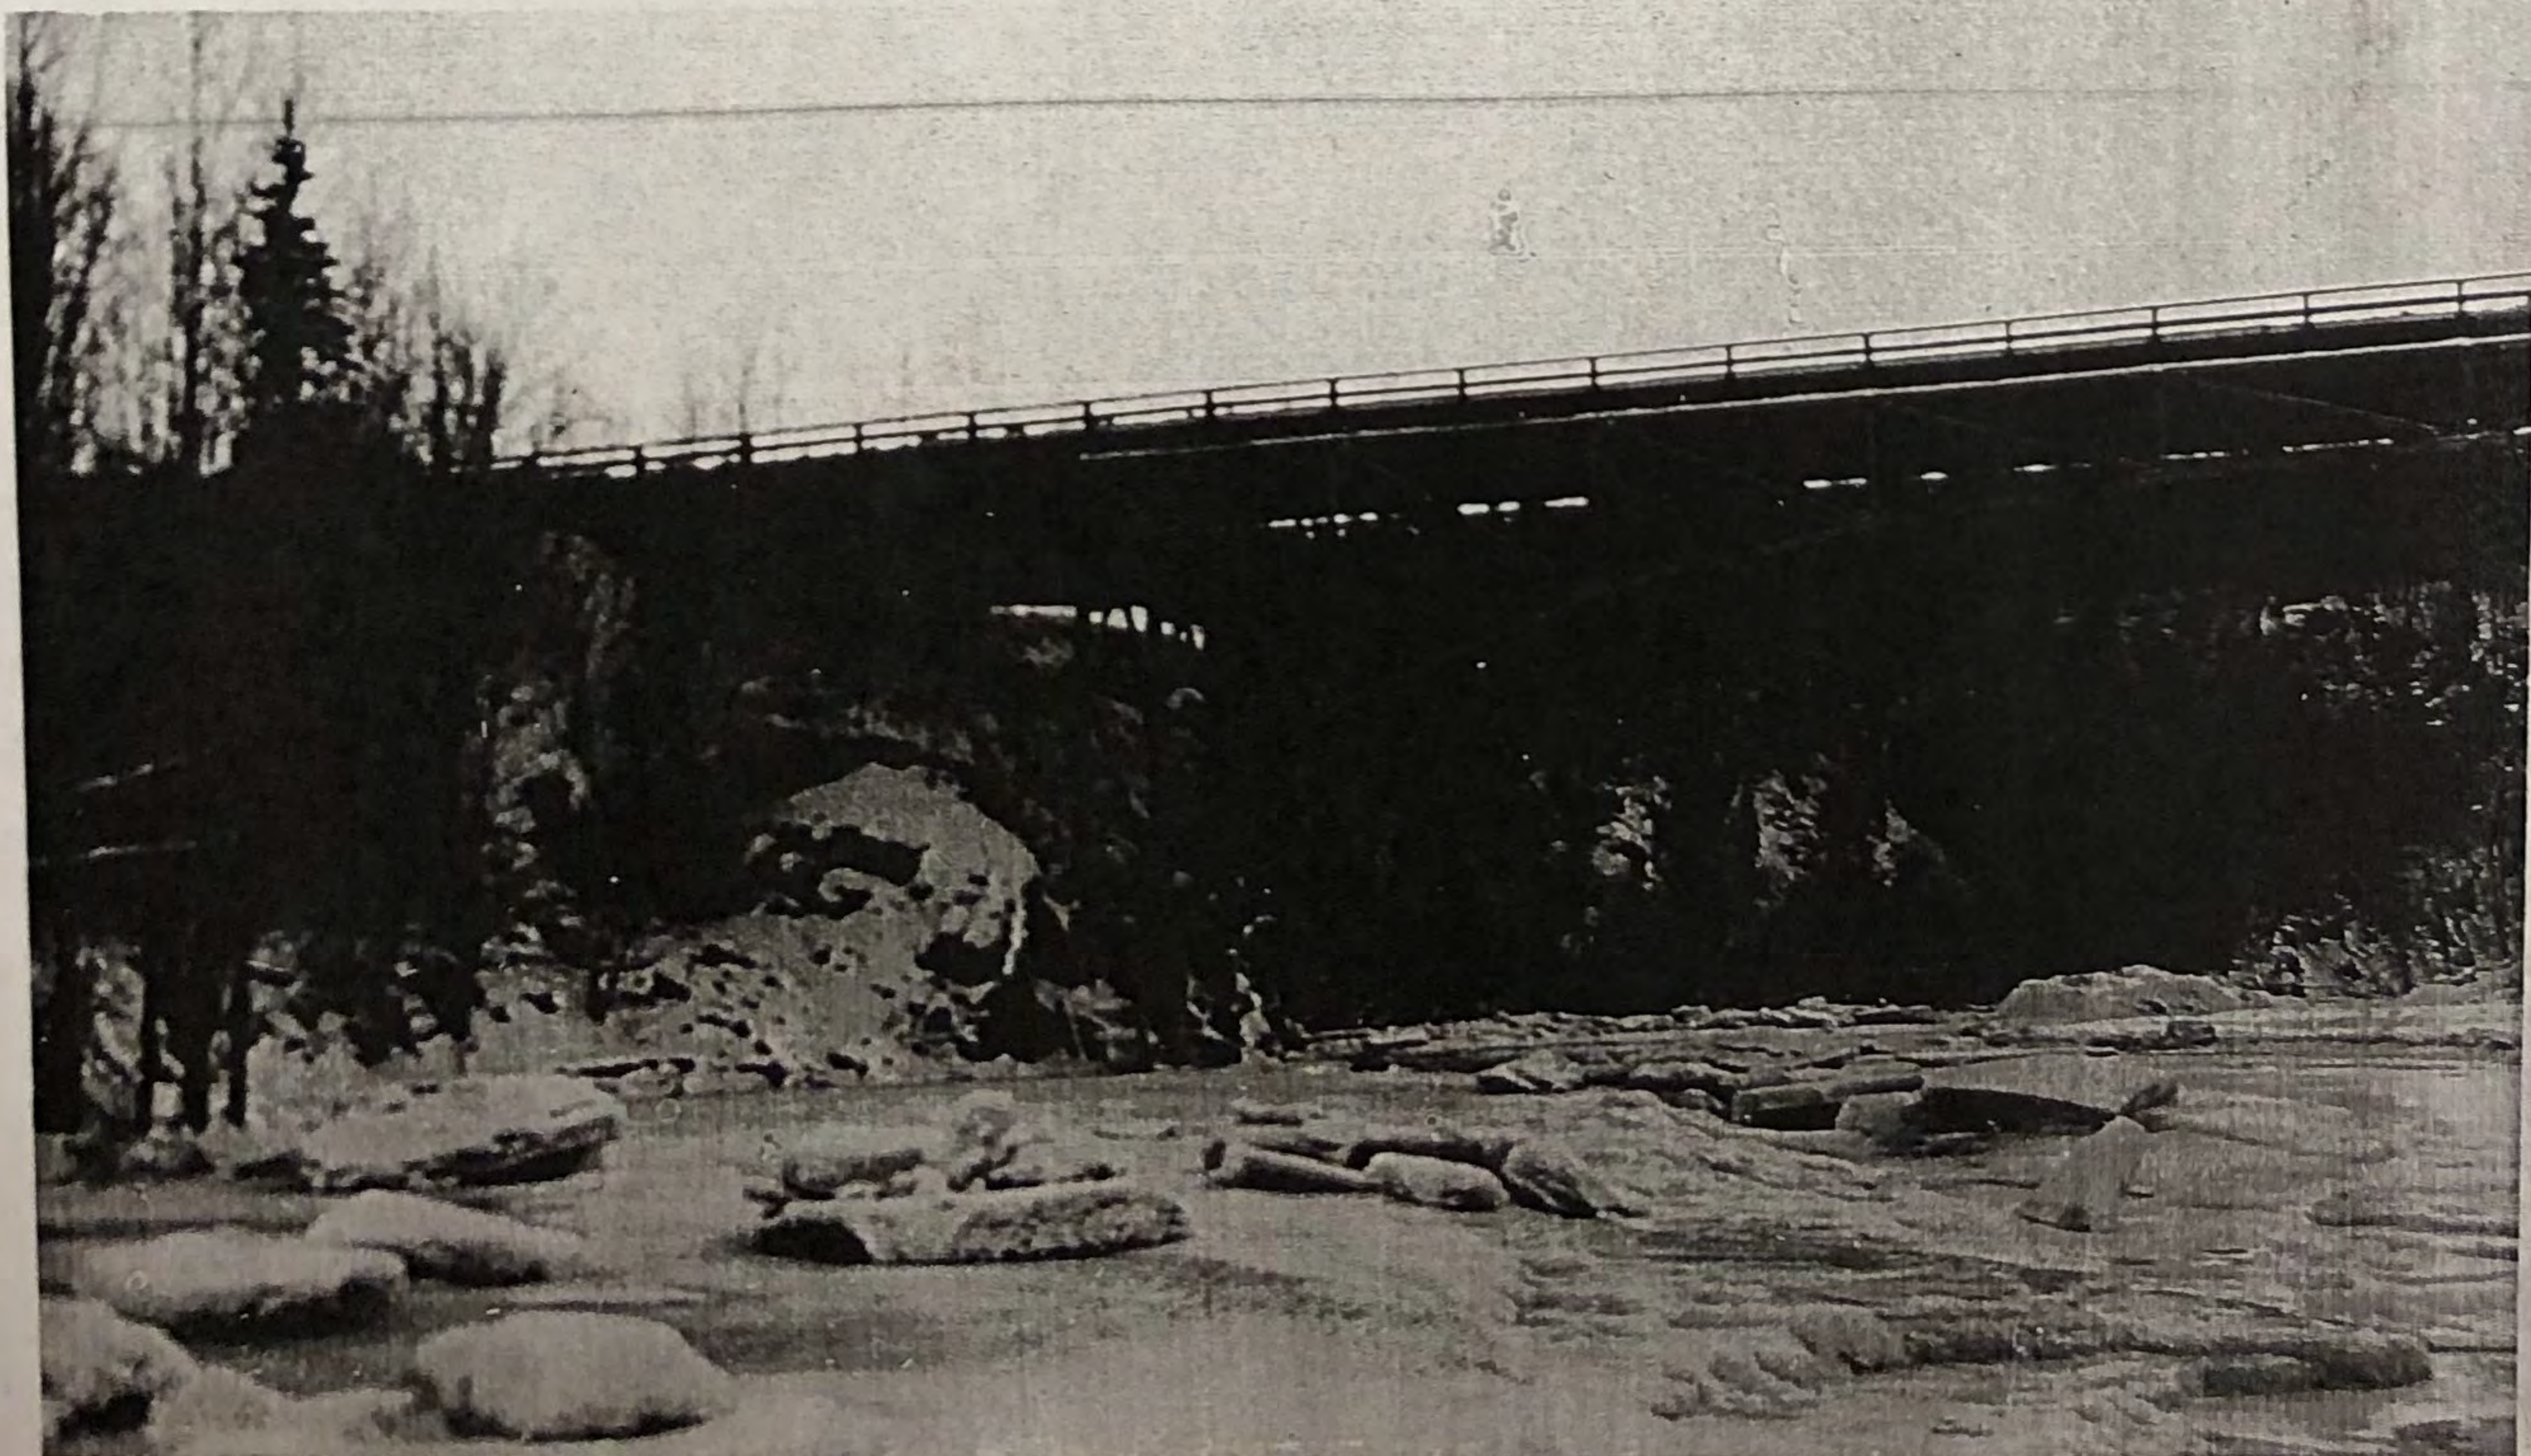
[RG 30-1953]

Looking across river at the completed structural arrangement of Anchorage side of bridge.

Palmer side of the Bridge

(Note the footings and excellent bearing material of solid rock.)

NO!

Rock is badly fractured and subject to stream erosion
WJL
