# Eklutna Hydroelectric Project

## Fish & Wildlife Program Development Site Reconnaissance Trip Report

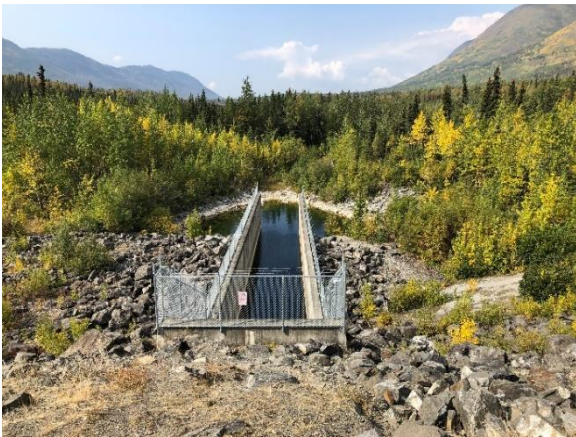
Eklutna Lake Dam and spillway area: Earthen dam with an ogee spillway that only releases water when lake elevation exceeds 871 feet<sup>1</sup>. A concrete lined outflow canal exits the spillway, creating a large scour pool at the start of the natural channel. Residual water in the canal and scour pool observed. Eklutna River is a dry channel, just downstream of the spillway area.

Figure 1: Spillway looking downstream

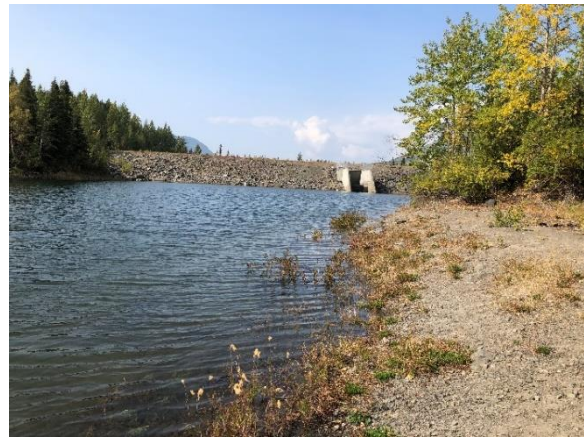
Figure 2: "Pond" between old and current dam

Original Eklutna Lake Dam area: Relic sheet piling and wooden piles were observed along the margins of natural lake outflow channel. Lake elevation was 865.69 feet during the site visit and connectivity from lake downstream to the earthen dam was not interrupted by the relict dam structure. The "pond" that is intermittently connected to the lake and flows to the current dam site would be an important feature to consider in the study effort. A small tributary stream was observed entering this pond from the eastern shore approximately 200 yards up from the current dam. A small delta where the stream enters the pond was more evident during a previous site visit on July 17, 2019.

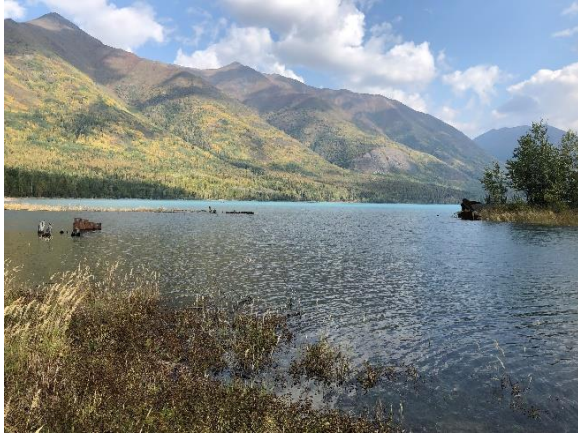
Figure 3: Remnants of old dam structures at lake outlet

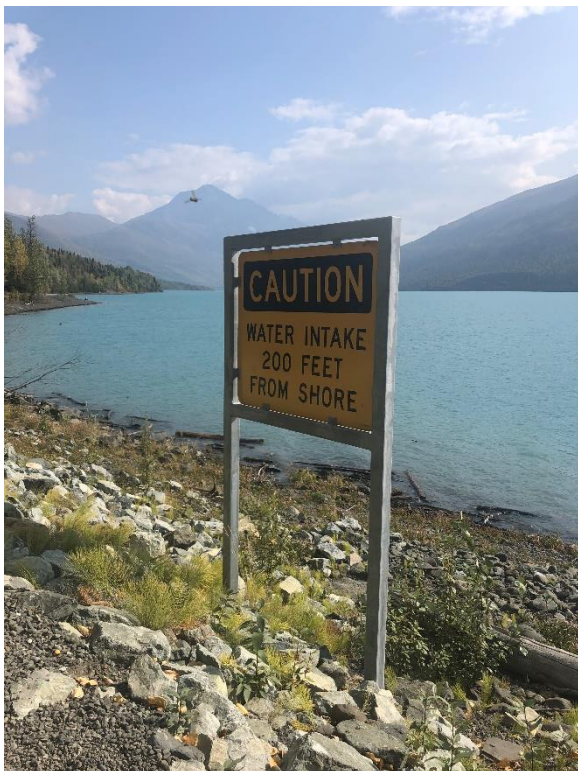
Intake and lake level monitoring area: Intake structure is completely submerged with the power project tunnel and AWWU tunnel buried below ground. A short section of the existing lakeside trail was walked to the location of the power project intake. Some concerns about trail erosion if lake levels were raised for spill events were mentioned by Kurt Hensel with Chugach State Park during the initial consultation meeting in April 2019. During the site visit, the lake elevation (865.69 feet) was well below the trail elevation at the project intake and some areas of exposed banks were observed.

Figure 4: Power tunnel intake

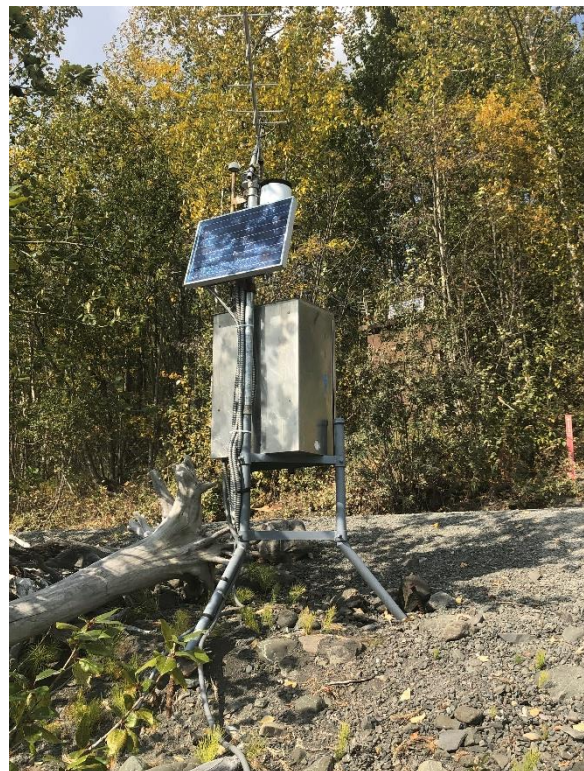
Figure 5: USGS gage at intake

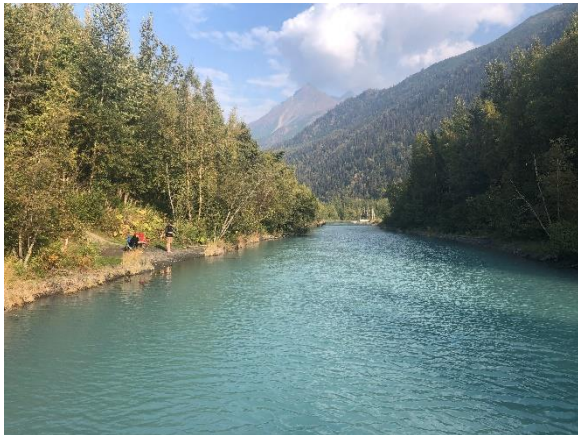
Project tailrace area: Constructed channel that drains into the Knik River and serves as the tailrace outflow for the project. There is currently a non-operational and unstaffed hatchery located at the upstream end of the tailrace with facilities still being used by ADF&G as an acclimation and release location for Chinook salmon. As a result, relatively large numbers of Chinook return annually to the tailrace area in an effort to spawn. This has led to a rather robust recreational fishing opportunity for the local population. A well-established parking area with bathrooms and rudimentary camping areas were observed along with a comprehensive kiosk outlining the fishing regulations for each species. Trails and cleared-out areas along the bank were also observed indicating areas of high fishing activity over many years. Multiple individuals were observed fishing in the tailrace area during our visit.

Figure 6: Fisherman at project tailrace

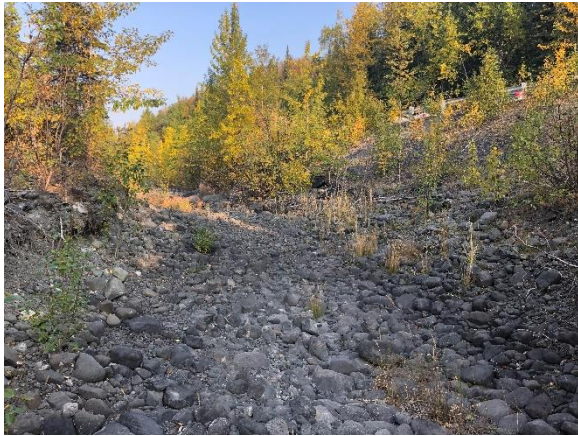
Eklutna Lake Dam to 2019 USFWS study site: Dry channel with a gradient ranging from 2-4% that has a dominant/sub-dominant substrate class of cobble/small boulder with very limited gravels (i.e. potential spawning habitat). Primary habitat appears to be riffles with intermittent pools. It is notable that these habitat designations are conceptual in nature and cannot be accurately defined in great detail without persistent water flow in the channel. In addition, many small, dry side channels were observed as the channel meanders through a relatively well confined valley. This area was completely dry with the exception of a few areas where groundwater and/or a small tributary create sporadic and intermittent pockets of water. In one such pocket, 3 Dolly Varden were observed.

Figure 7: 2019 USFWS study site looking downstream

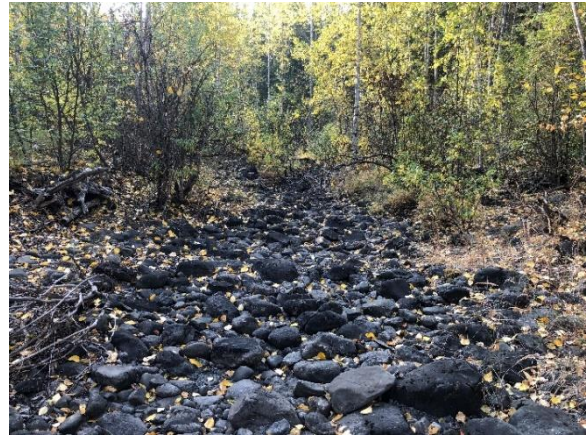
Figure 8: Upstream of 2019 USFWS study site

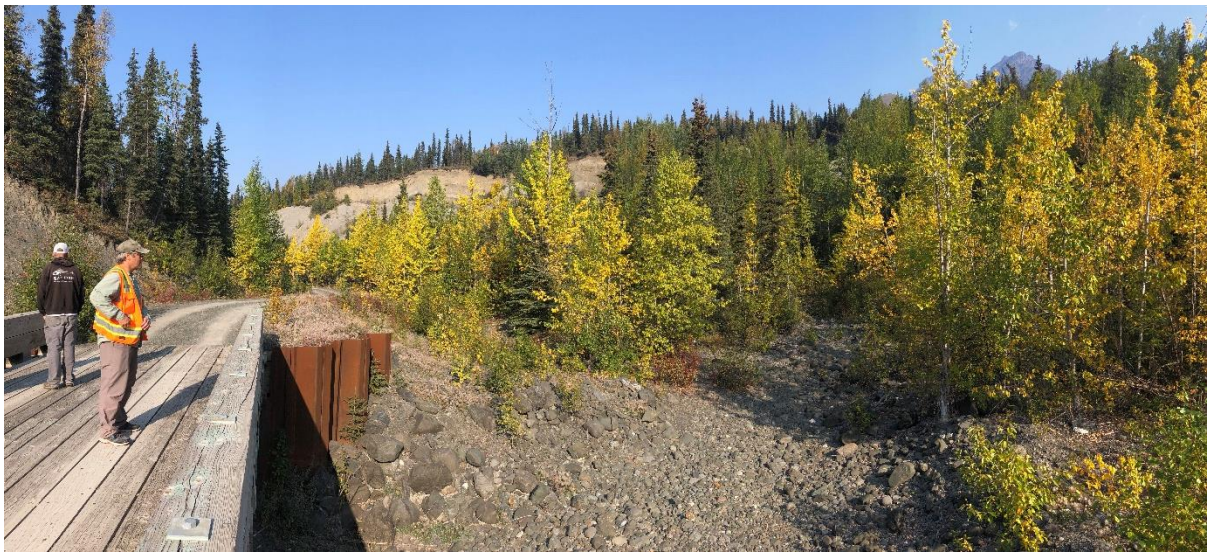
NOTE: Channel morphology of the 2019 USFWS study site continues downstream to the first AWWU access road bridge crossing.

Figure 9: Eklutna riverbed at 1<sup>st</sup> AWWU bridge crossing

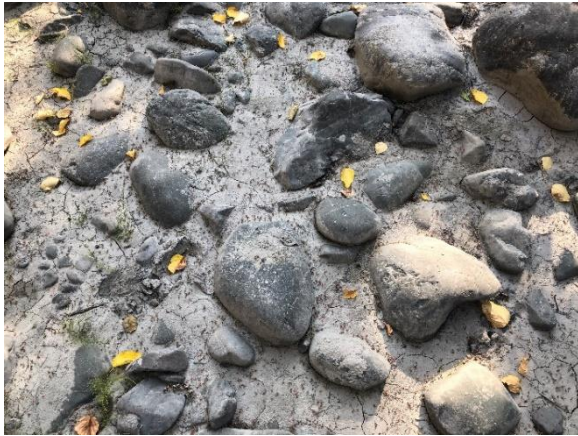
Eklutna River 2<sup>nd</sup> AWWU bridge crossing/Portal Valve Area and downstream: Channel remains dry, but an appreciable amount of fine silt is detected in this area. Many steep, eroding cliffs are observed in the surrounding valley and are most likely contributing to the detectable sedimentation. Cobble remains the dominant substrate class and the channel gradient slightly decreases to 1-3%. Certain areas however, are so overwhelmed with fine sediment that the embedded coarser substrate that lies below cannot be observed. Progressing downstream from the portal valve area, the AWWU road fords the channel at several locations with intermittent water seepage and dry sections of channel. At GPS Waypoint 083, approximately 4 miles downstream of the current dam, the Eklutna River has a consistent, stable flow of approximately 1-2 cfs. Approximately 4.6 miles below the earthen dam (GPS waypoint 084), the wetted channel width ranges from 15-18 feet, flows slightly increase to approximately 2-3cfs, and silt is still observed infilling the interstitial spaces of the cobble/boulder substrate.

Figure 10: Fine silt between cobble

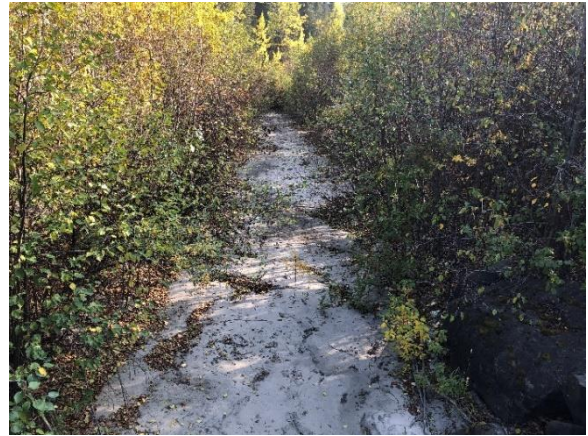
Figure 11: Fine sediment covering coarser substrate

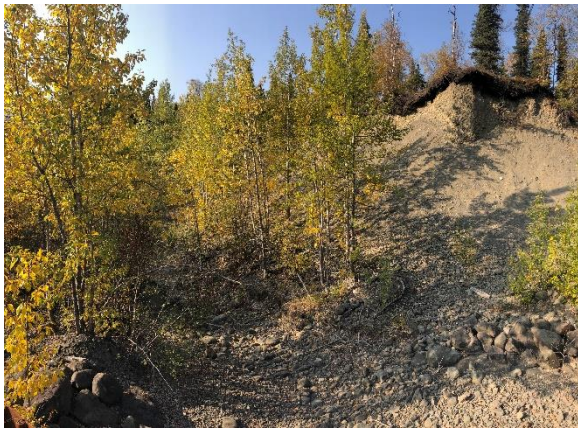
Figure 12: Sedimentation source adjacent to river

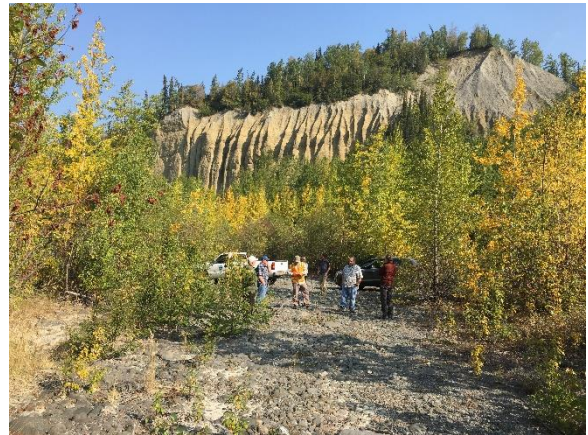
Figure 13: Eroding cliffs contributing to sedimentation

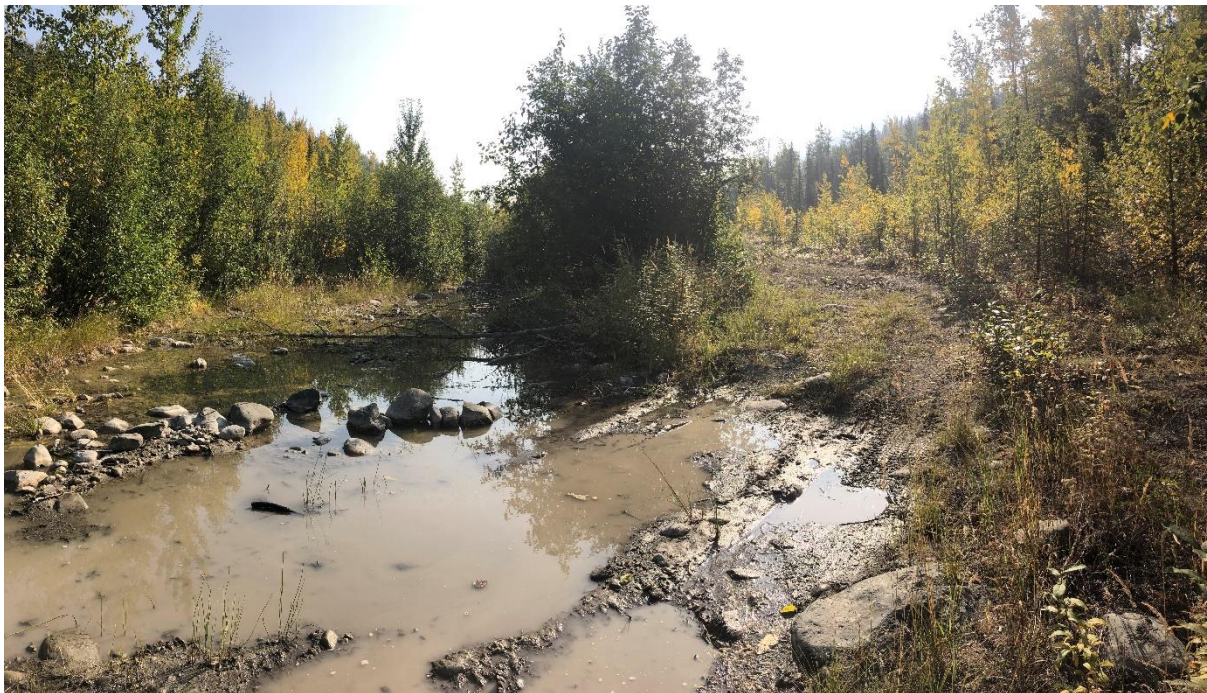
Figure 14: AWWU access road fords the Eklutna river

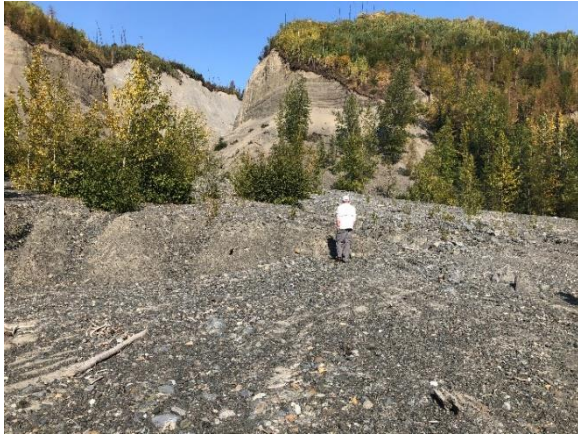
comparison to the upper river sections. A large active landslide area of sand and gravel was observed on the right side of the channel (looking downstream). The active slide area is immediately adjacent to the channel and constricts the wetted channel width to about 5-6 feet.

Figure 15: Large active landslide area

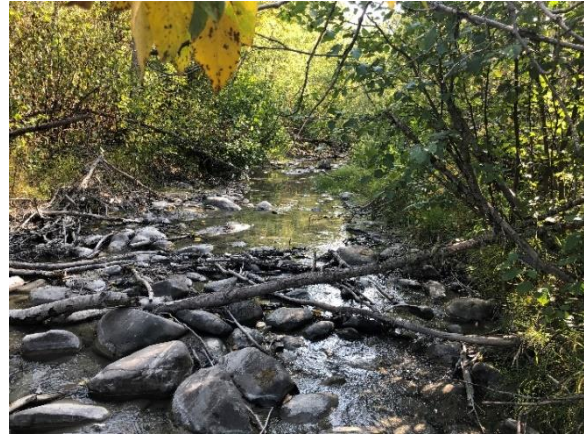
Figure 16: Eklutna river with sustained flow of 2-3 cfs

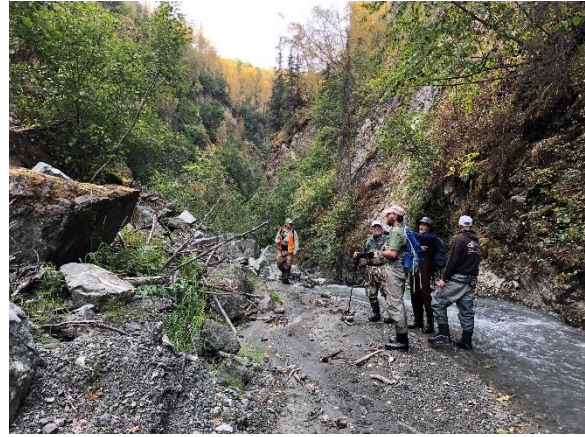
Figure 23: Channel constriction from landslide

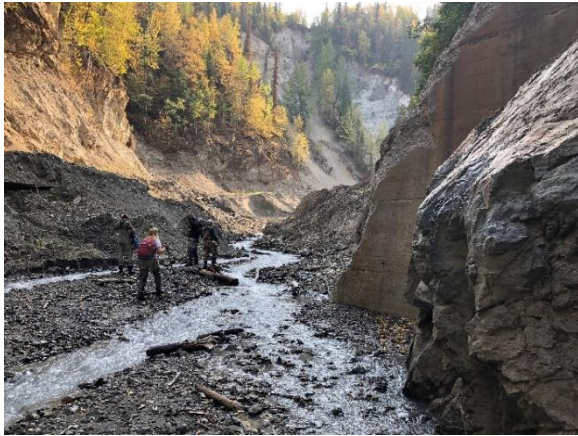
Lower dam removal site: Extensive unconsolidated sediments adjacent to each bank were observed. In addition, there was construction debris such as wood, lengths of metal, plastic tubing, tires and other refuse at this location. It's unknown but seems possible that additional debris and refuse may be located in the sediments. Progressing upstream, the channel steepens and narrows (4-6 feet wide) for several hundred feet through unconsolidated streambanks while slowly cutting a channel through the middle section of the significant amount of fines. After exiting the influence of the lower dam site, the gradient lessens to about 1-3% and the water clarity noticeably improves.

Figure 25: Lower dam site looking upstream

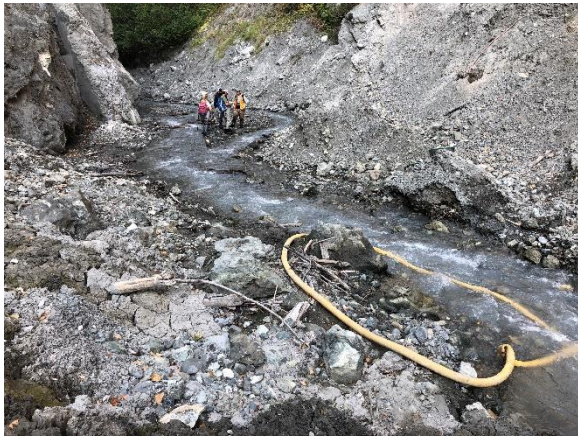
Figure 27: Plastic tubing construction debris

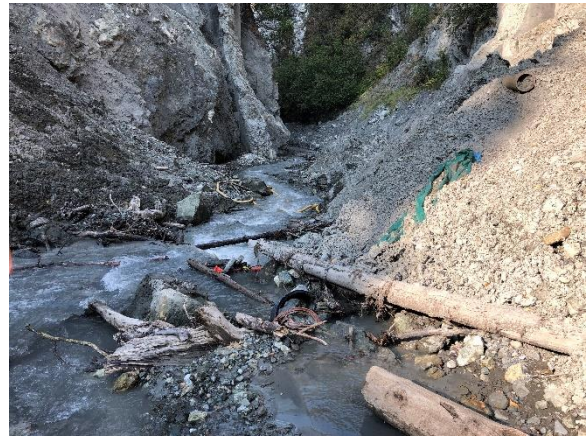
Figure 28: Miscellaneous construction debris

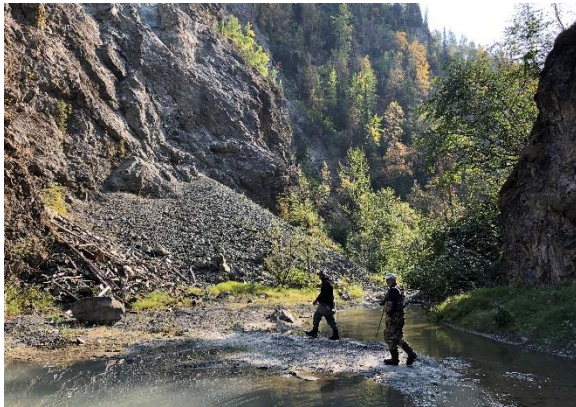
Eklutna River above the lower dam removal site to the downstream terminus of the AWWU access road: Low gradient (1-3%) channel with improved water clarity, but still a noticeable input of fines. Approximately 1,000 feet beyond the influence of the diversion dam site, a beaver dam and pond were encountered. Leading up to the beaver pond, a large berm was constructed along the left bank (looking downstream) presumably to move heavy equipment out of the channel. This berm creates a pinch point, narrowing and increasing the channel gradient leading up to the beaver pond. Upstream of the beaver pond, the Eklutna River returns to a low gradient, cobble-dominated channel with riffle-pool habitat features. Several resident fish were observed between the beaver pond and the

Figure 31: Sedimentation input upstream of lower dam site

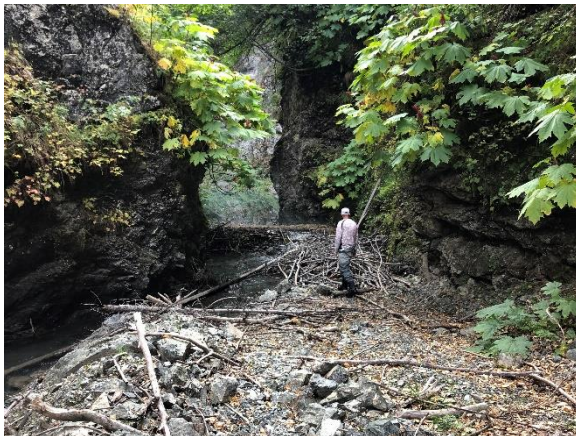
Figure 33: Beaver dam and pond
