Eklutna Hydroelectric Project

Fish & Wildlife Program Development Site Reconnaissance Trip Report

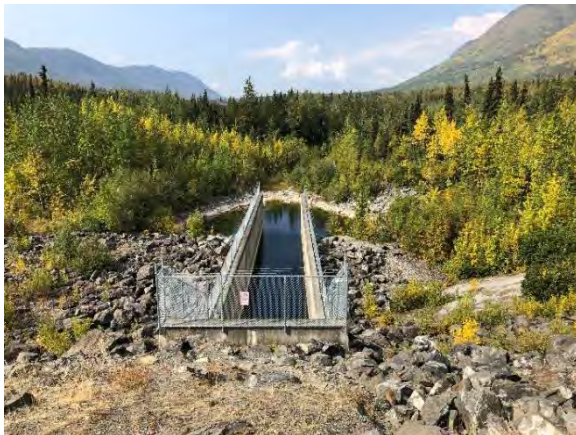
Eklutna Lake Dam and spillway area: Earthen dam with an ogee spillway that only releases water when lake elevation exceeds 871 feet¹. A concrete lined outflow canal exits the spillway, creating a large scour pool at the start of the natural channel. Residual water in the canal and scour pool observed. Eklutna River is a dry channel, just downstream of the spillway area.

Figure 1: Spillway looking downstream

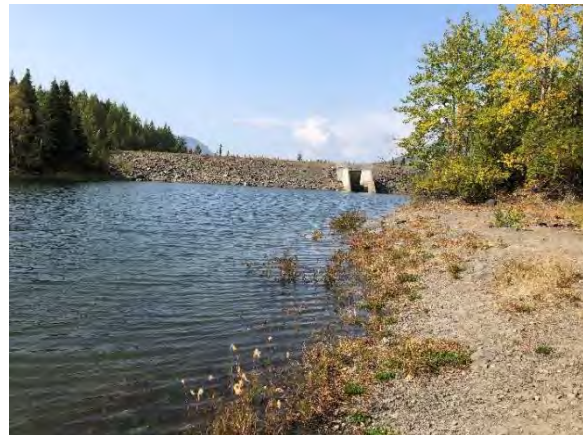
Figure 2: "Pond" between old and current dam

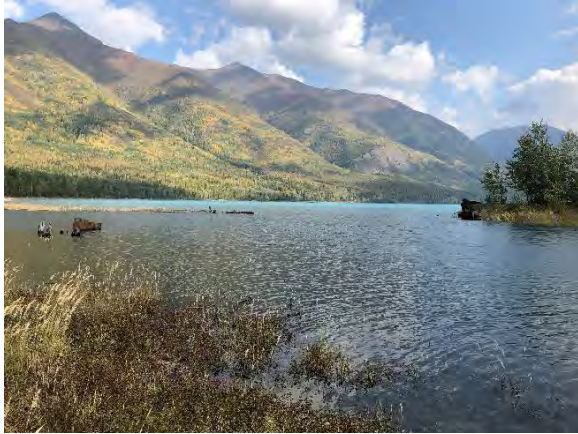
Original Eklutna Lake Dam area: Relic sheet piling and wooden piles were observed along the margins of natural lake outflow channel. Lake elevation was 865.69 feet during the site visit and connectivity from lake downstream to the earthen dam was not interrupted by the relict dam structure. The "pond" that is intermittently connected to the lake and flows to the current dam site would be an important feature to consider in the study effort. A small tributary stream was observed entering this pond from the eastern shore approximately 200 yards up from the current dam. A small delta where the stream enters the pond was more evident during a previous site visit on July 17, 2019.

Figure 3: Remnants of old dam structures at lake outlet

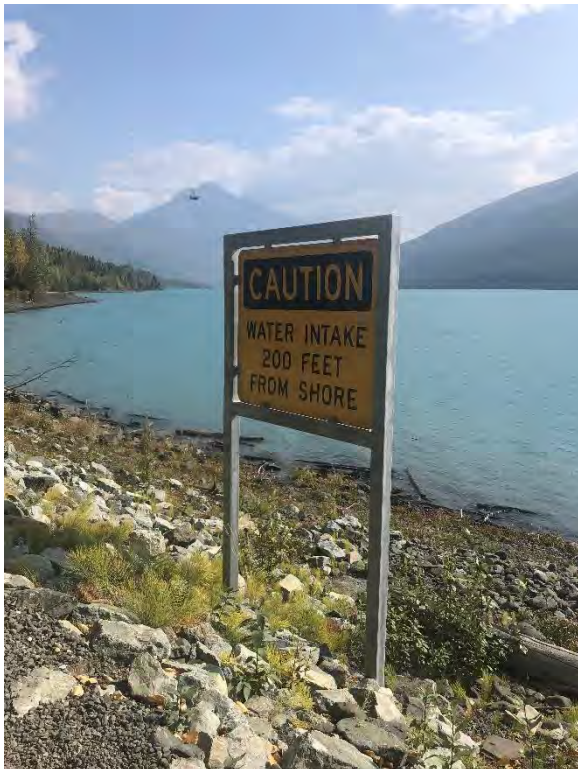
Intake and lake level monitoring area: Intake structure is completely submerged with the power project tunnel and AWWU tunnel buried below ground. A short section of the existing lakeside trail was walked to the location of the power project intake. Some concerns about trail erosion if lake levels were raised for spill events were mentioned by Kurt Hensel with Chugach State Park during the initial consultation meeting in April 2019. During the site visit, the lake elevation (865.69 feet) was well below the trail elevation at the project intake and some areas of exposed banks were observed.

Figure 4: Power tunnel intake

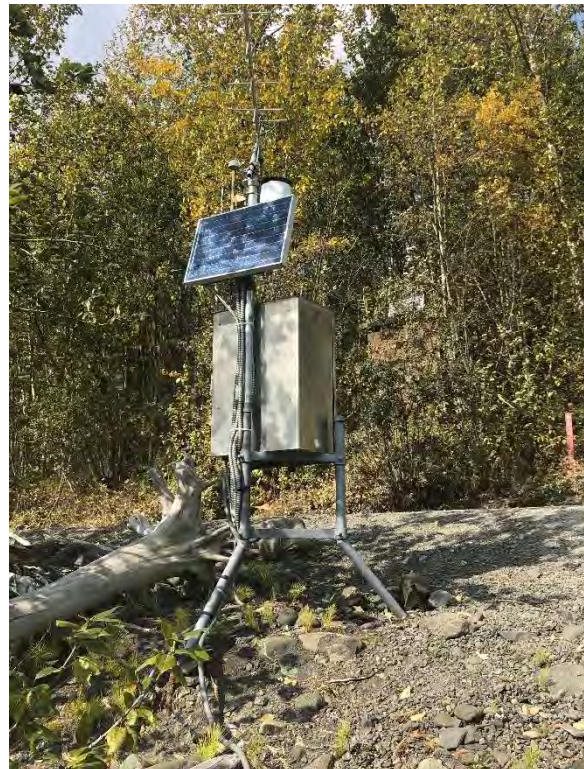
Figure 5: USGS gage at intake

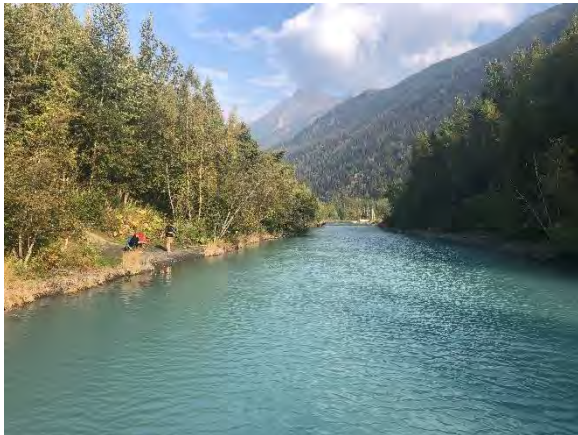
Figure 6: Fisherman at project tailrace

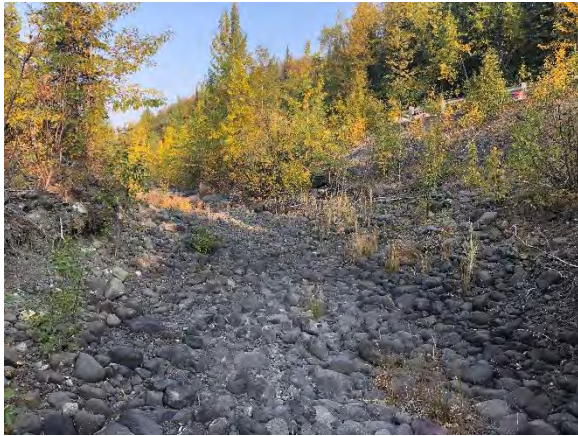
Eklutna Lake Dam to 2019 USFWS study site: Dry channel with a gradient ranging from 2-4% that has a dominant/sub-dominant substrate class of cobble/small boulder with very limited gravels (i.e. potential spawning habitat). Primary habitat appears to be riffles with intermittent pools. It is notable that these habitat designations are conceptual in nature and cannot be accurately defined in great detail without persistent water flow in the channel. In addition, many small, dry side channels were observed as the channel meanders through a relatively well confined valley. This area was completely dry with the exception of a few areas where groundwater and/or a small tributary create sporadic and intermittent pockets of water. In one such pocket, 3 Dolly Varden were observed.

Figure 7: 2019 USFWS study site looking downstream

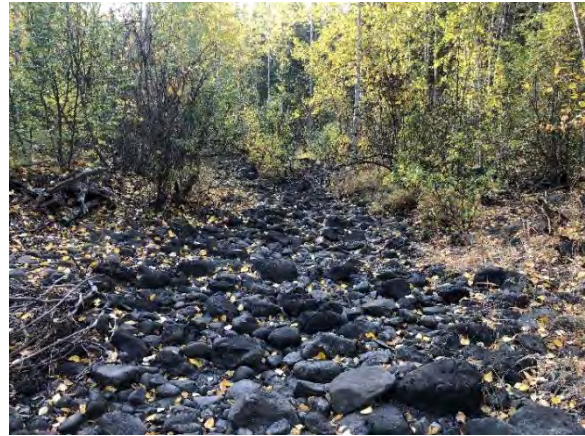
Figure 8: Upstream of 2019 USFWS study site

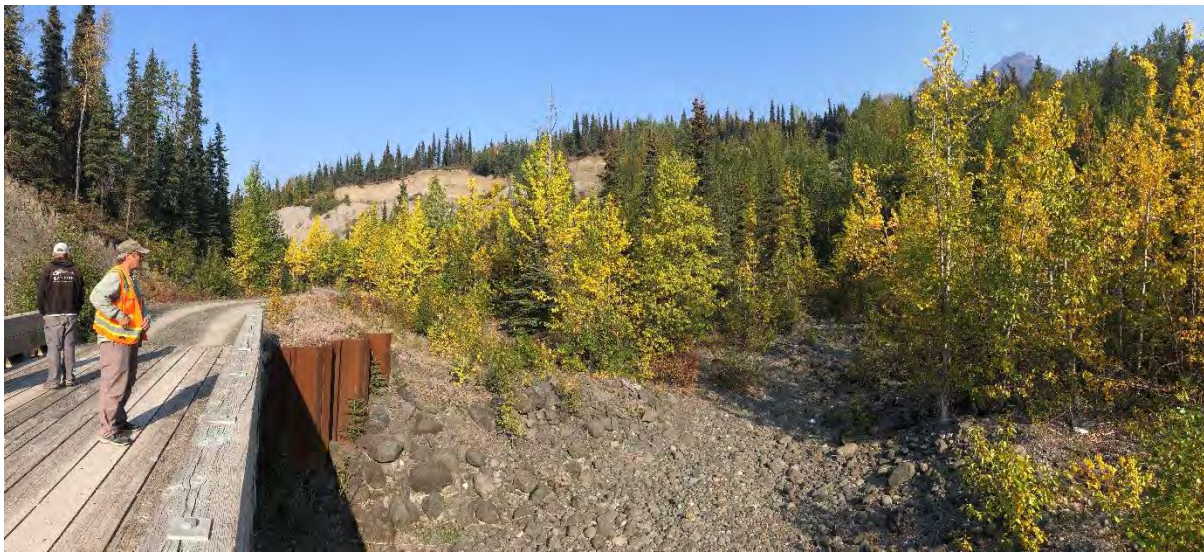
Figure 9: Eklutna riverbed at 1st AWWU bridge crossing

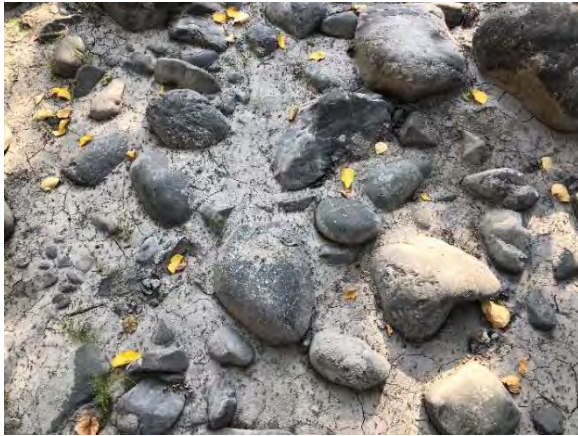
Eklutna River 2nd AWWU bridge crossing/Portal Valve Area and downstream: Channel remains dry, but an appreciable amount of fine silt is detected in this area. Many steep, eroding cliffs are observed in the surrounding valley and are most likely contributing to the detectable sedimentation. Cobble remains the dominant substrate class and the channel gradient slightly decreases to 1-3%. Certain areas however, are so overwhelmed with fine sediment that the embedded coarser substrate that lies below cannot be observed. Progressing downstream from the portal valve area, the AWWU road fords the channel at several locations with intermittent water seepage and dry sections of channel. At GPS Waypoint 083, approximately 4 miles downstream of the current dam, the Eklutna River has a consistent, stable flow of approximately 1-2 cfs. Approximately 4.6 miles below the earthen dam (GPS waypoint 084), the wetted channel width ranges from 15-18 feet, flows slightly increase to approximately 2-3cfs, and silt is still observed infilling the interstitial spaces of the cobble/boulder substrate.

Figure 10: Fine silt between cobble

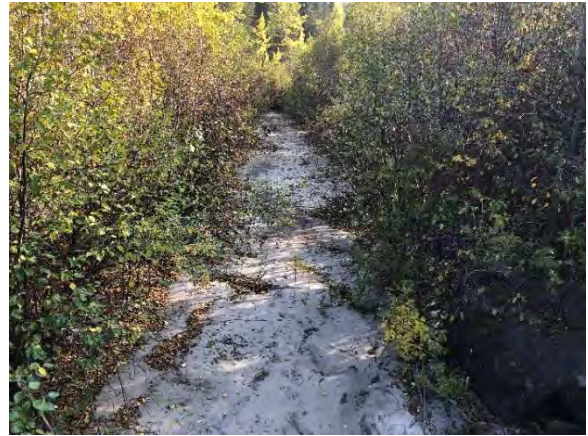
Figure 11: Fine sediment covering coarser substrate

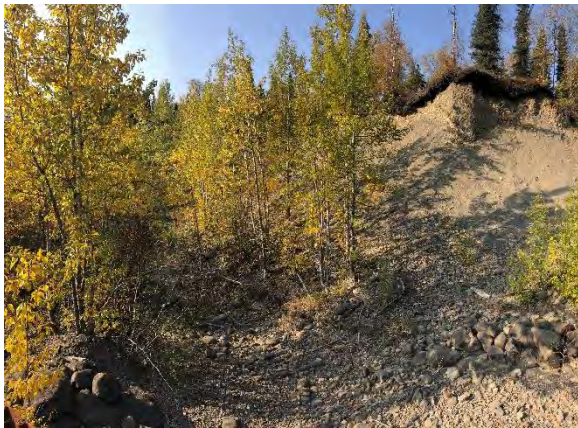
Figure 12: Sedimentation source adjacent to river

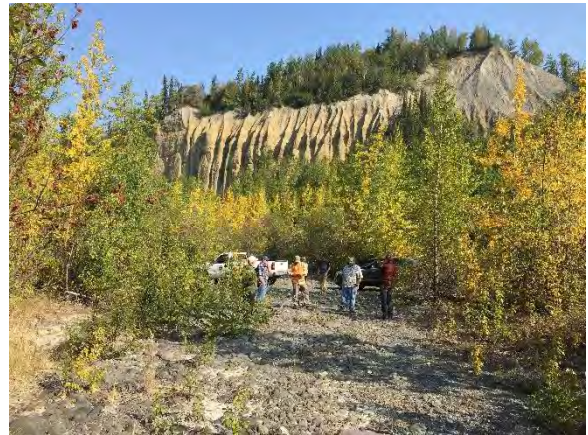
Figure 13: Eroding cliffs contributing to sedimentation

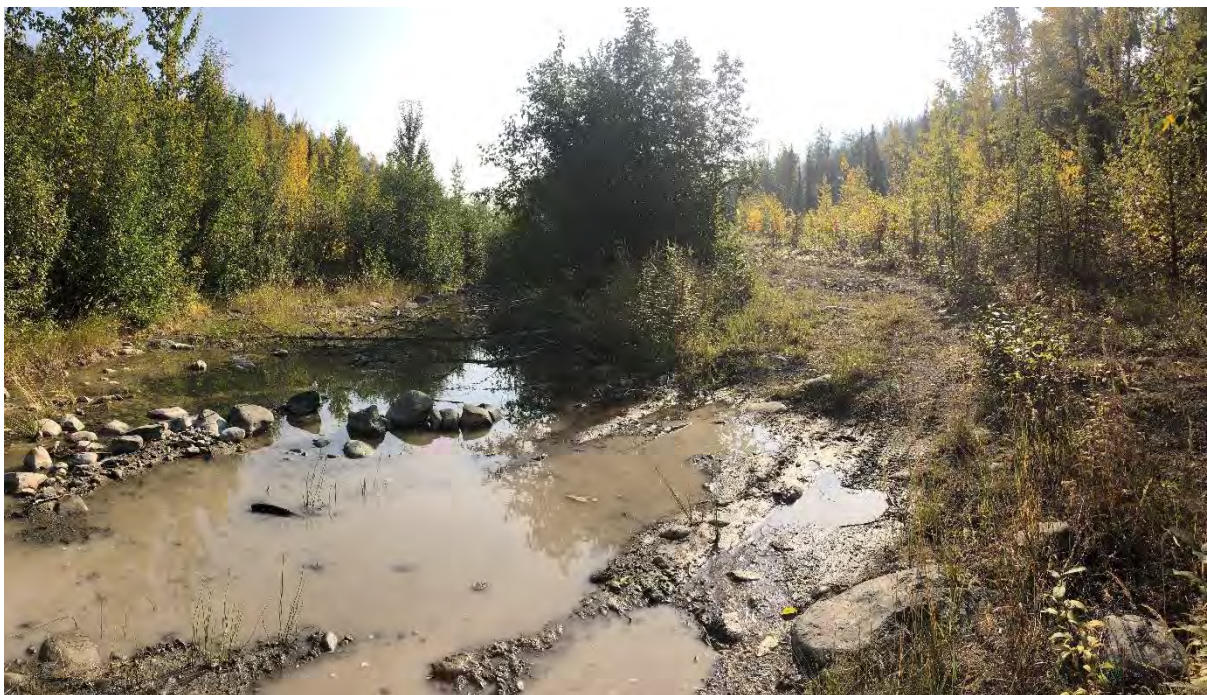
Figure 14: AWWU access road fords the Eklutna river

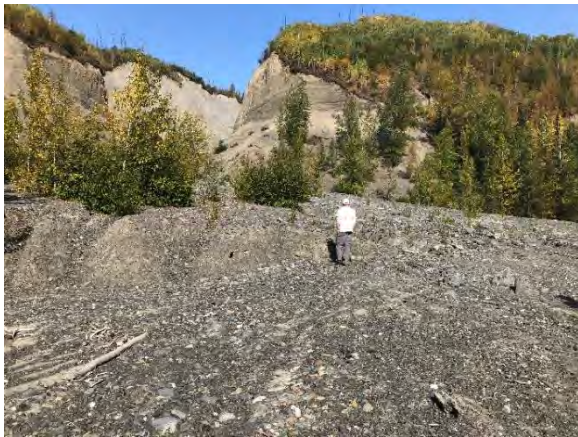
comparison to the upper river sections. A large active landslide area of sand and gravel was observed on the right side of the channel (looking downstream). The active slide area is immediately adjacent to the channel and constricts the wetted channel width to about 5-6 feet.

Figure 15: Large active landslide area

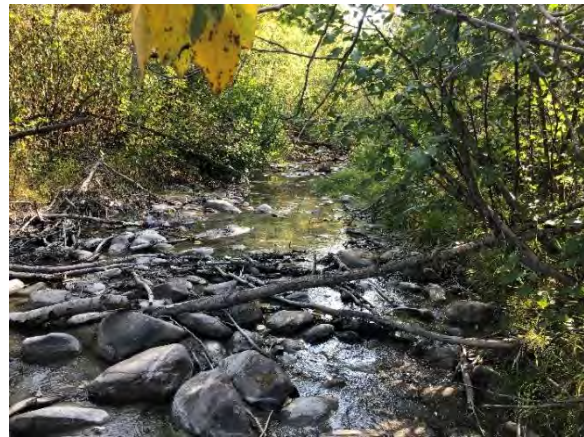
Figure 16: Eklutna river with sustained flow of 2-3 cfs

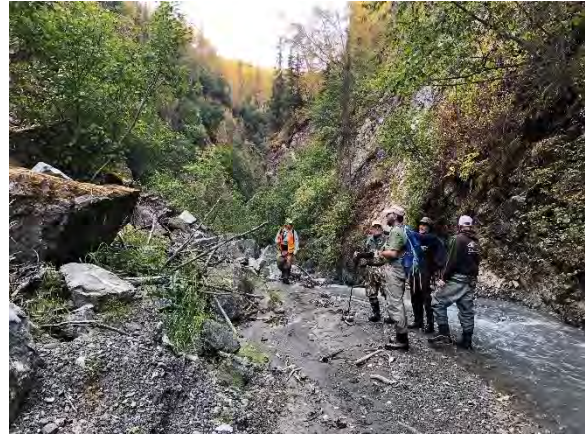
Figure 23: Channel constriction from landslide

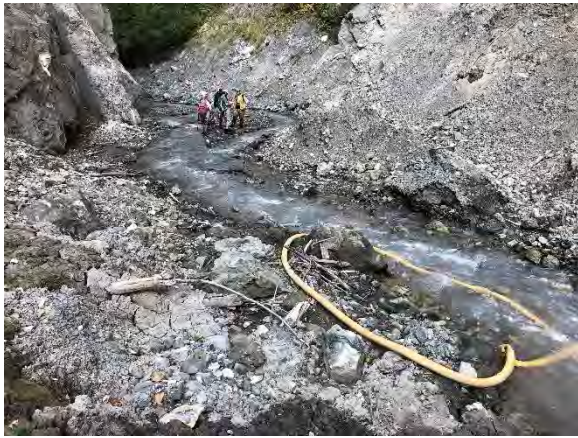
Lower dam removal site: Extensive unconsolidated sediments adjacent to each bank were observed. In addition, there was construction debris such as wood, lengths of metal, plastic tubing, tires and other refuse at this location. It's unknown but seems possible that additional debris and refuse may be located in the sediments. Progressing upstream, the channel steepens and narrows (4-6 feet wide) for several hundred feet through unconsolidated streambanks while slowly cutting a channel through the middle section of the significant amount of fines. After exiting the influence of the lower dam site, the gradient lessens to about 1-3% and the water clarity noticeably improves.

Figure 27: Plastic tubing construction debris

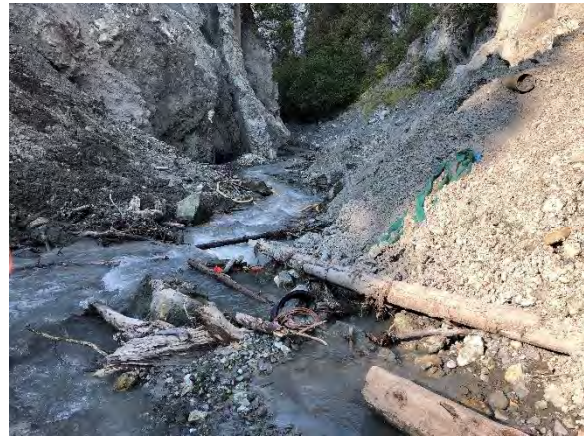
Figure 28: Miscellaneous construction debris

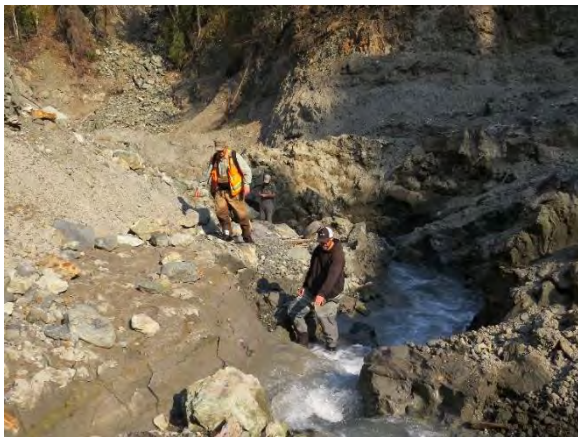
Figure 29: Conditions within lower dam reservoir site

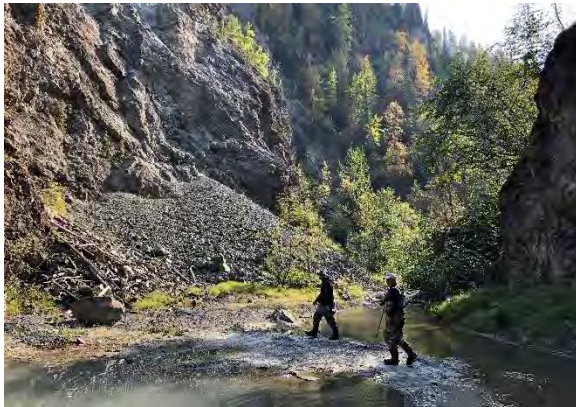
Figure 31: Sedimentation input upstream of lower dam site

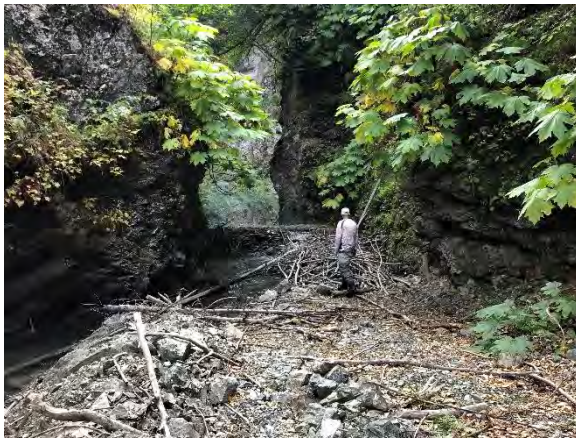
Figure 33: Beaver dam and pond
