UNITED STATES
DEPARTMENT OF THE INTERIOR
Bureau of Reclamation

Eklutna Project
Annual Project History

Calendar Year 1962

Volume XII

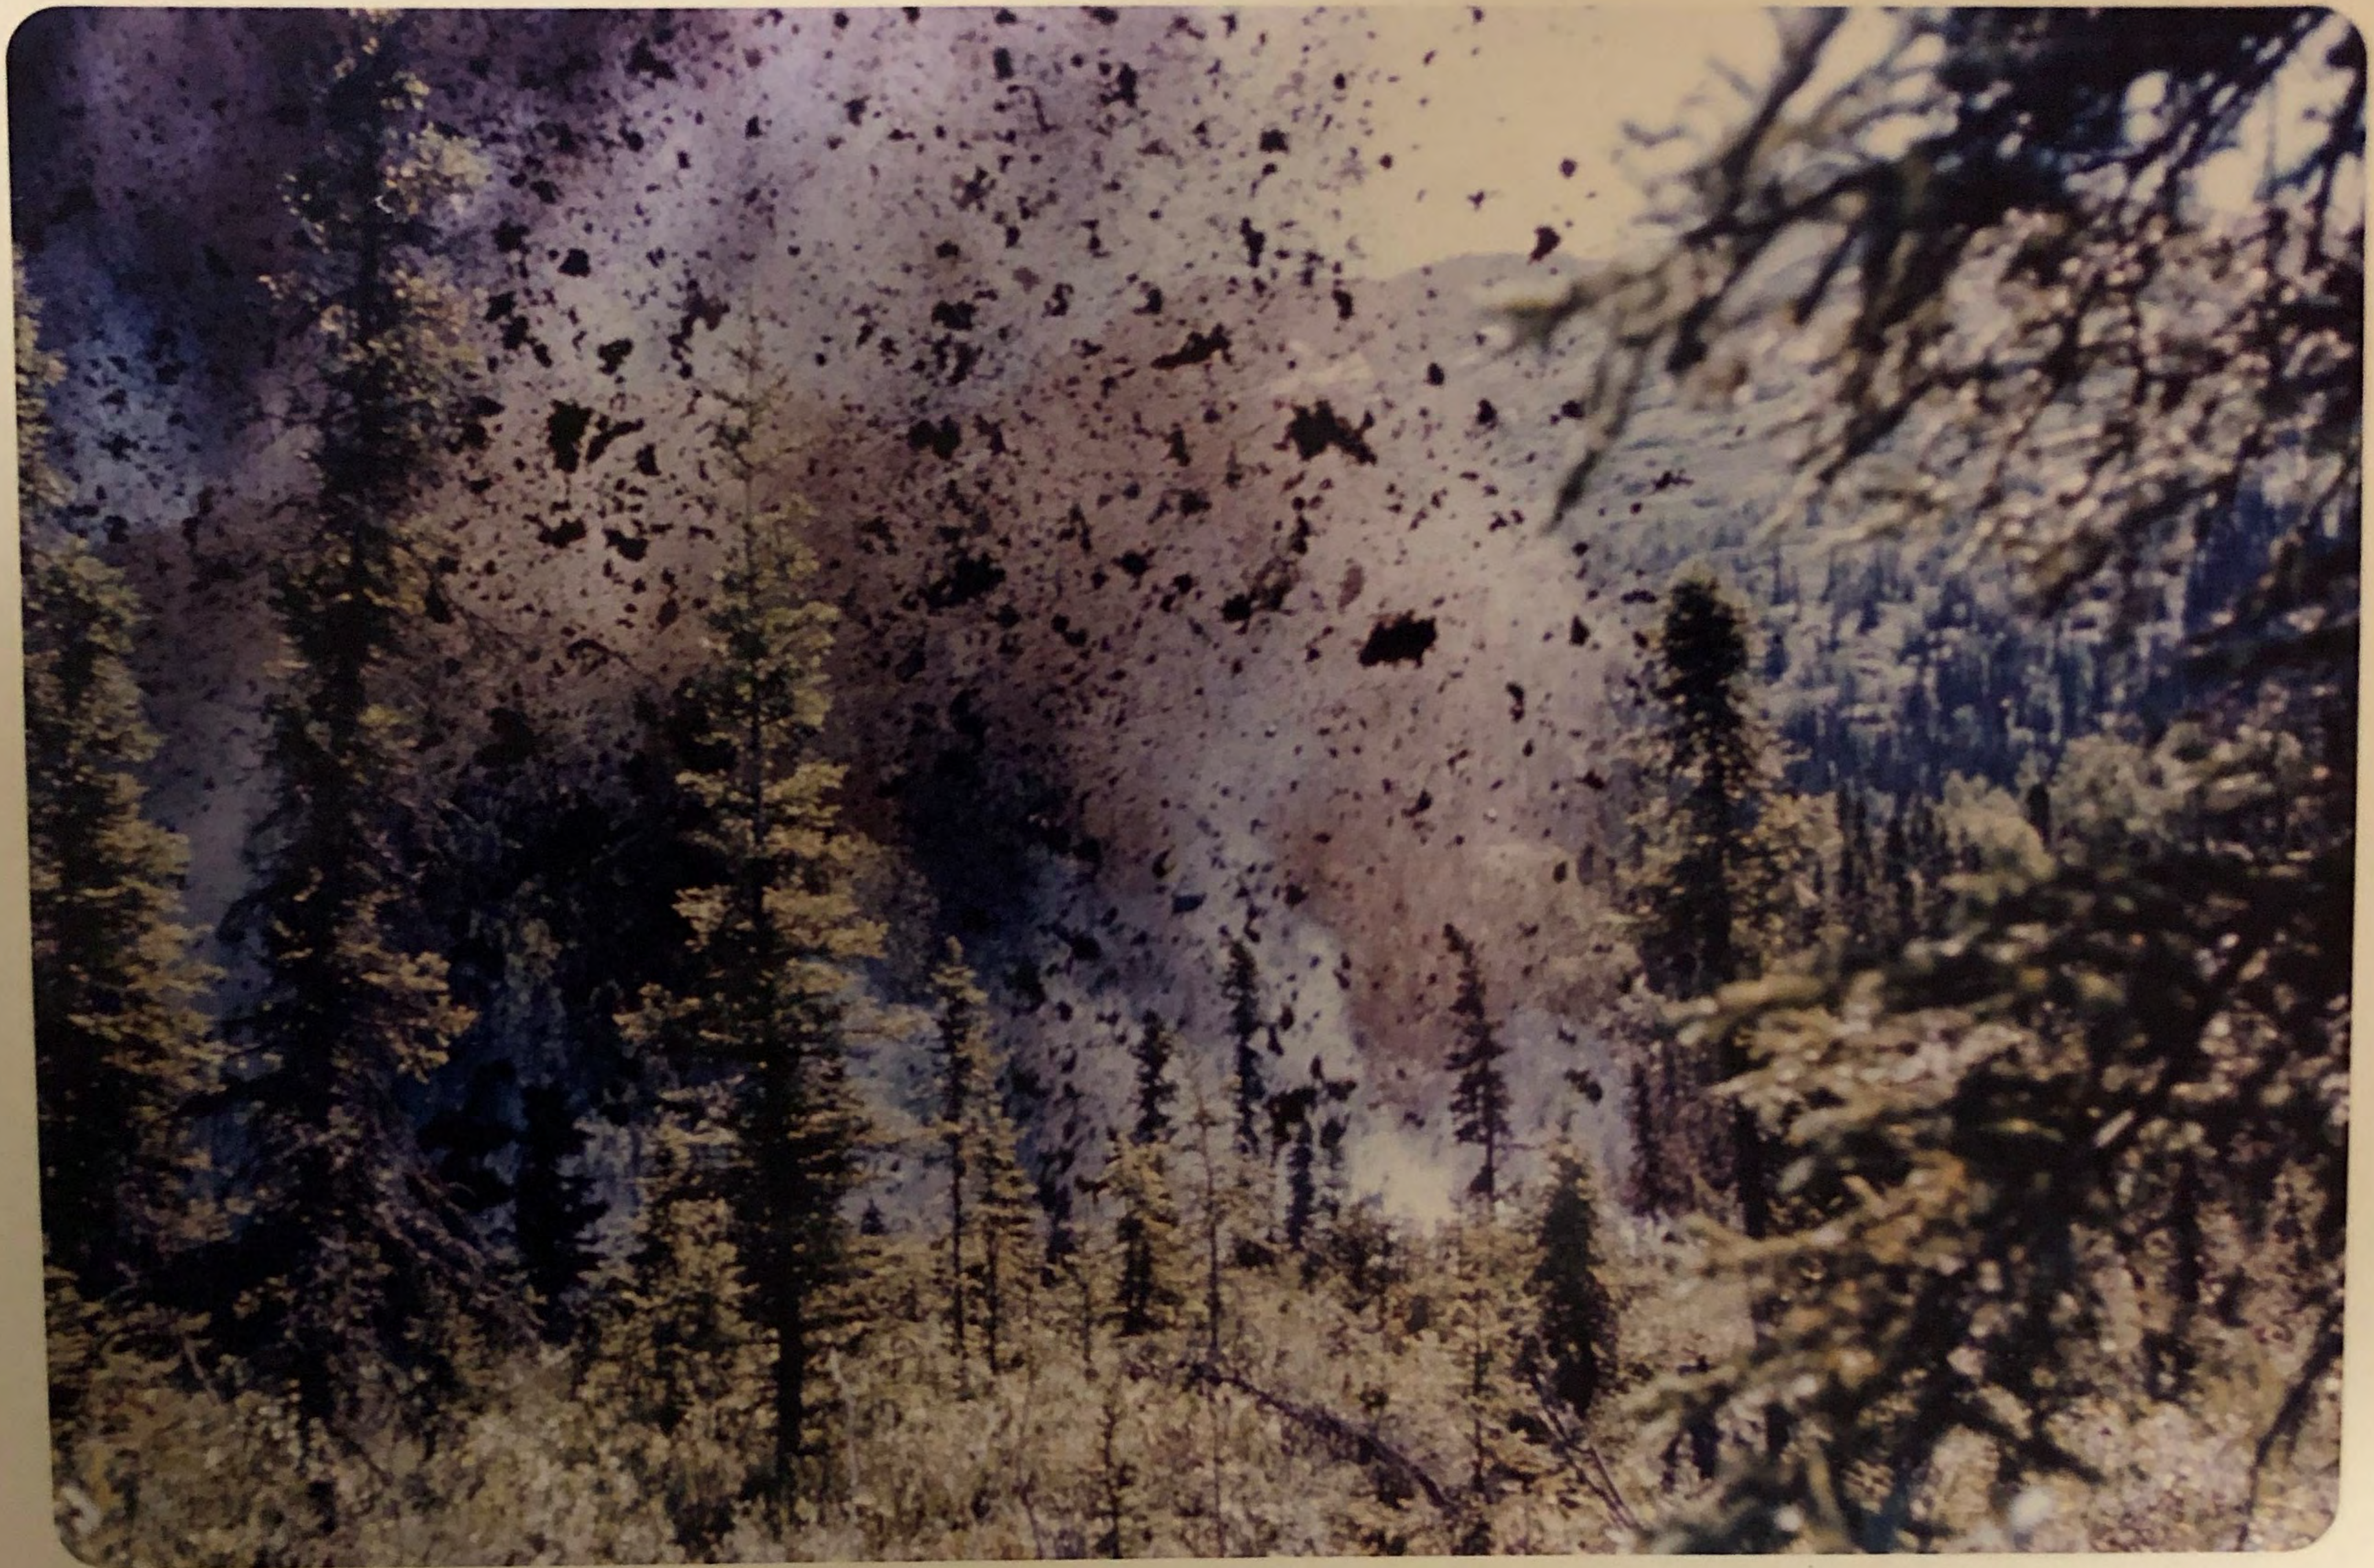
P783-908-2167 - Eklutna Project, Alaska
Dynamiting channel for the diversion of a
stream into Eklutna Lake. This stream
originally ran into Eklutna Creek several
hundred yards below the dam.
5/62 - USBR Photo by T. Lappi

A small stream below the dam was diverted into the lake by digging a short ditch with ditching powder. The flow of the creek was gauged and found to be less than expected, possibly due to the light snow fall during the winter.

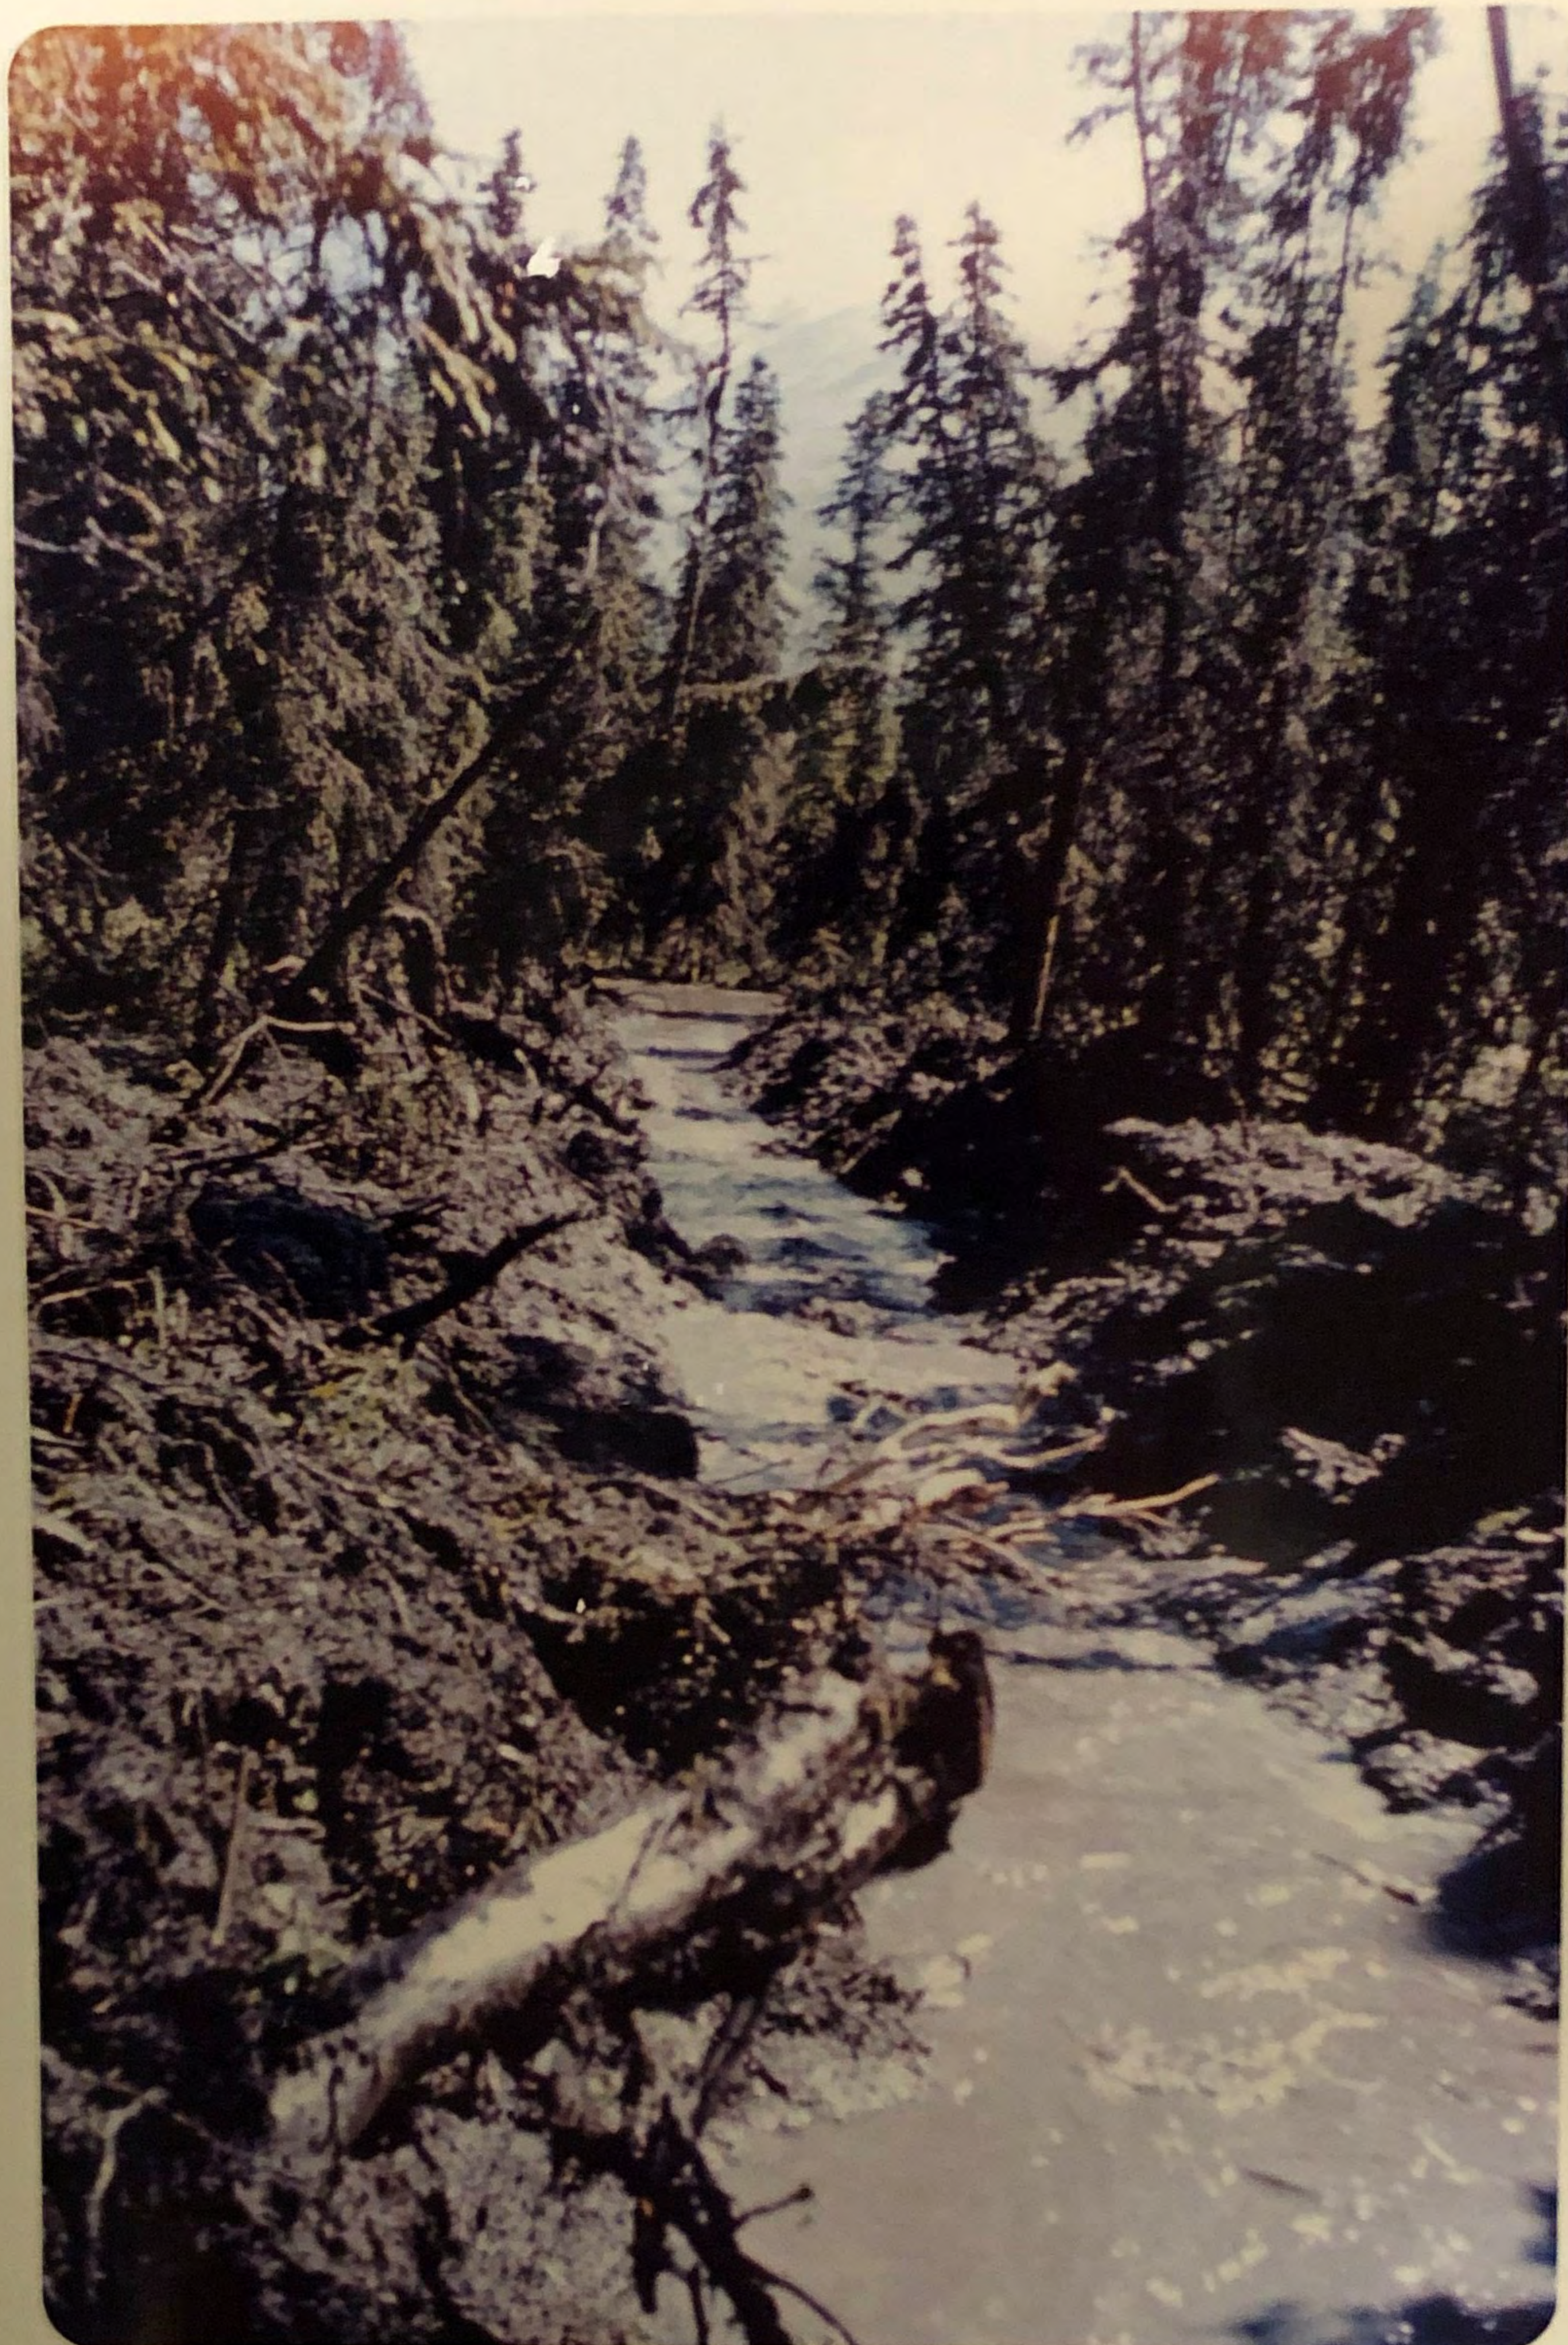
P783-908-2169 - Eklutna Project, Alaska
New channel and water flow in "Blasted
Creek." View looking toward lake.
5/62 - USBR Photo by T. Lappi
