UNITED STATES
DEPARTMENT OF THE INTERIOR
Bureau of Reclamation

Eklutna Project
Annual Project History

Calendar Year 1963

NARRATIVE STATEMENT

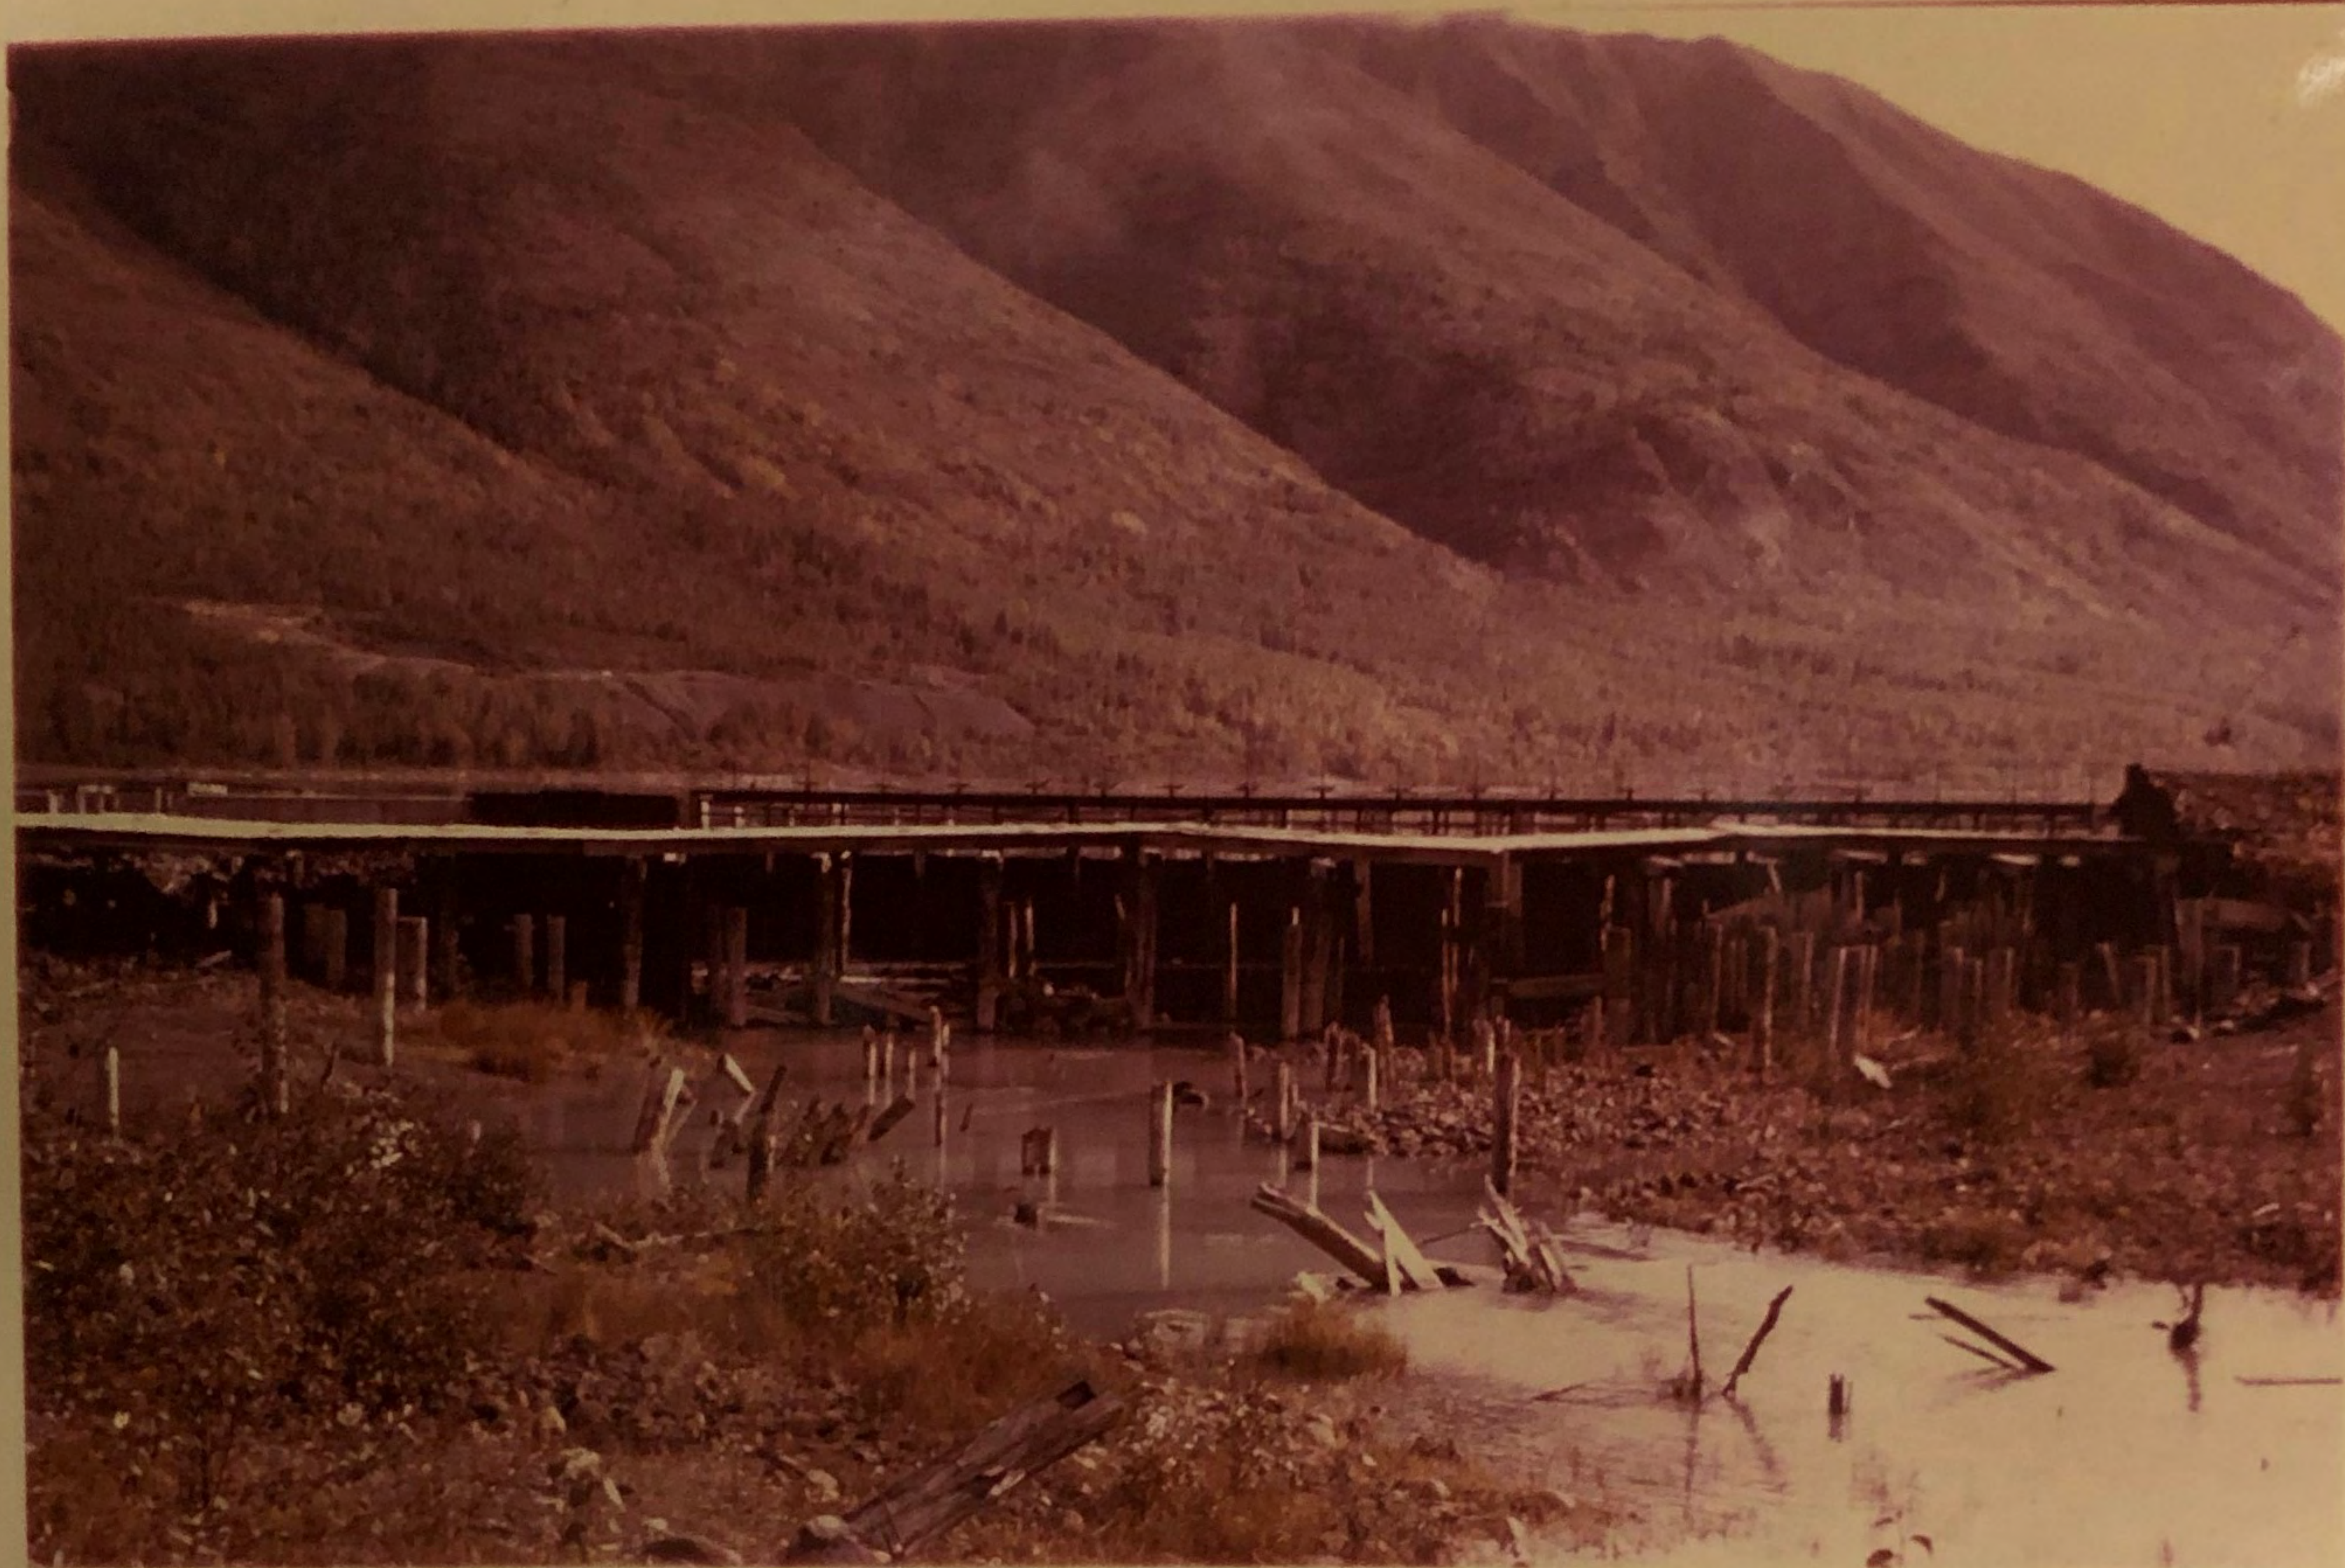
P783-908-2198 - Eklutna Project, Alaska
View of Eklutna Dam showing leakage flow
below dam.
9/63 - USBR Photo by Tauno Lappi

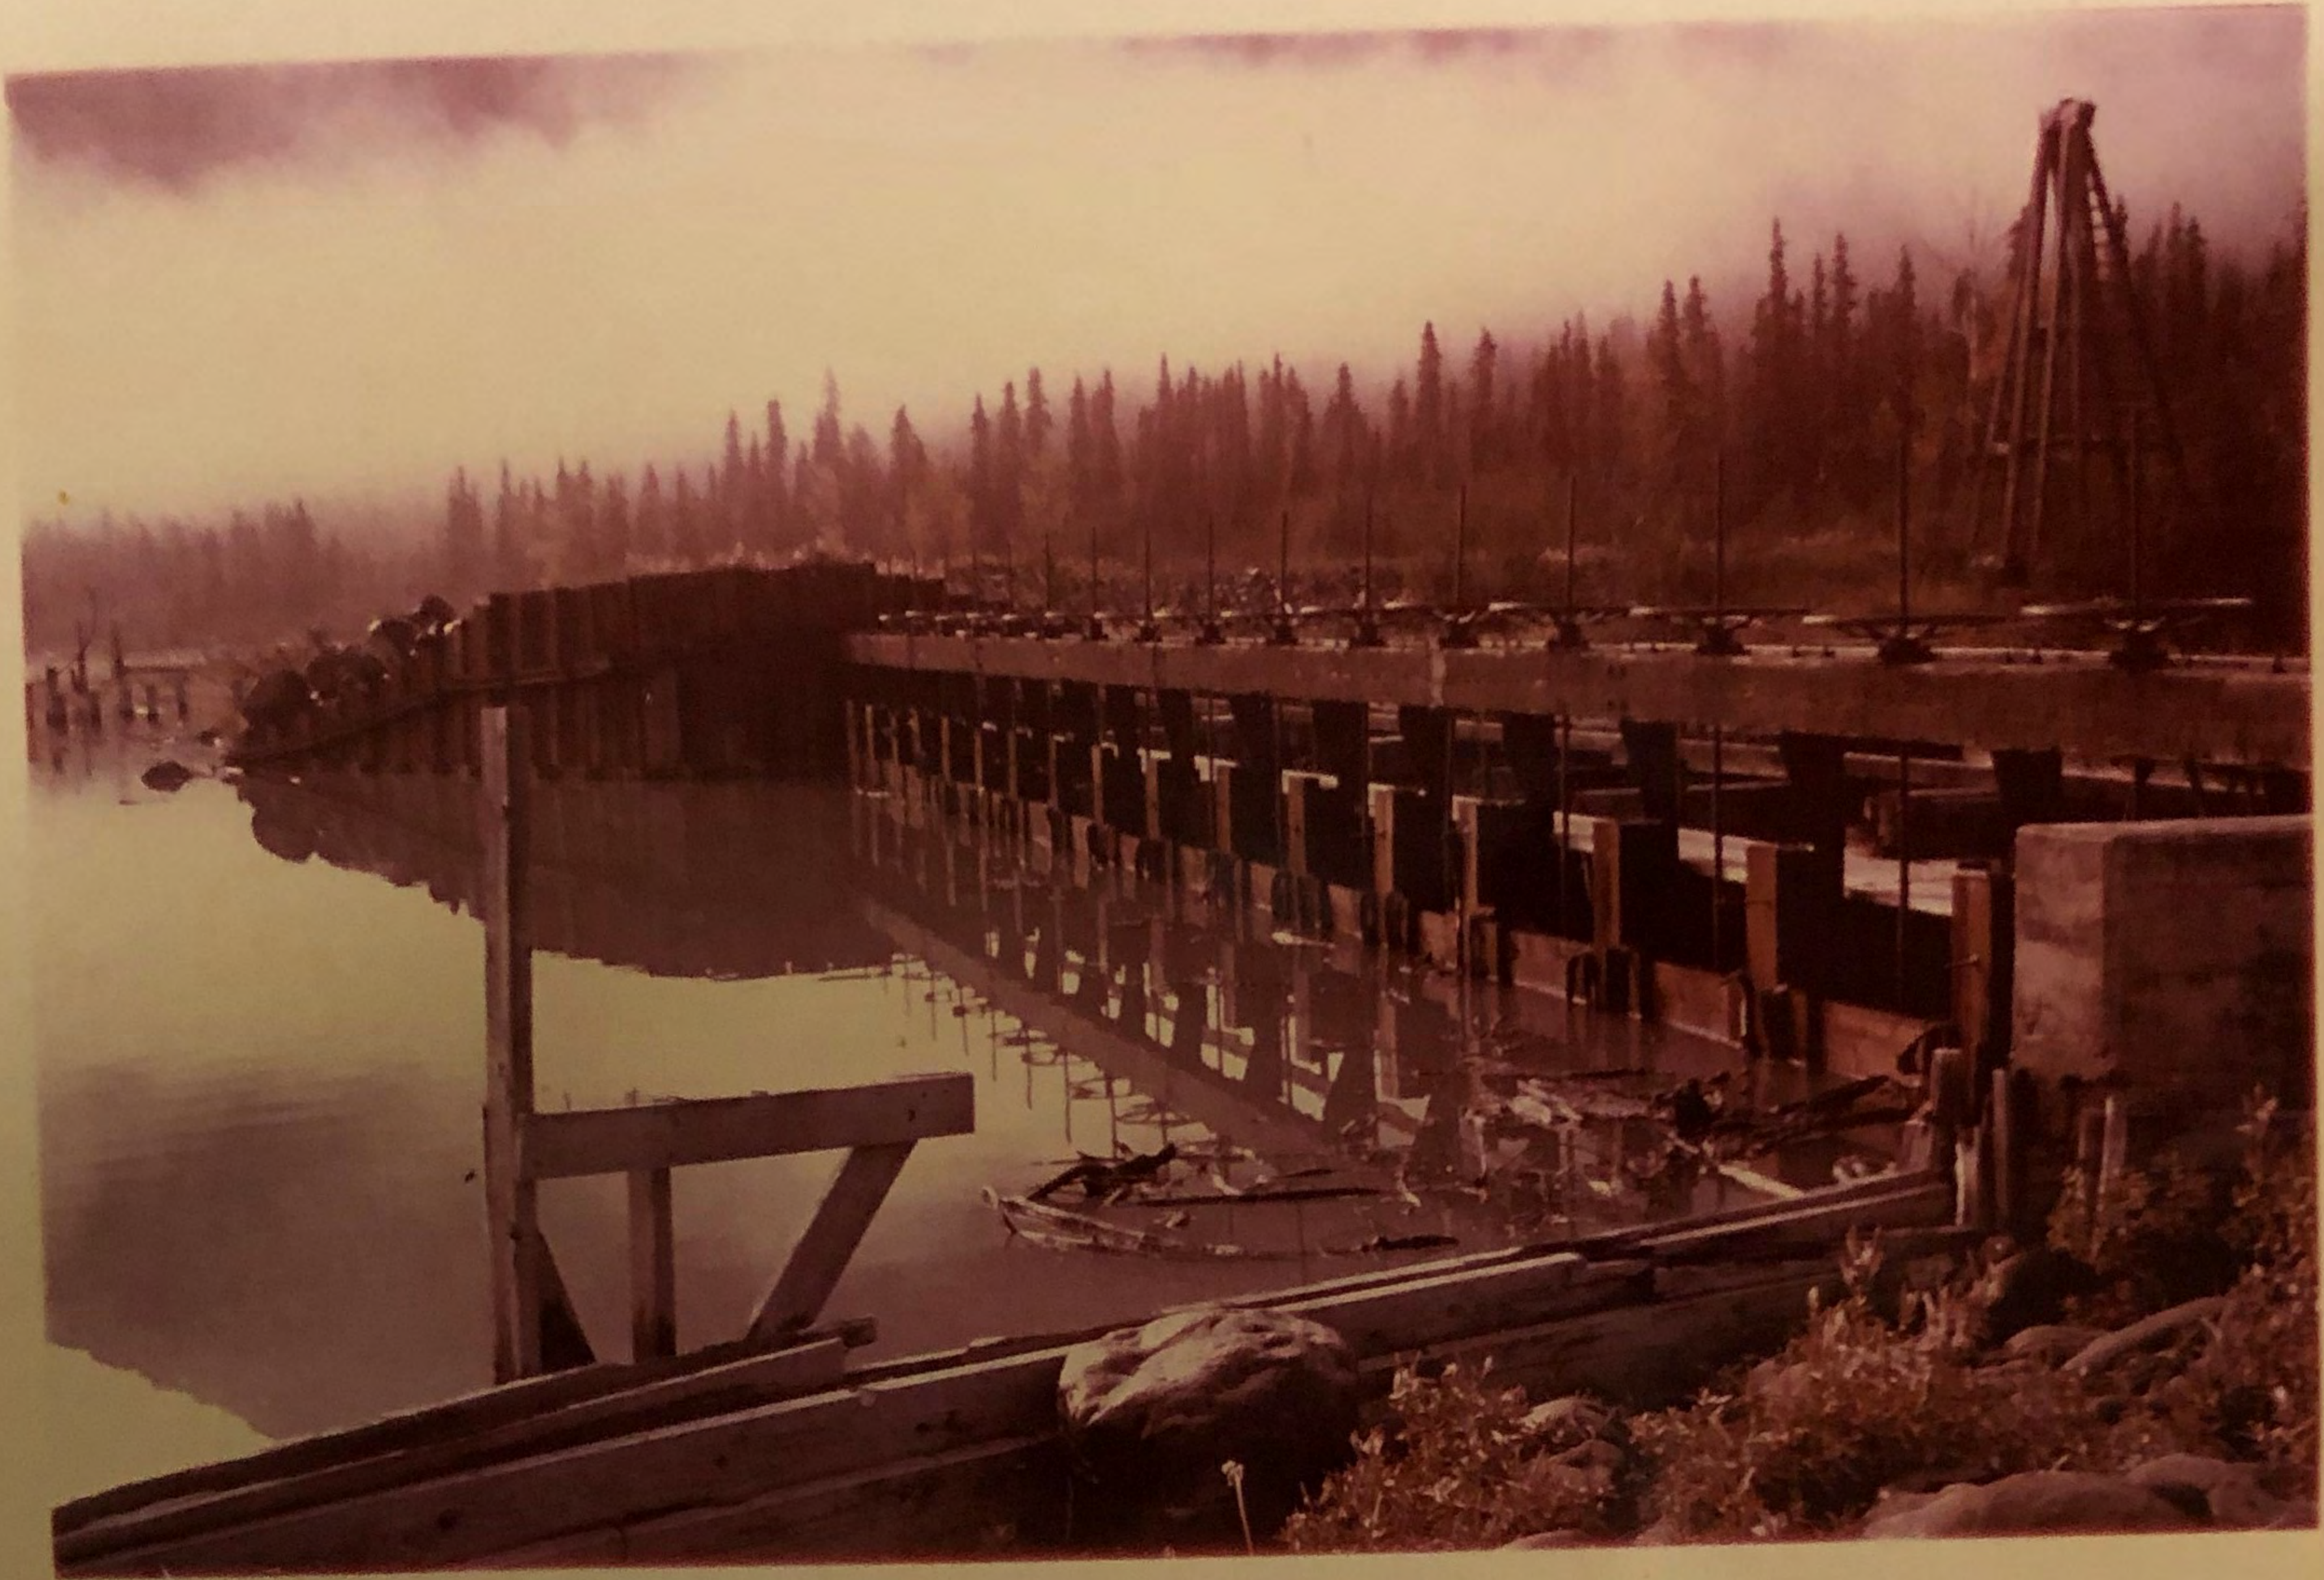
P783-908-2204 - Eklutna Project, Alaska
Eklutna Dam gate structure showing lake
level.
