UNITED STATES  
DEPARTMENT OF THE INTERIOR  
BUREAU OF RECLAMATION

Eklutna Project  
Annual Project History

Calendar Year 1964

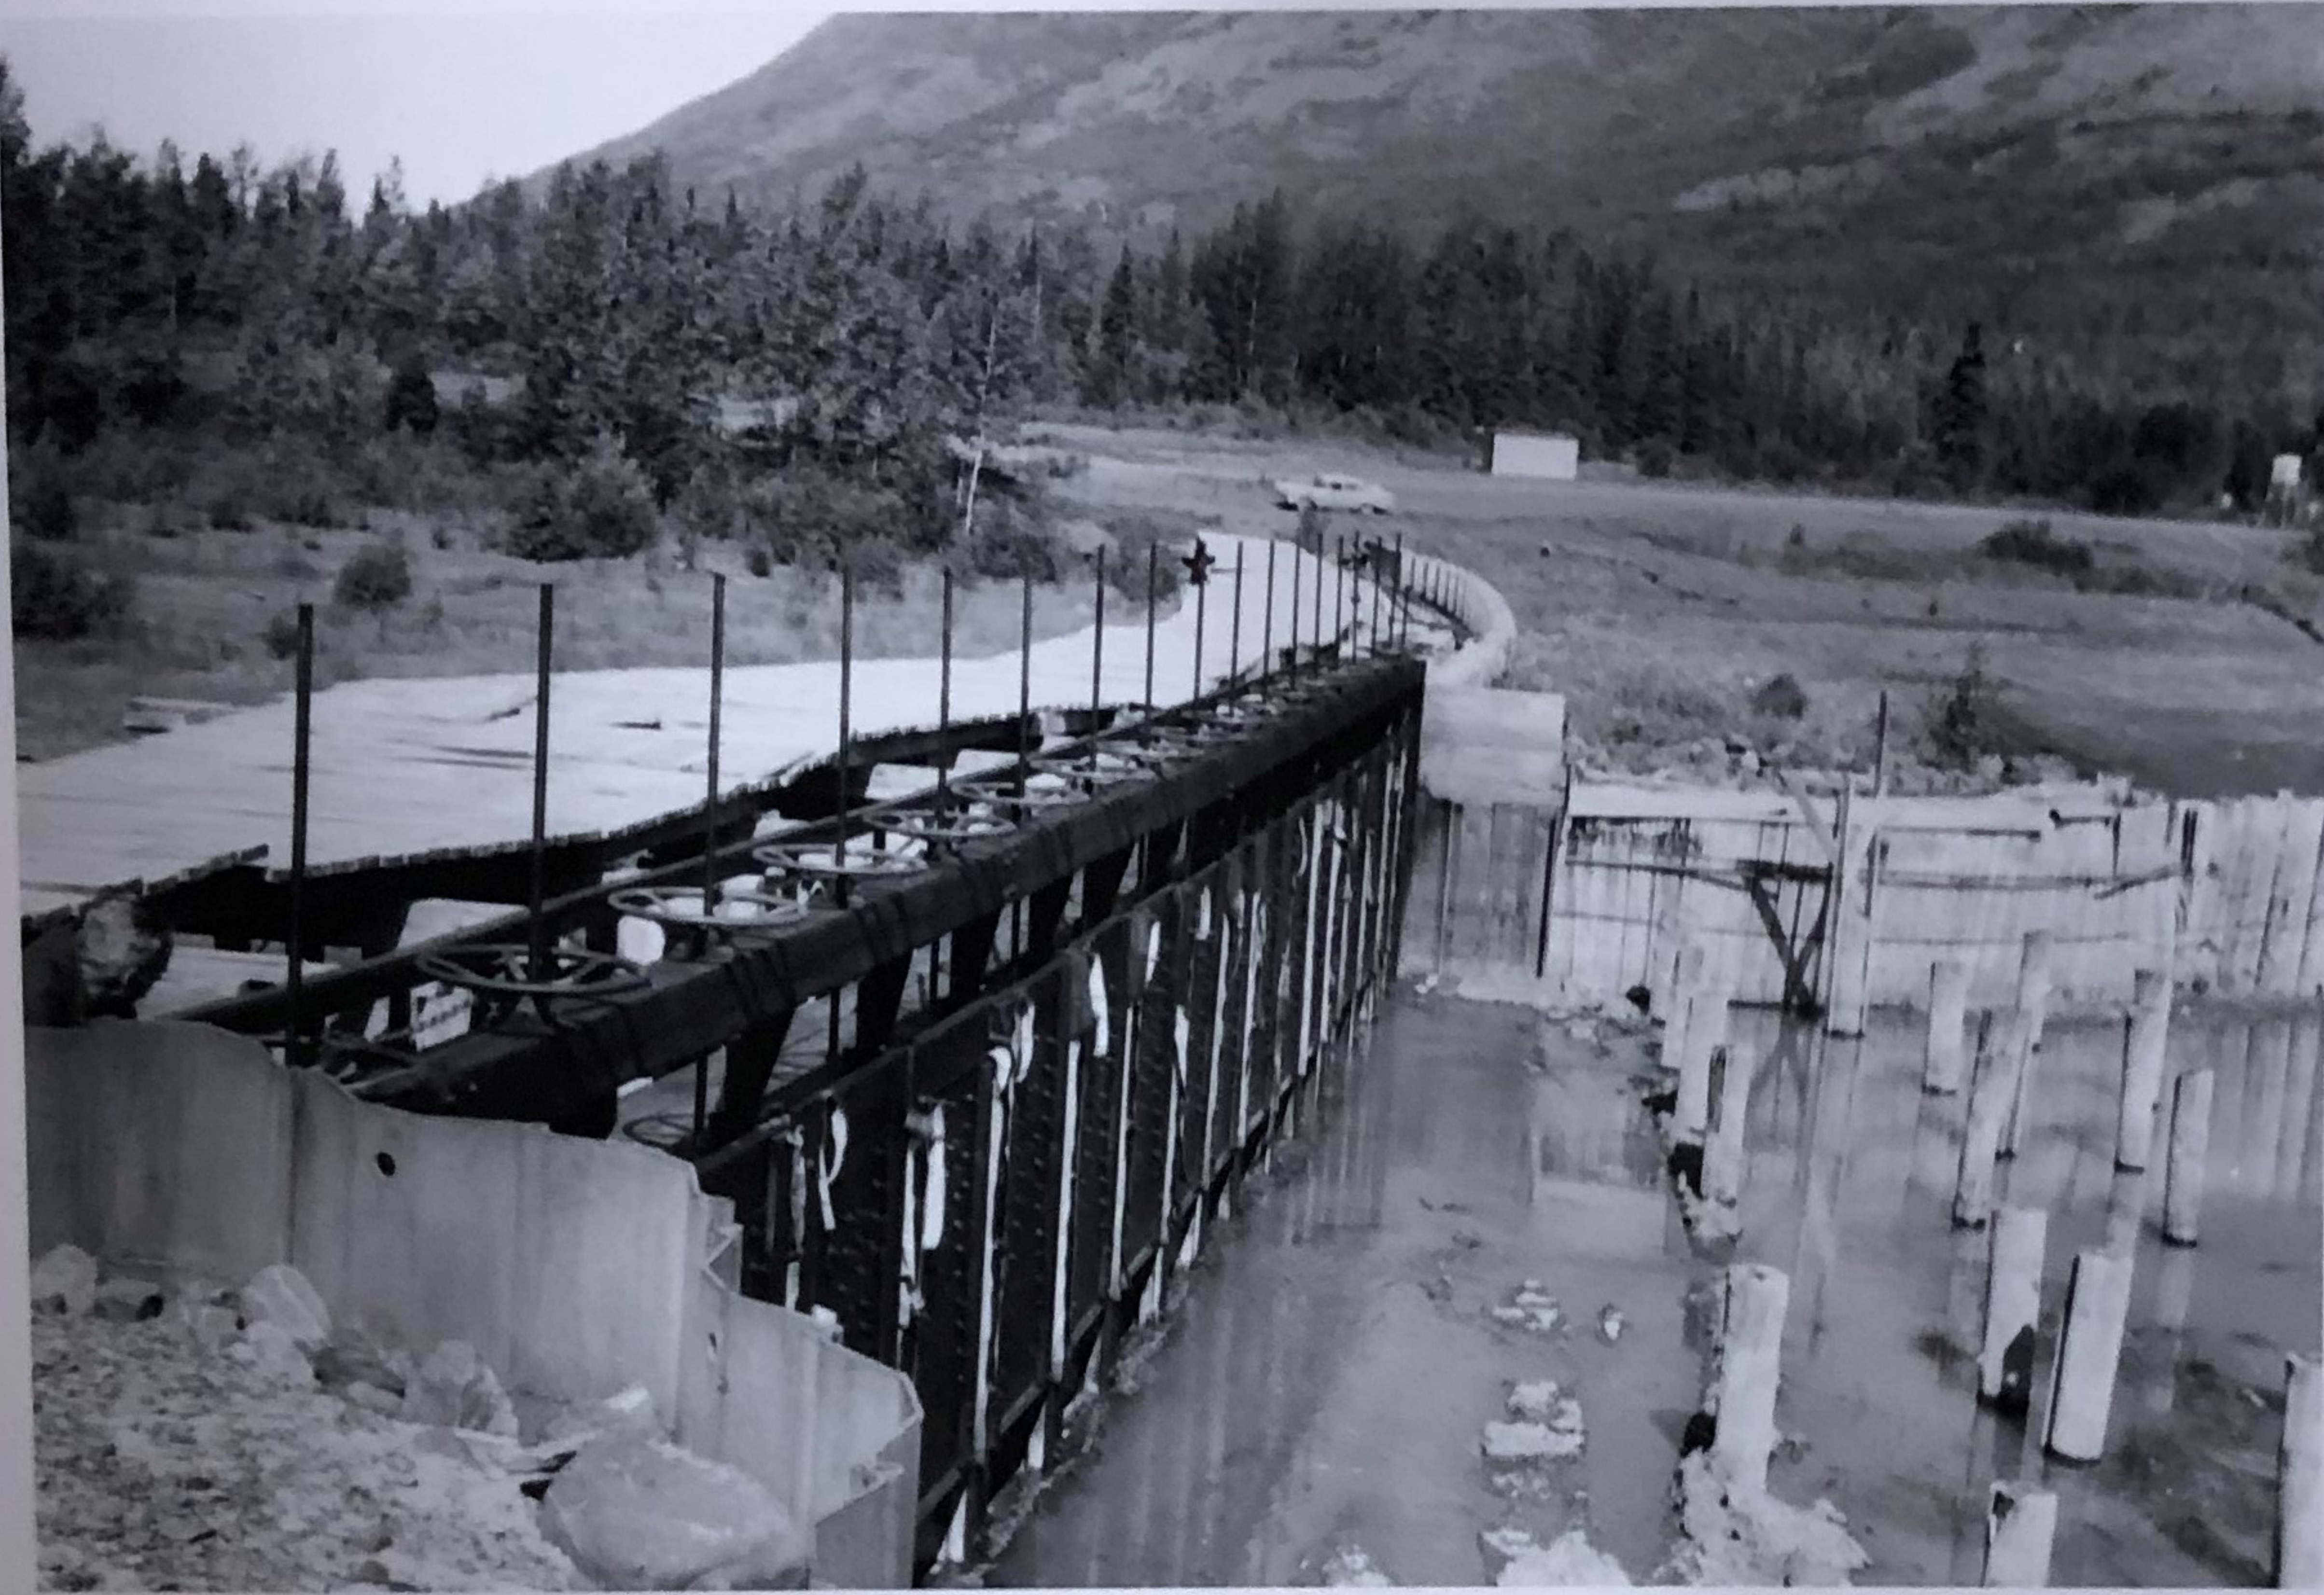
Photo No.  
109

P783-906-2358 Eklutna Powerplant - Alaska. View of the dam and spillway gate structure at Eklutna Lake. This structure, built by private interests in 1929, was declared unsafe for impounding water after the March 27 earthquake. All gates were locked open throughout the spring run-off and plans were started immediately by the Bureau of Reclamation for the construction of a new spillway and gate structure.

Permanent repairs of the intake and dam are scheduled for the Spring of 1965.
