UNITED STATES
DEPARTMENT OF THE INTERIOR
BUREAU OF RECLAMATION

Eklutna Project
Annual Project History

Calendar Year 1965

Volume XV

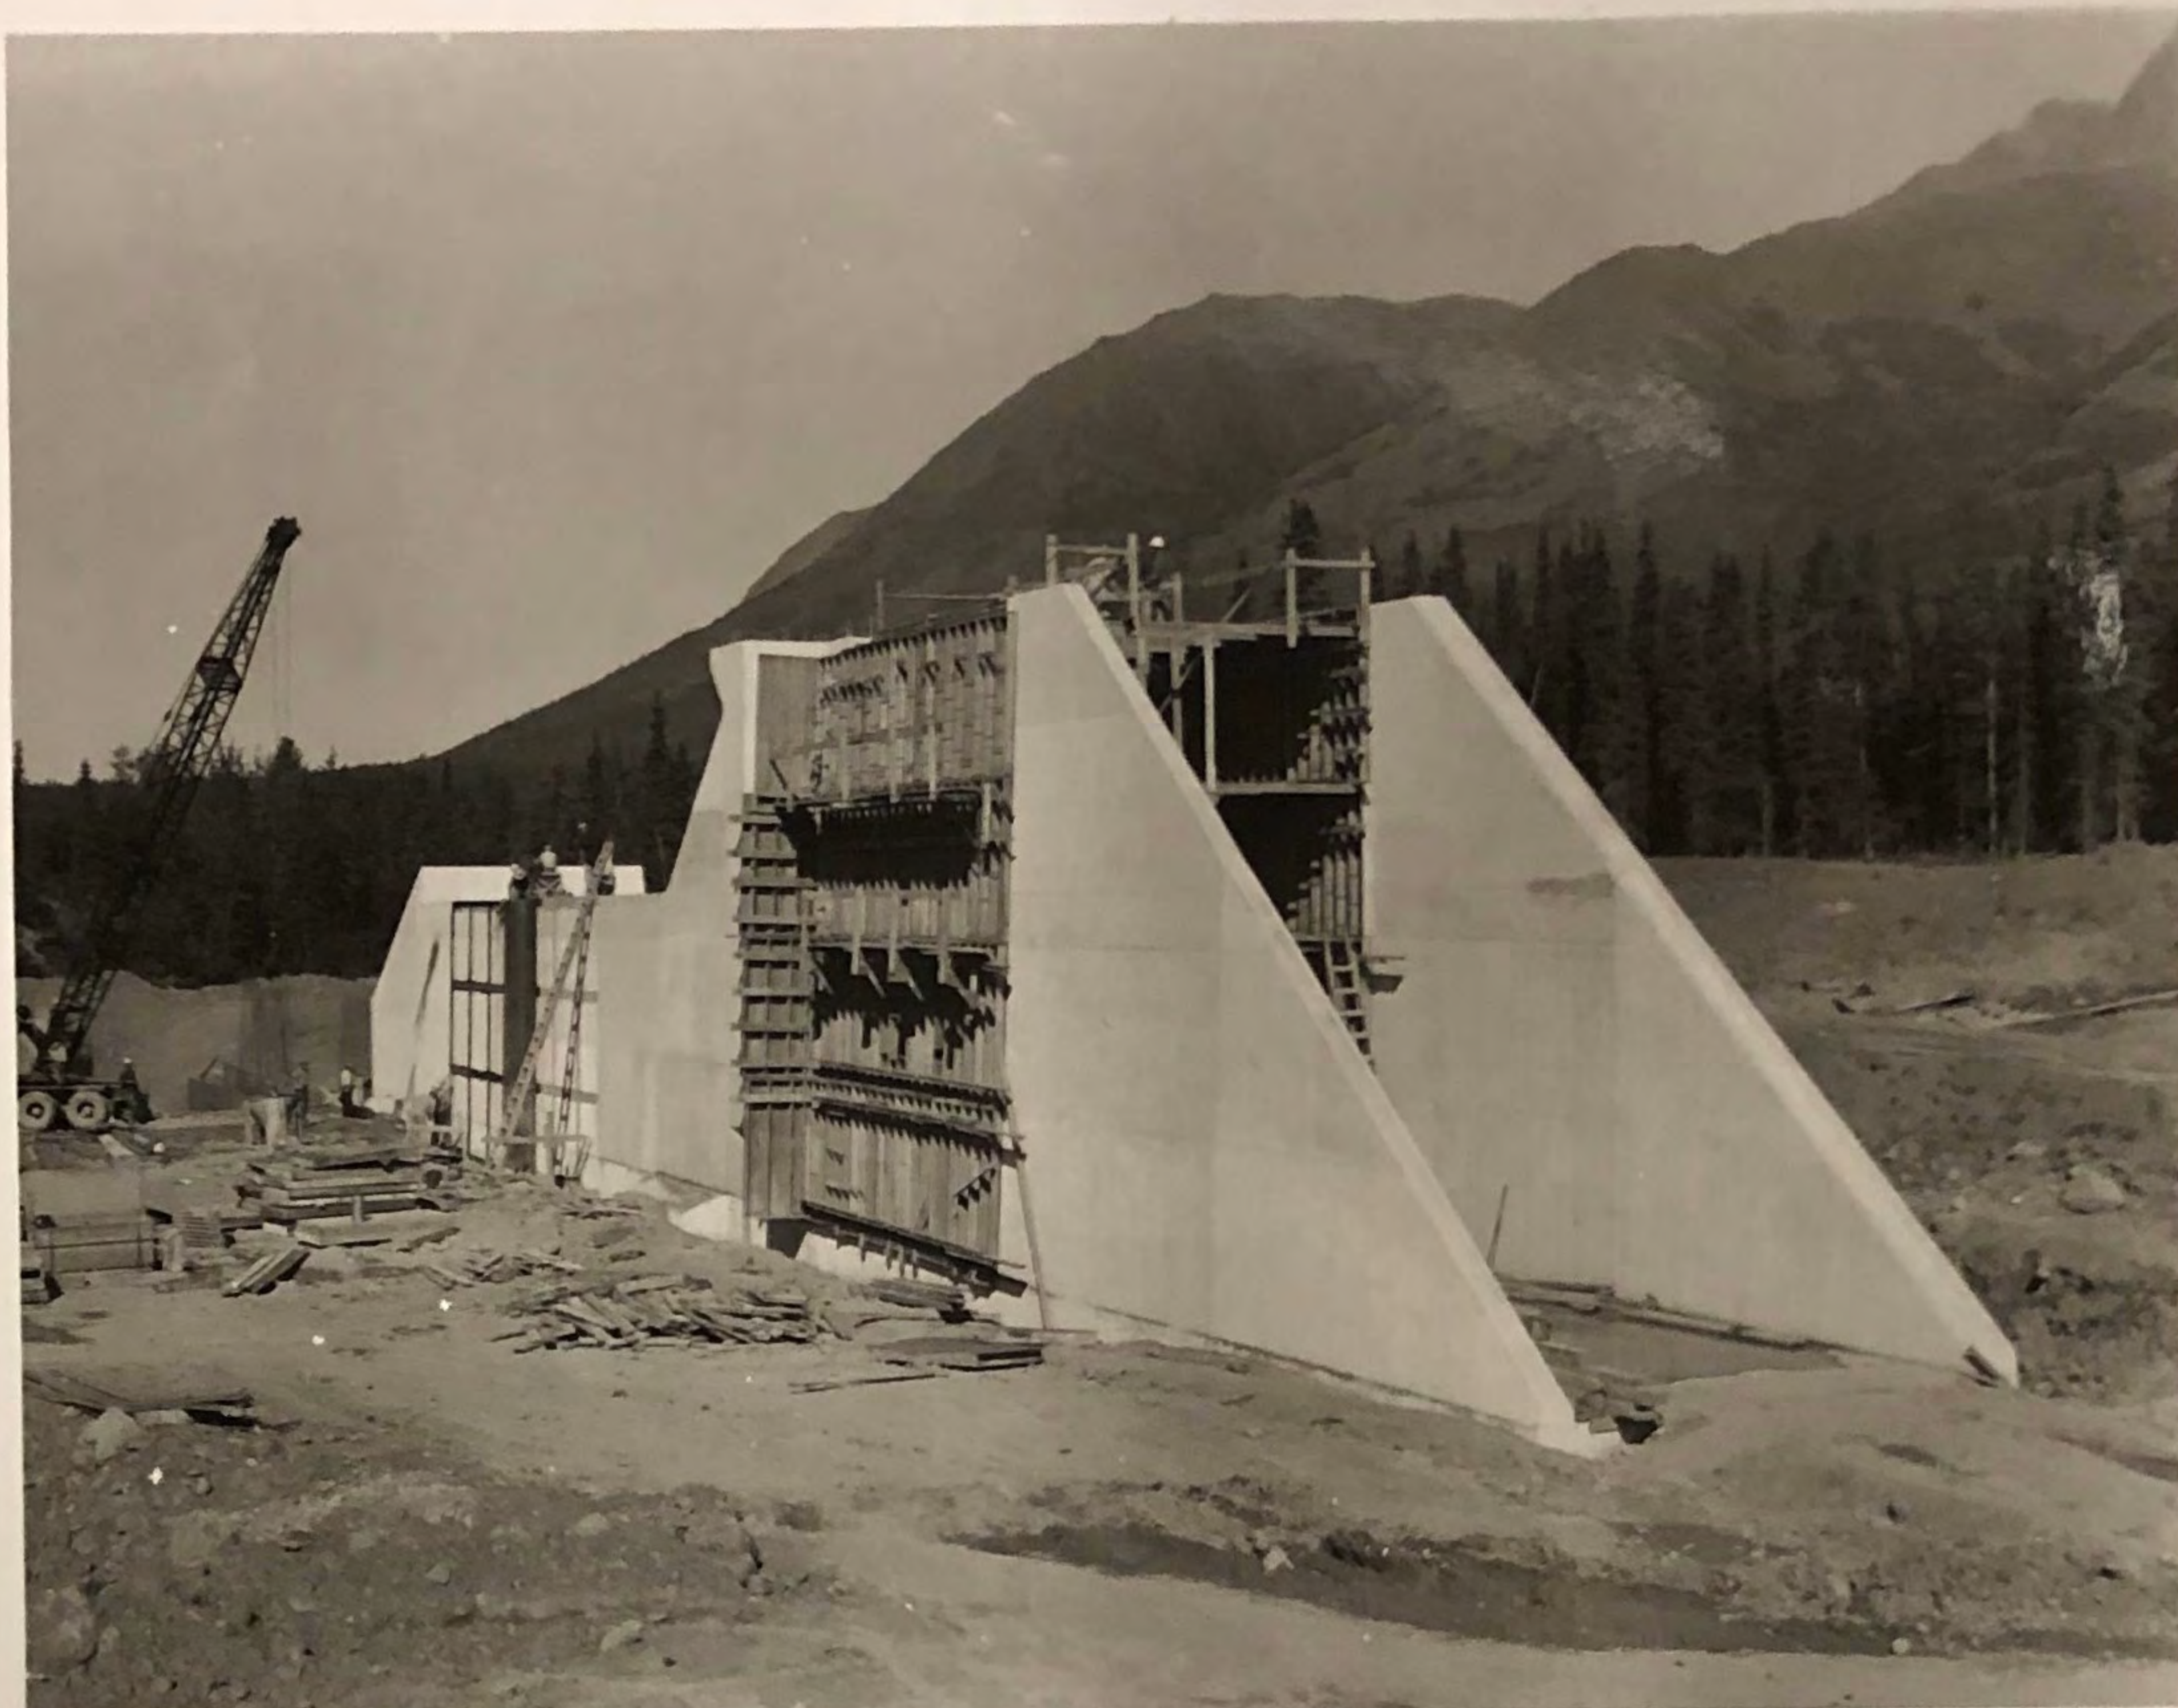
P783-908-C&R-173NA. Looking downstream from near Sta. 3+00 on approach channel for spillway, showing work continuing on inlet walls and conduit sections.

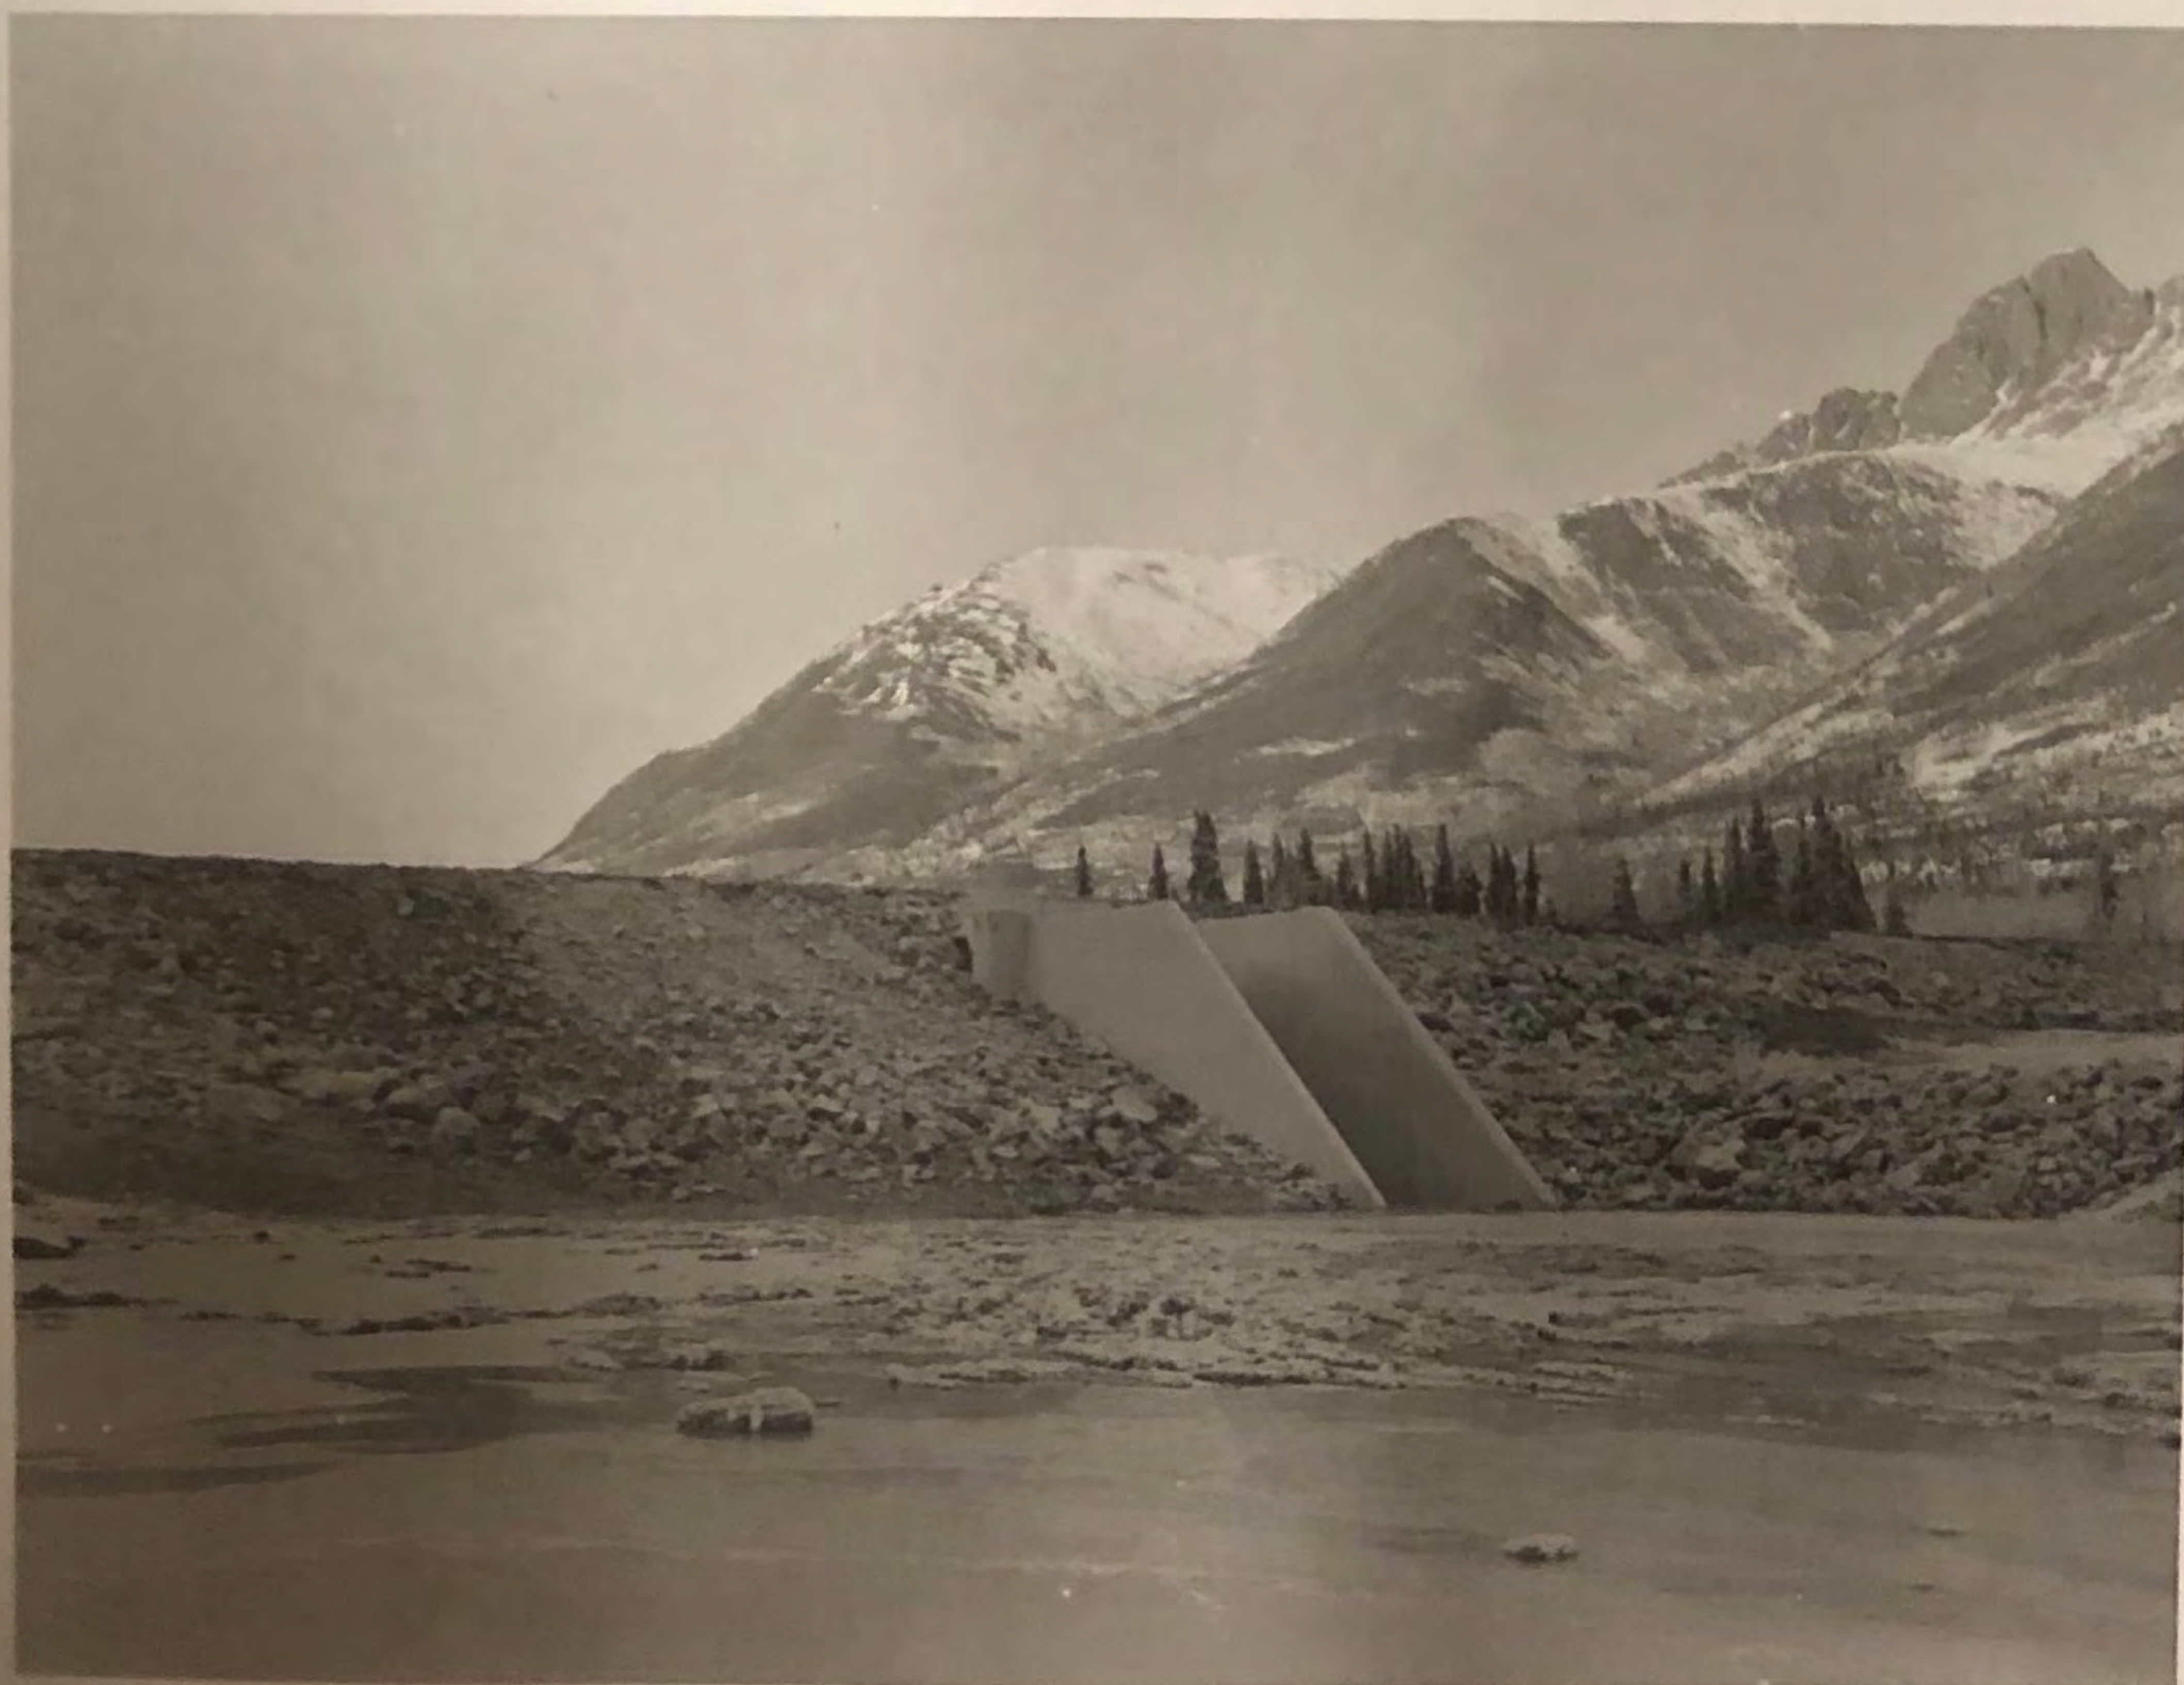
P783-908-C&R-216A. View of upstream face of completed dam.

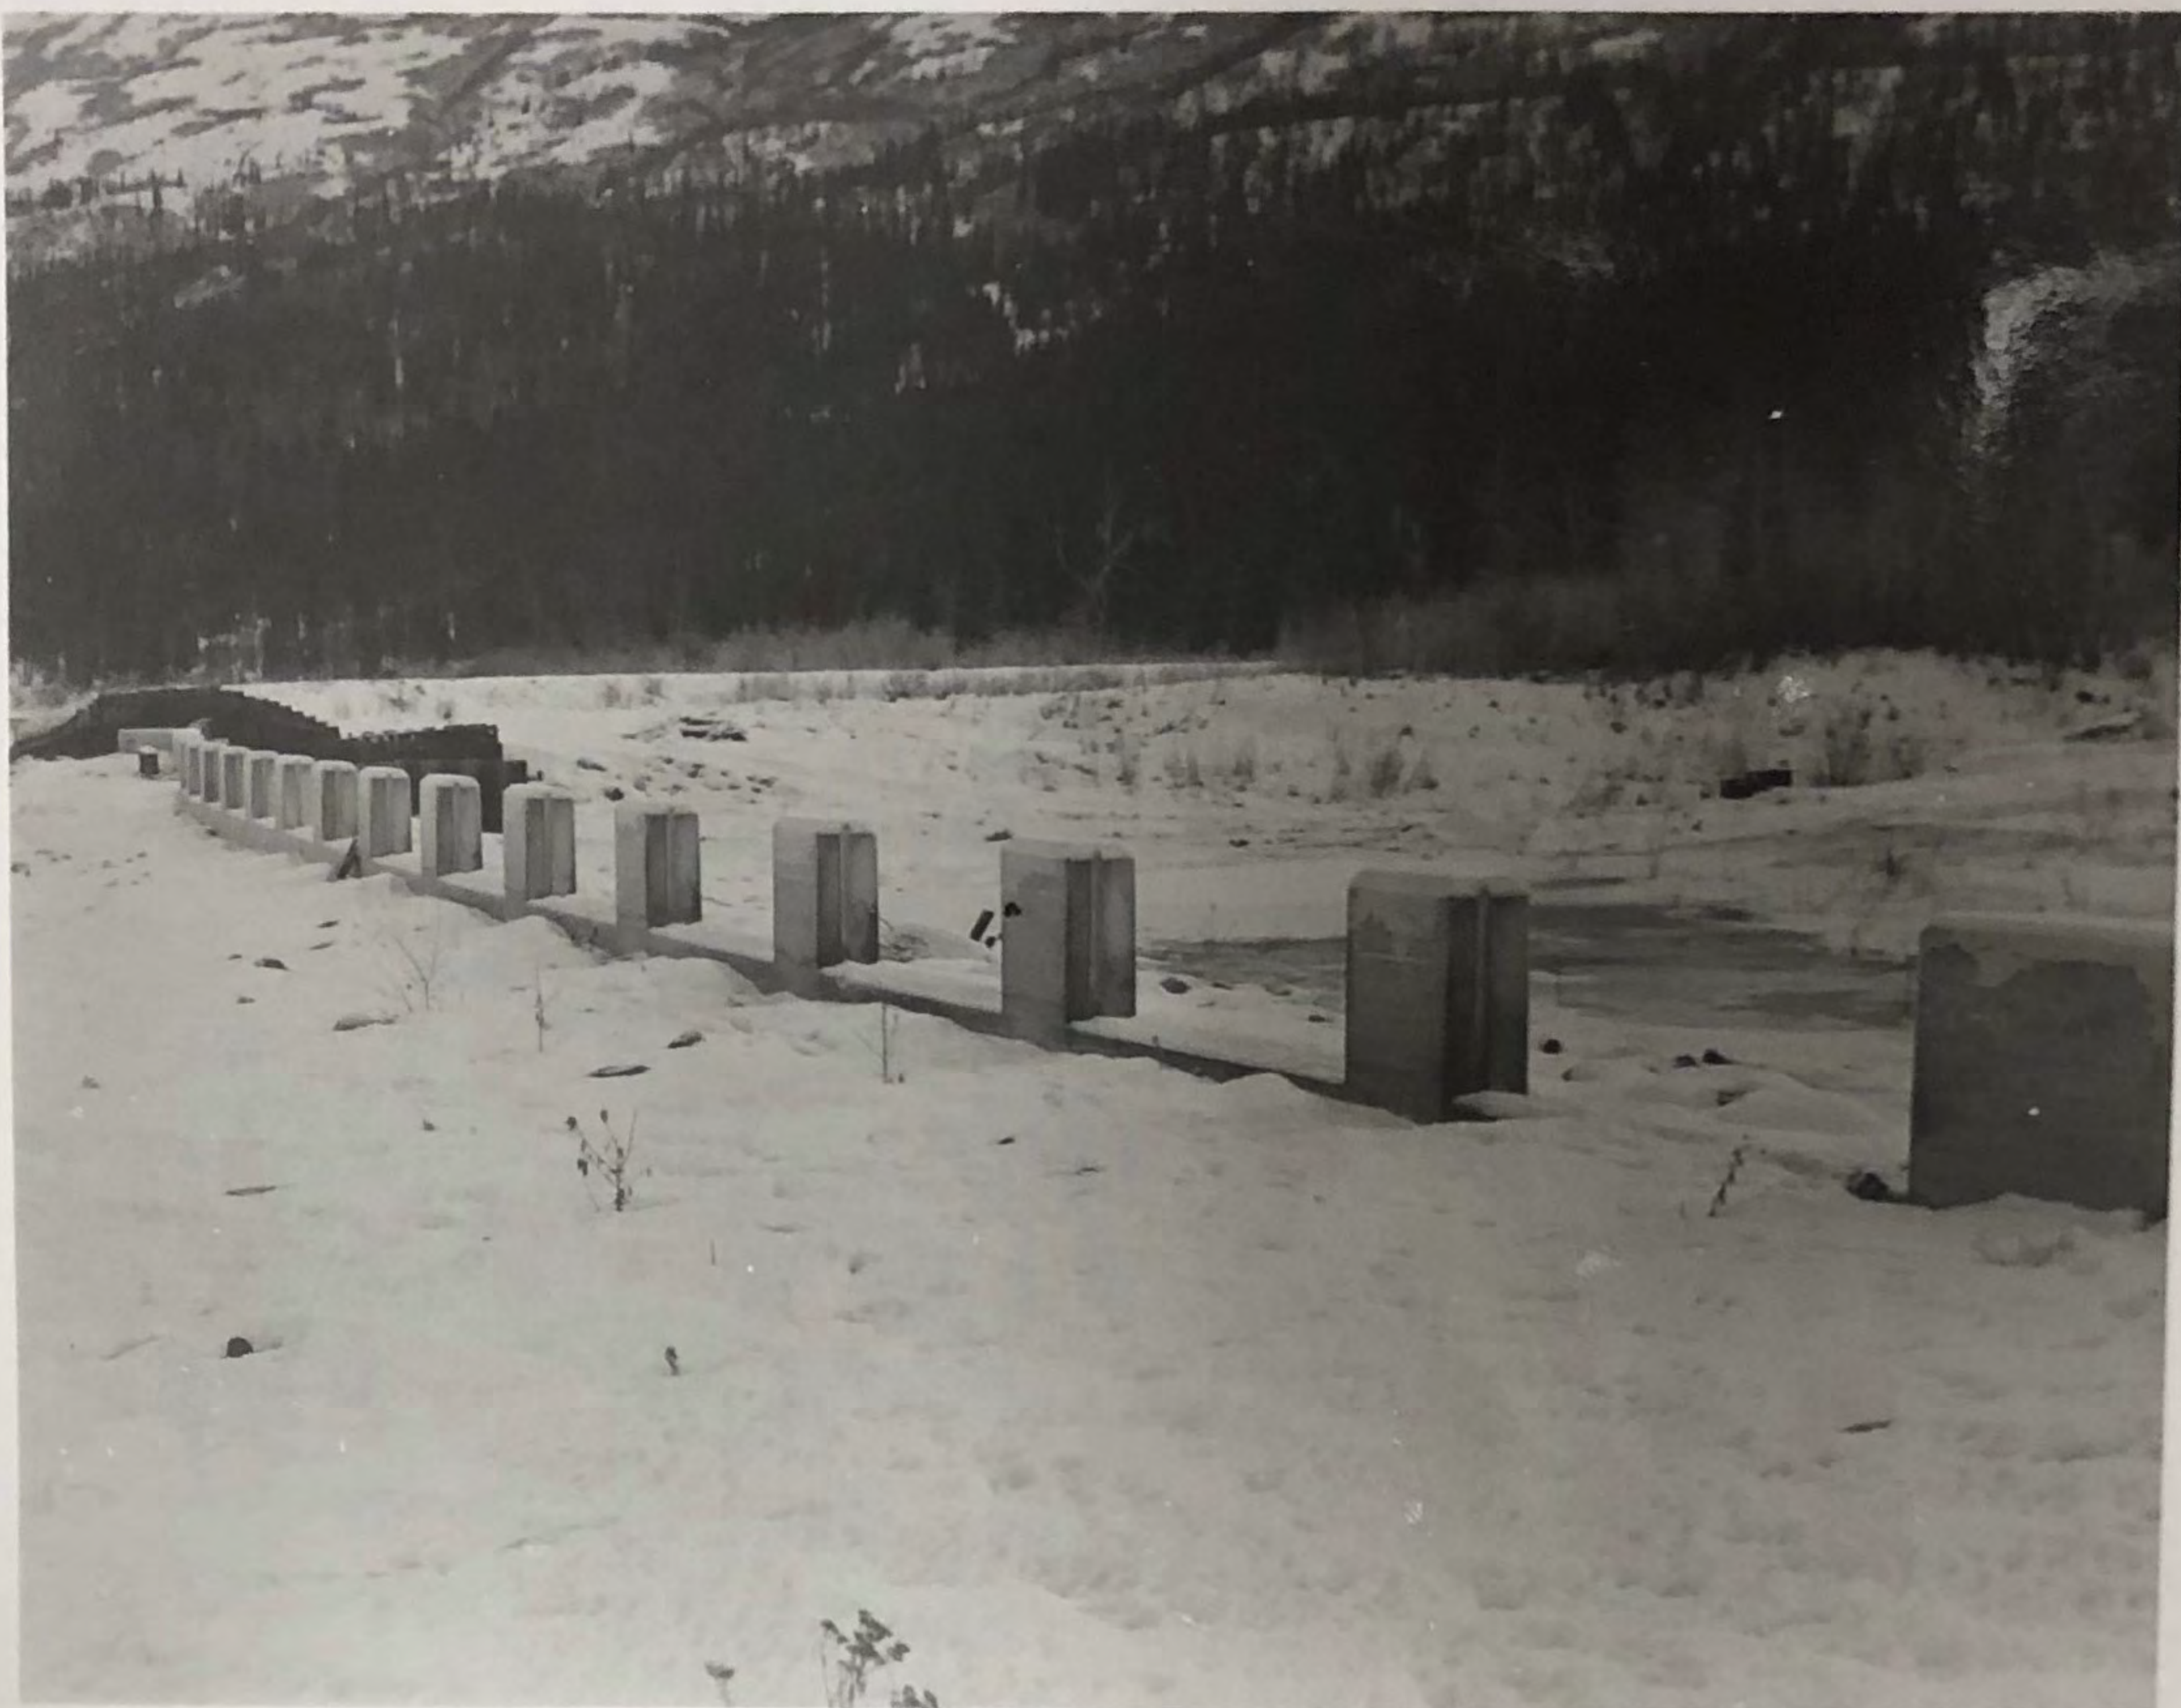
P783-908-2370. View of spillway section, Old Eklutna Dam, Eklutna Lake.

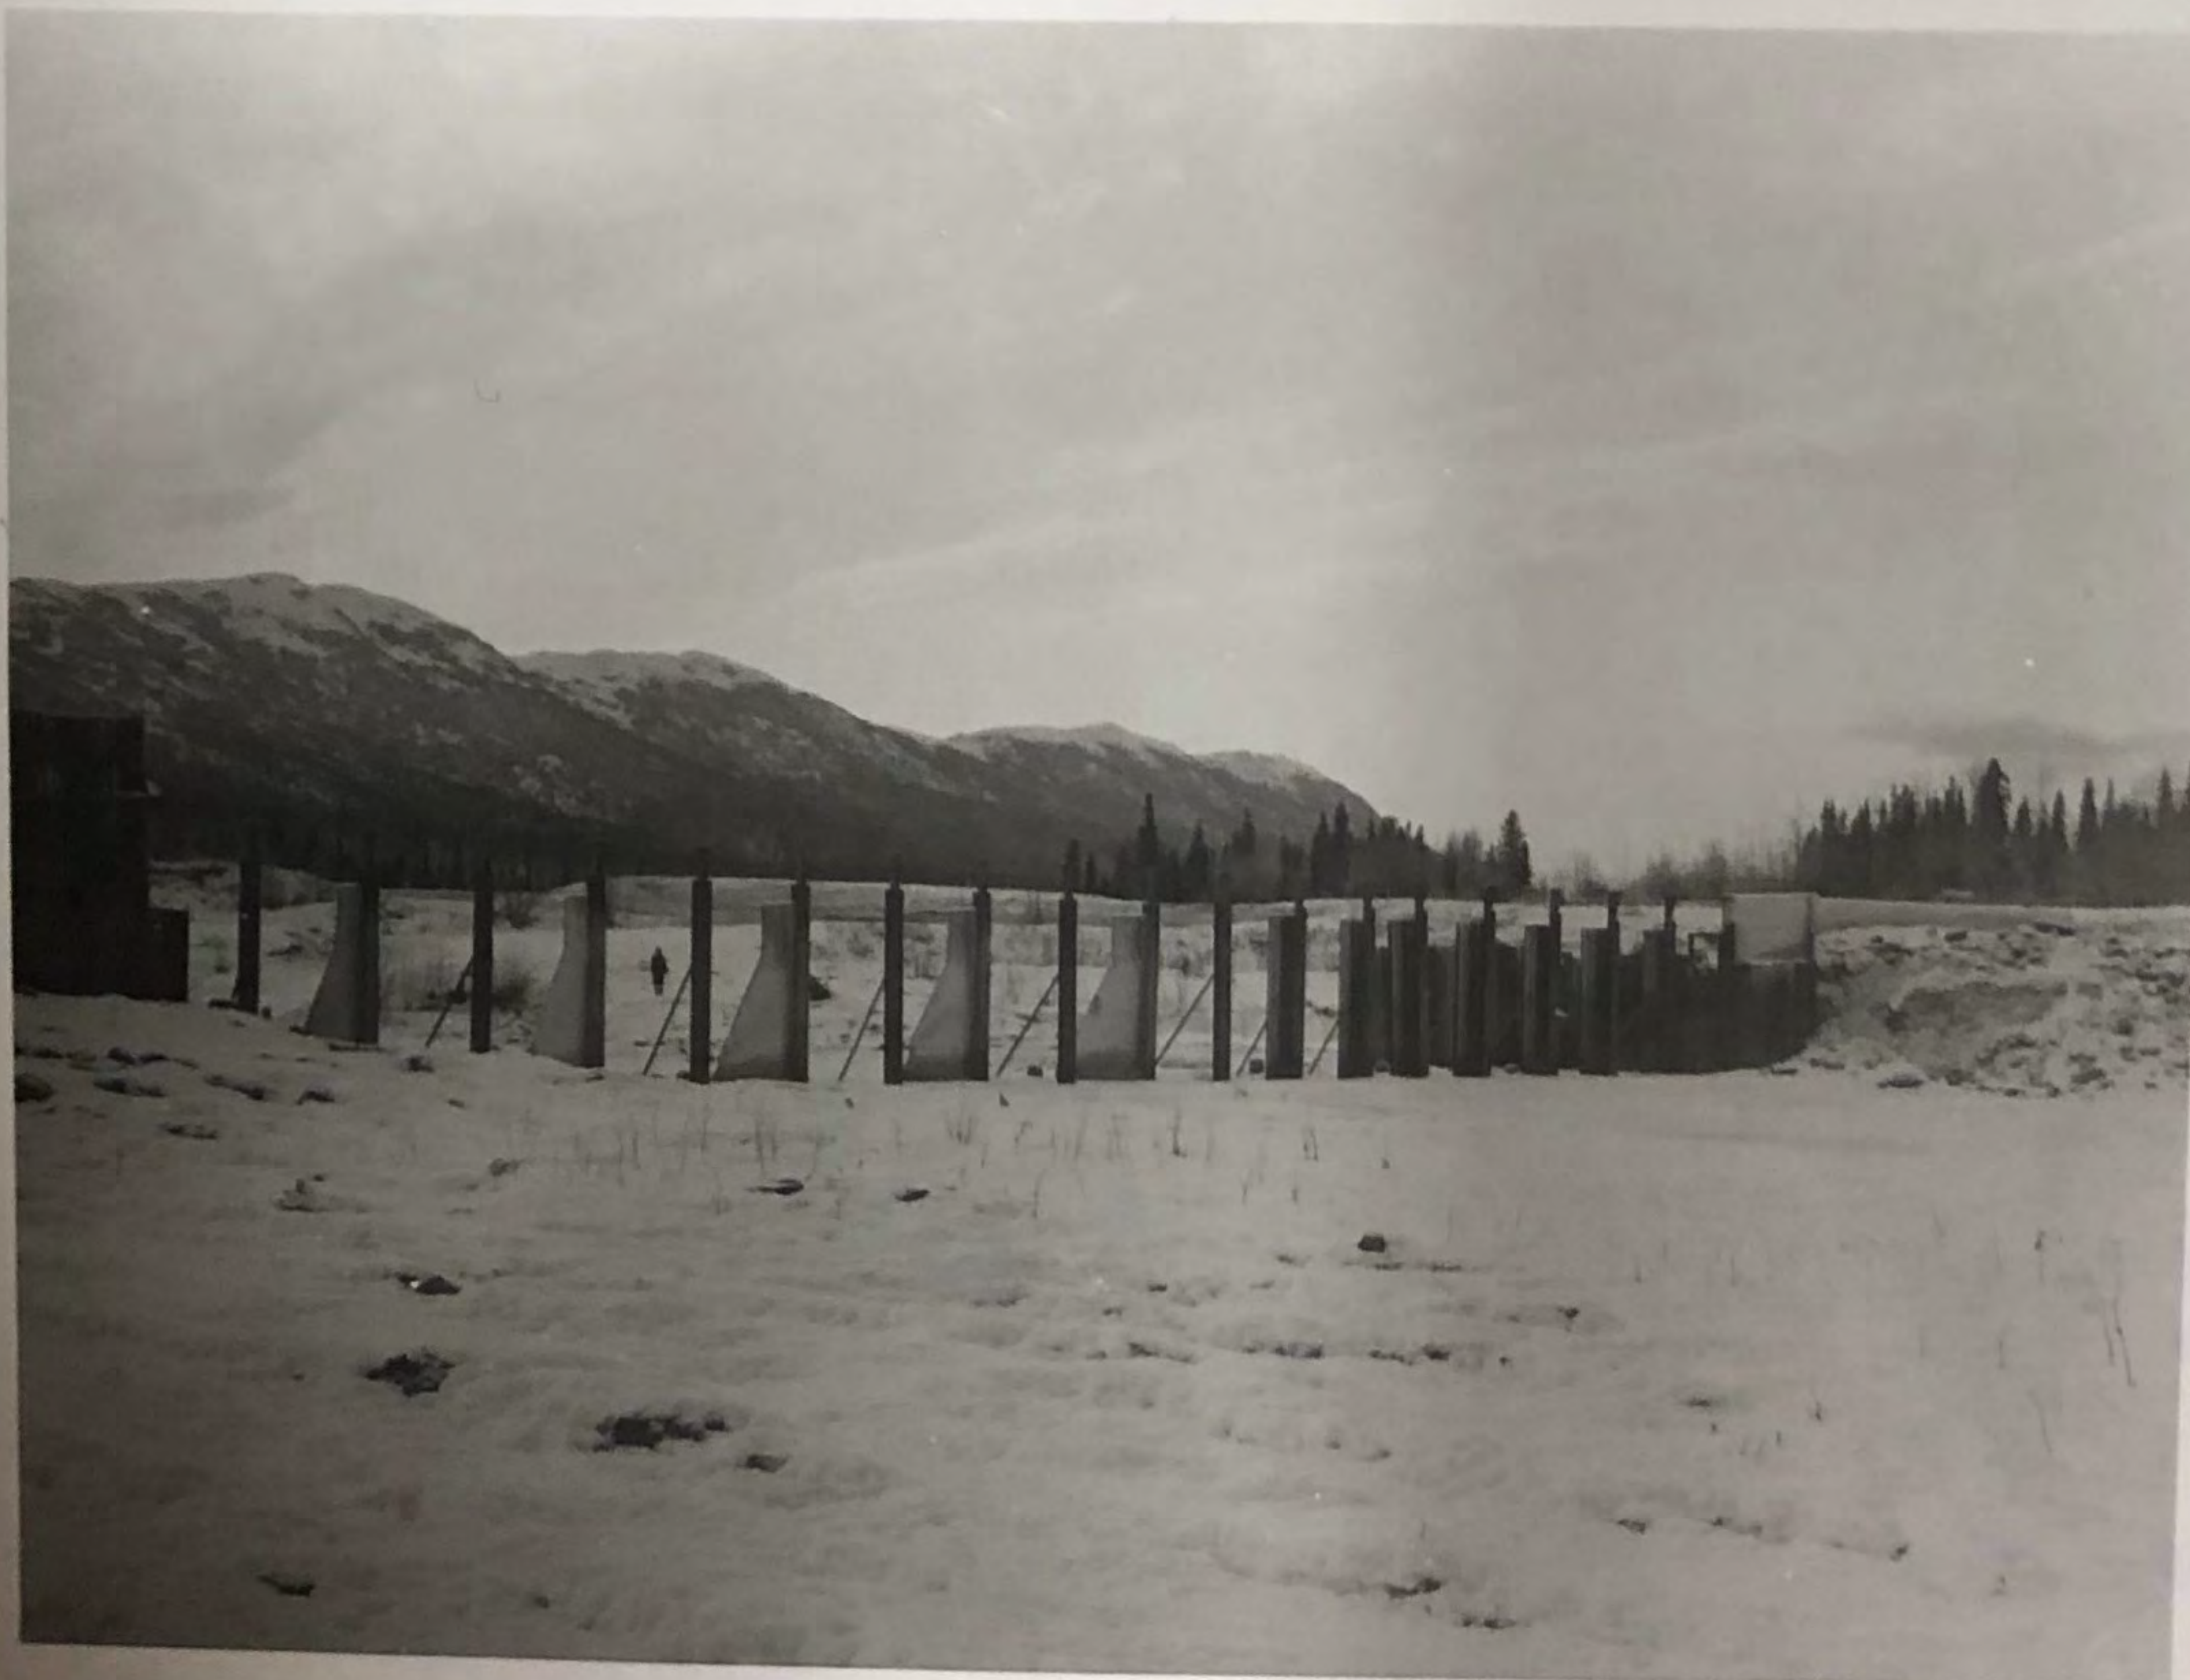
P783-908-2371. View of gated spillway section of Old Eklutna Dam after removal of gates by contractor on new dam.
