REHABILITATION OF EKLUTNA PROJECT FEATURES FOLLOWING EARTHQUAKE OF MARCH 1964

EKLUTNA DAM, TUNNEL AND POWERPLANT
TECHNICAL RECORD OF DESIGN AND CONSTRUCTION, MARCH 1958

Constructed 1951-1955
Rehabilitated 1964-1965

Eklutna Project
Alaska

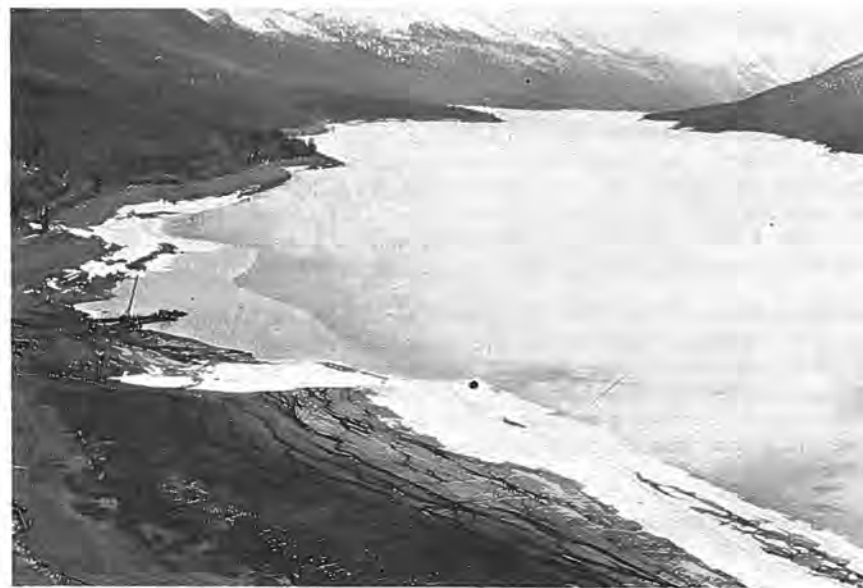
Figure 14. --View of shoreline of Eklutna Lake in the vicinity of the intake structure after the earthquake. Intake structure is located at left center of photograph on shoreline. P783-D-44348-A.

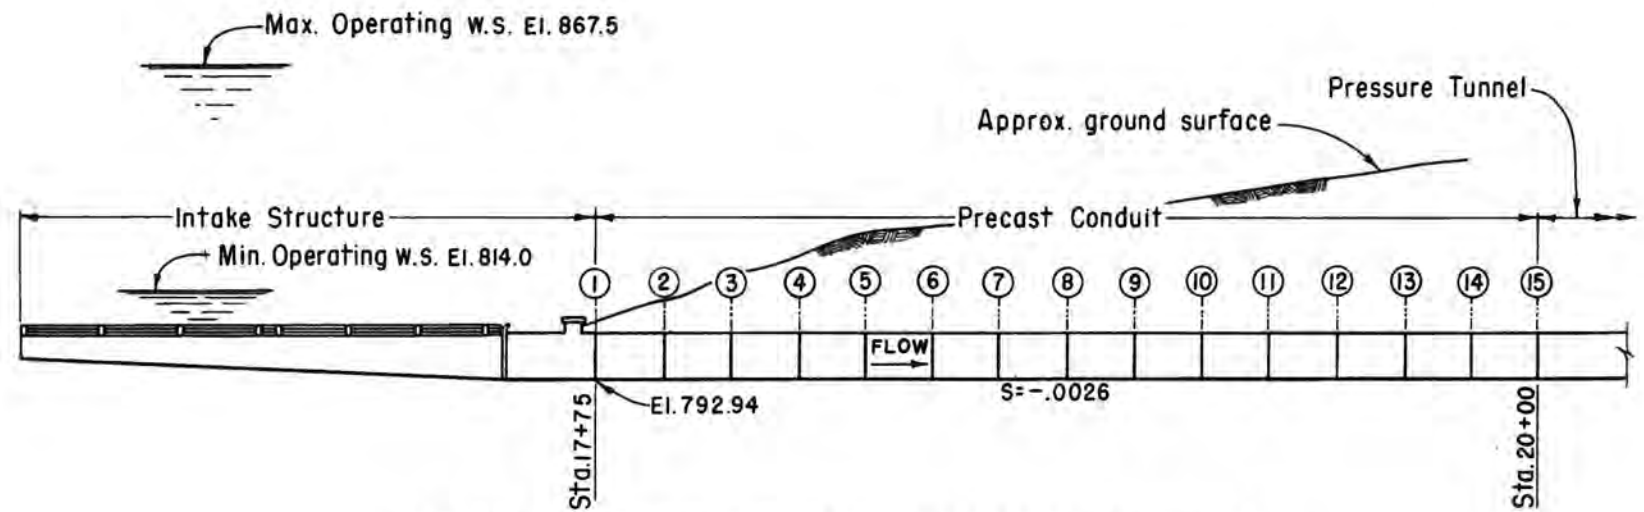
Figure 18. --Eklutna Powerplant intake structure and conduit--Joint separations after earthquake. From drawing No. 783-D-773.

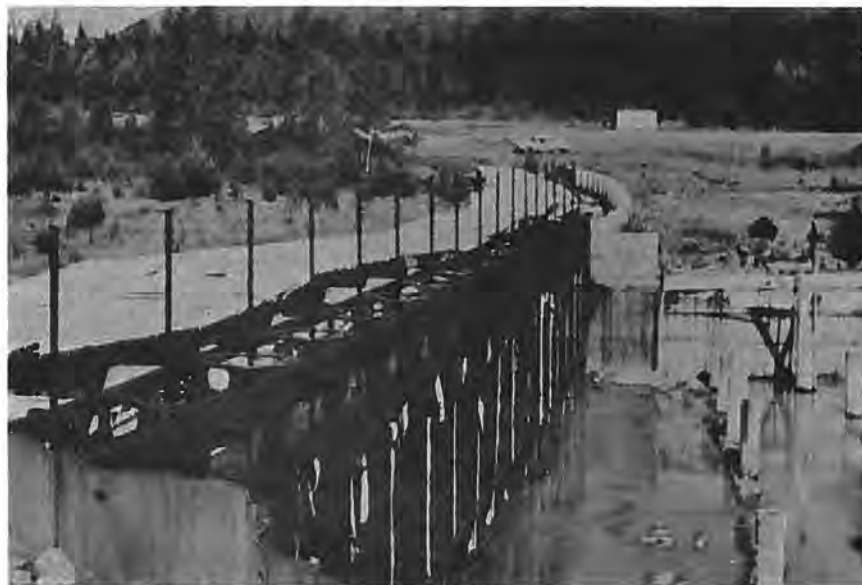
Figure 21. --View of spillway gate structure of existing dam. P783-906-2358NA.

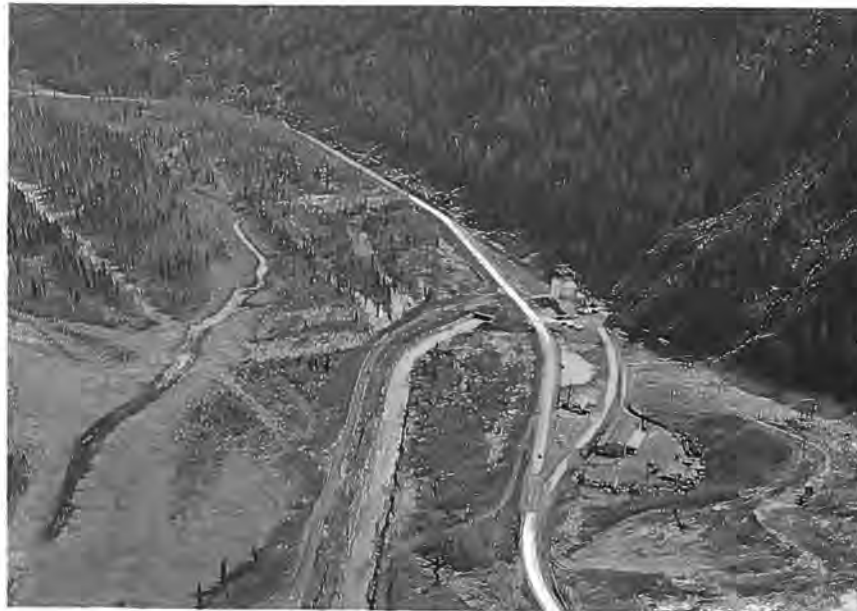
Figure 32. --General view of Eklutna Powerplant after the earthquake. Cracks up to 5 feet wide along the banks of the 2,000-foot tailrace channel are clearly visible below the powerplant. The cracks had the effect of squeezing in the sides of the channel. The channel was cleaned by means of both blasting and dragline operation. P783-D-44504A.

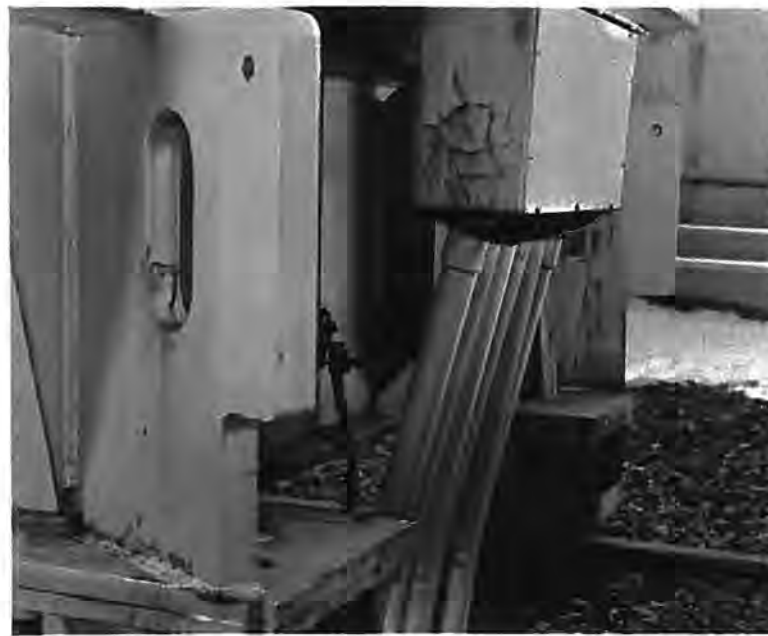
Figure 33. --View of 20,000-kv. -a. transformer conduit and terminal box showing damage caused by movement of the transformer during the earthquake. Rail stops, consisting of 1/4-inch by 1-inch-wide steel bars, were tack-welded to the rails. The welds broke and allowed the transformer to move on the rails. P783-906-2254NA, April 6, 1964.

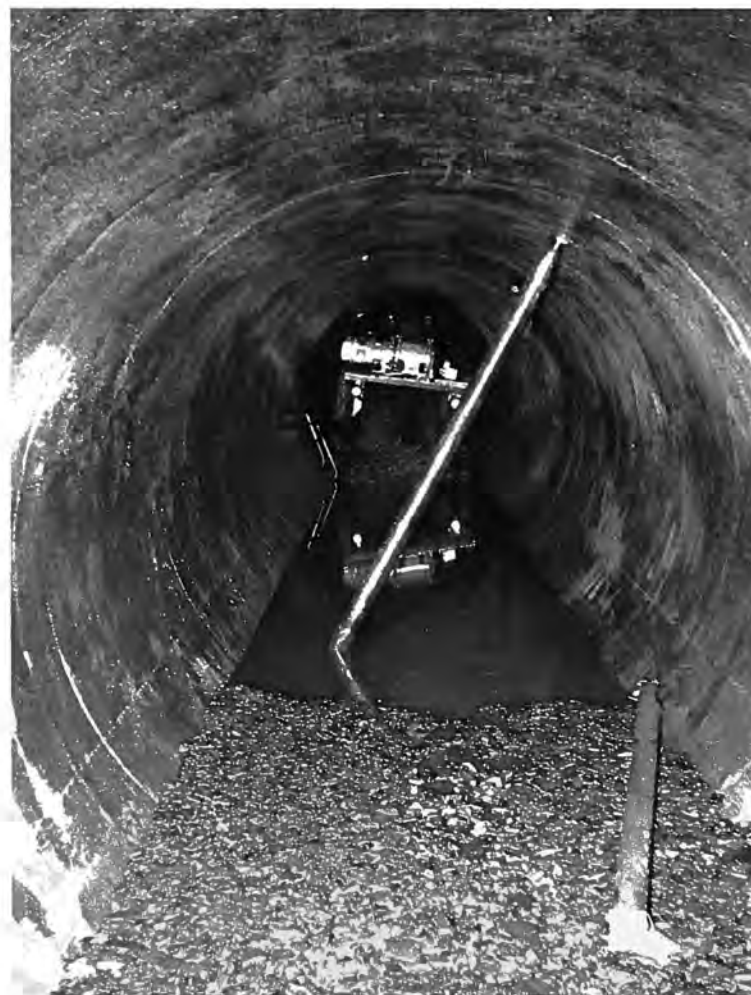
Figure 45. -- Accumulation of debris in pressure tunnel as a result of earthquake damage to pre-cast concrete intake conduit. Rock in foreground is typical of that deposited throughout 3-1/2 miles of the tunnel. View is looking upstream toward the loading end of the slusher unit. The drag bucket is being drawn toward the slusher from the gin pole in the center of the picture. P783-906-2351, June 1964.

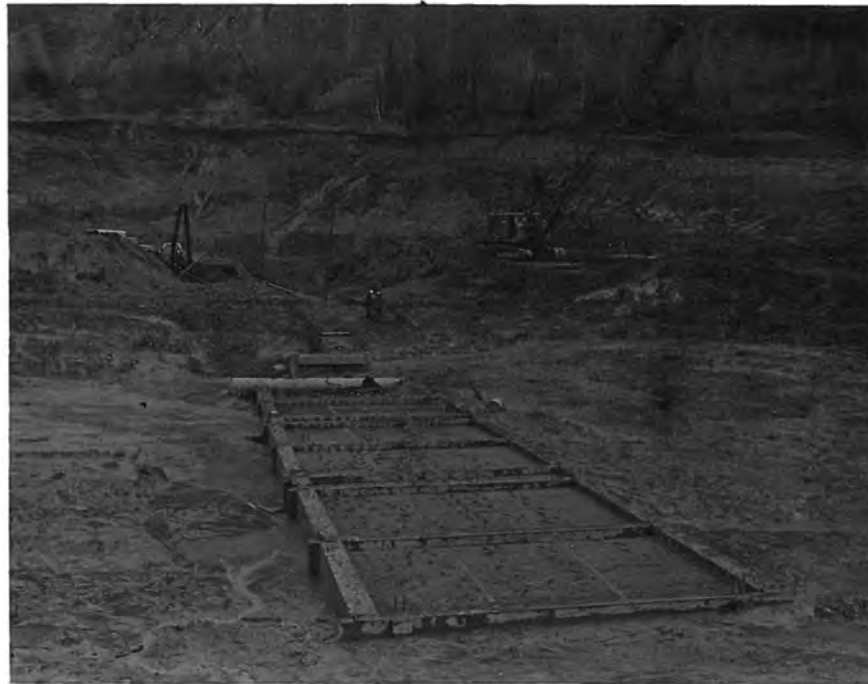
Figure 49. --View showing exposed top side (trashracked side) of original intake structure after removal of water. P783-908 C&R-17A, March 26, 1965.

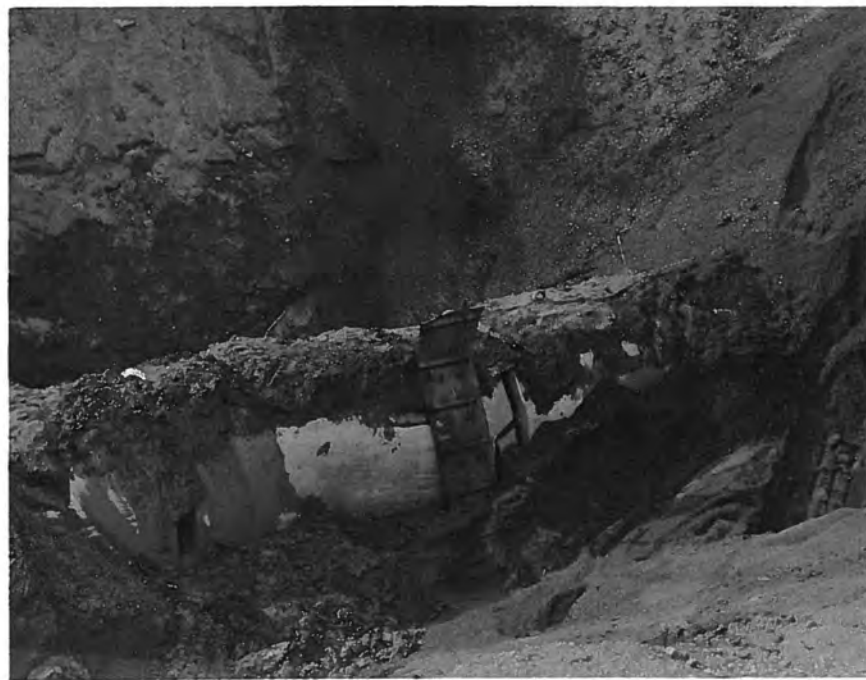
Figure 50. --Two damaged joints on the existing 9-foot-diameter precast concrete conduit. P783-908 C&R-27A, March 21, 1965.
