**Technical Report No. 19-13**

# **Eklutna River Aquatic Habitat Monitoring, 2019**

Alaska Department of Fish and Game

Habitat Section

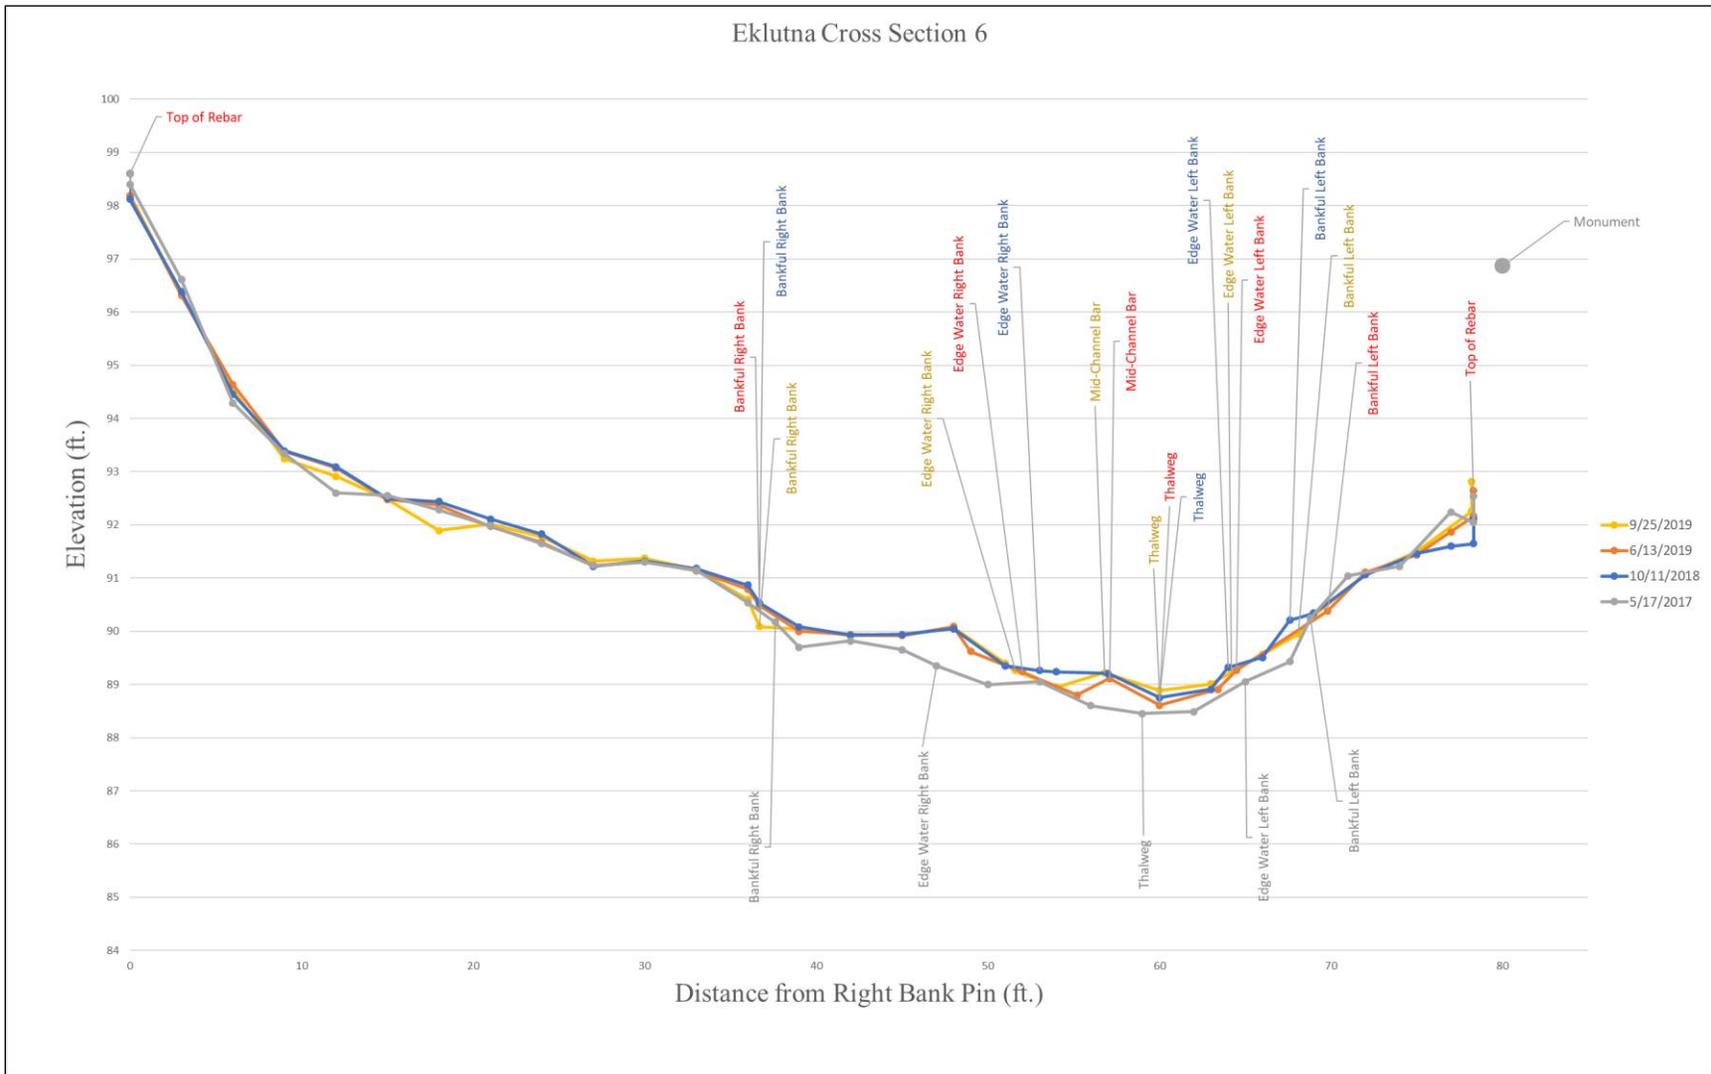
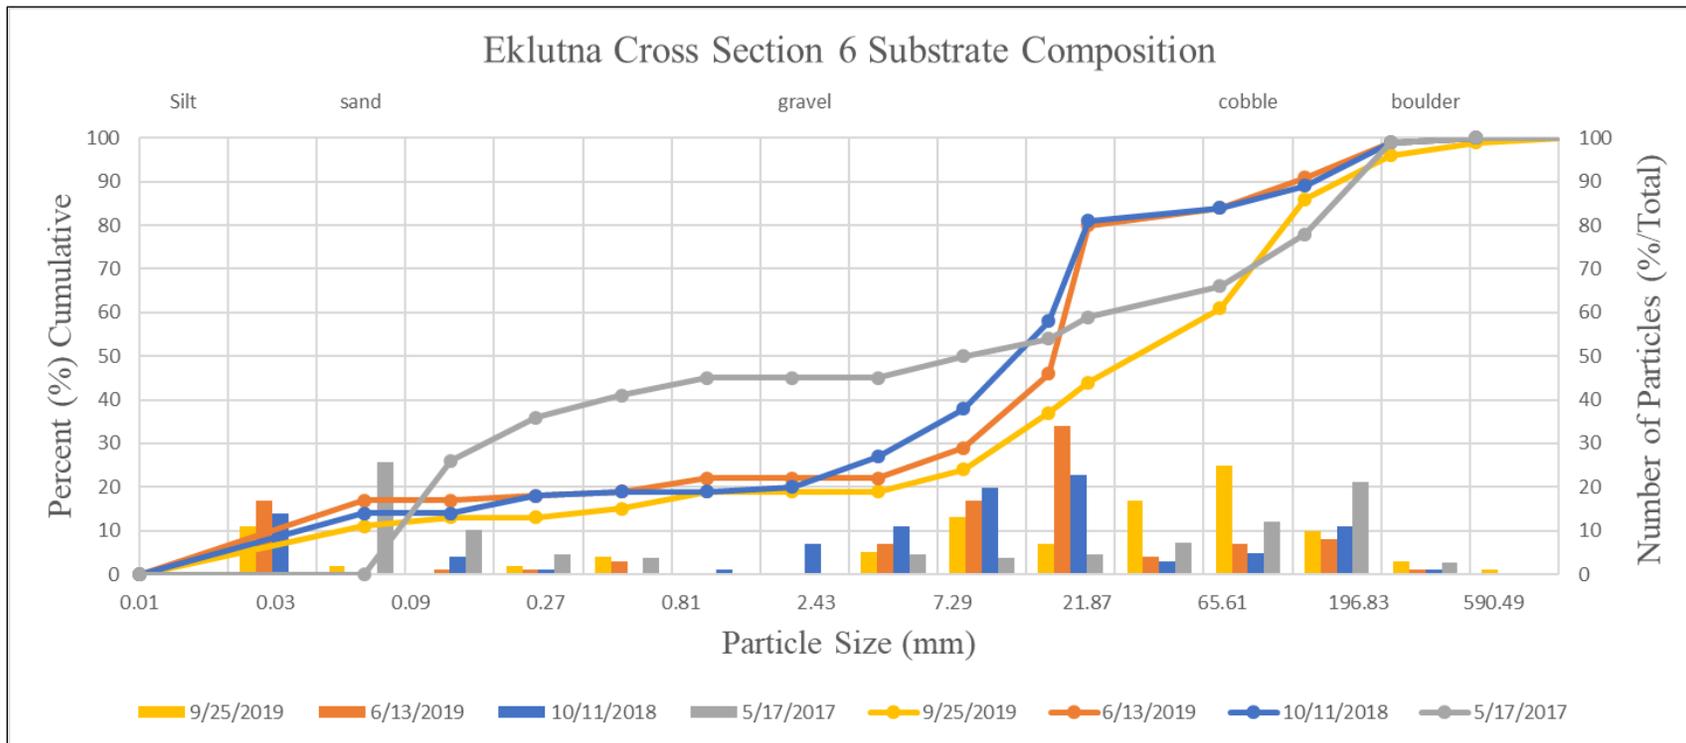
Appendix A1.-Eklutna 6 Channel Geometry and Substrate Composition.

Substrate composition was generally dominated by fine sands and large cobbles with a  $D_{50}$  of fine gravel and a  $D_{84}$  of coarse cobble.

We found that the channel had begun to down-cut into the previously aggraded material by about ¼ foot. Substrate composition became increasingly dominated by silts and coarse gravel, with the  $D_{50}$  increasing further to coarse gravel and the  $D_{84}$  decreasing slightly. Embeddedness was noted to have decreased from prior sampling events. Water quality variables generally were non-noteworthy; however, pH was recorded at 8.7 which is high. The dissolved oxygen level was recorded to be within expected range (approximately 100% saturation).

The channel had again begun to aggrade nearly to the level observed during the October 2018 visit. Substrate composition was dominated by silts and fine cobble, while the  $D_{50}$  increased to very coarse gravel and the  $D_{84}$  increased to small cobble. Substrate embeddedness was noted to have continued to decrease from previous sampling events. Water quality variables were not noteworthy, but pH was high at 8.44.

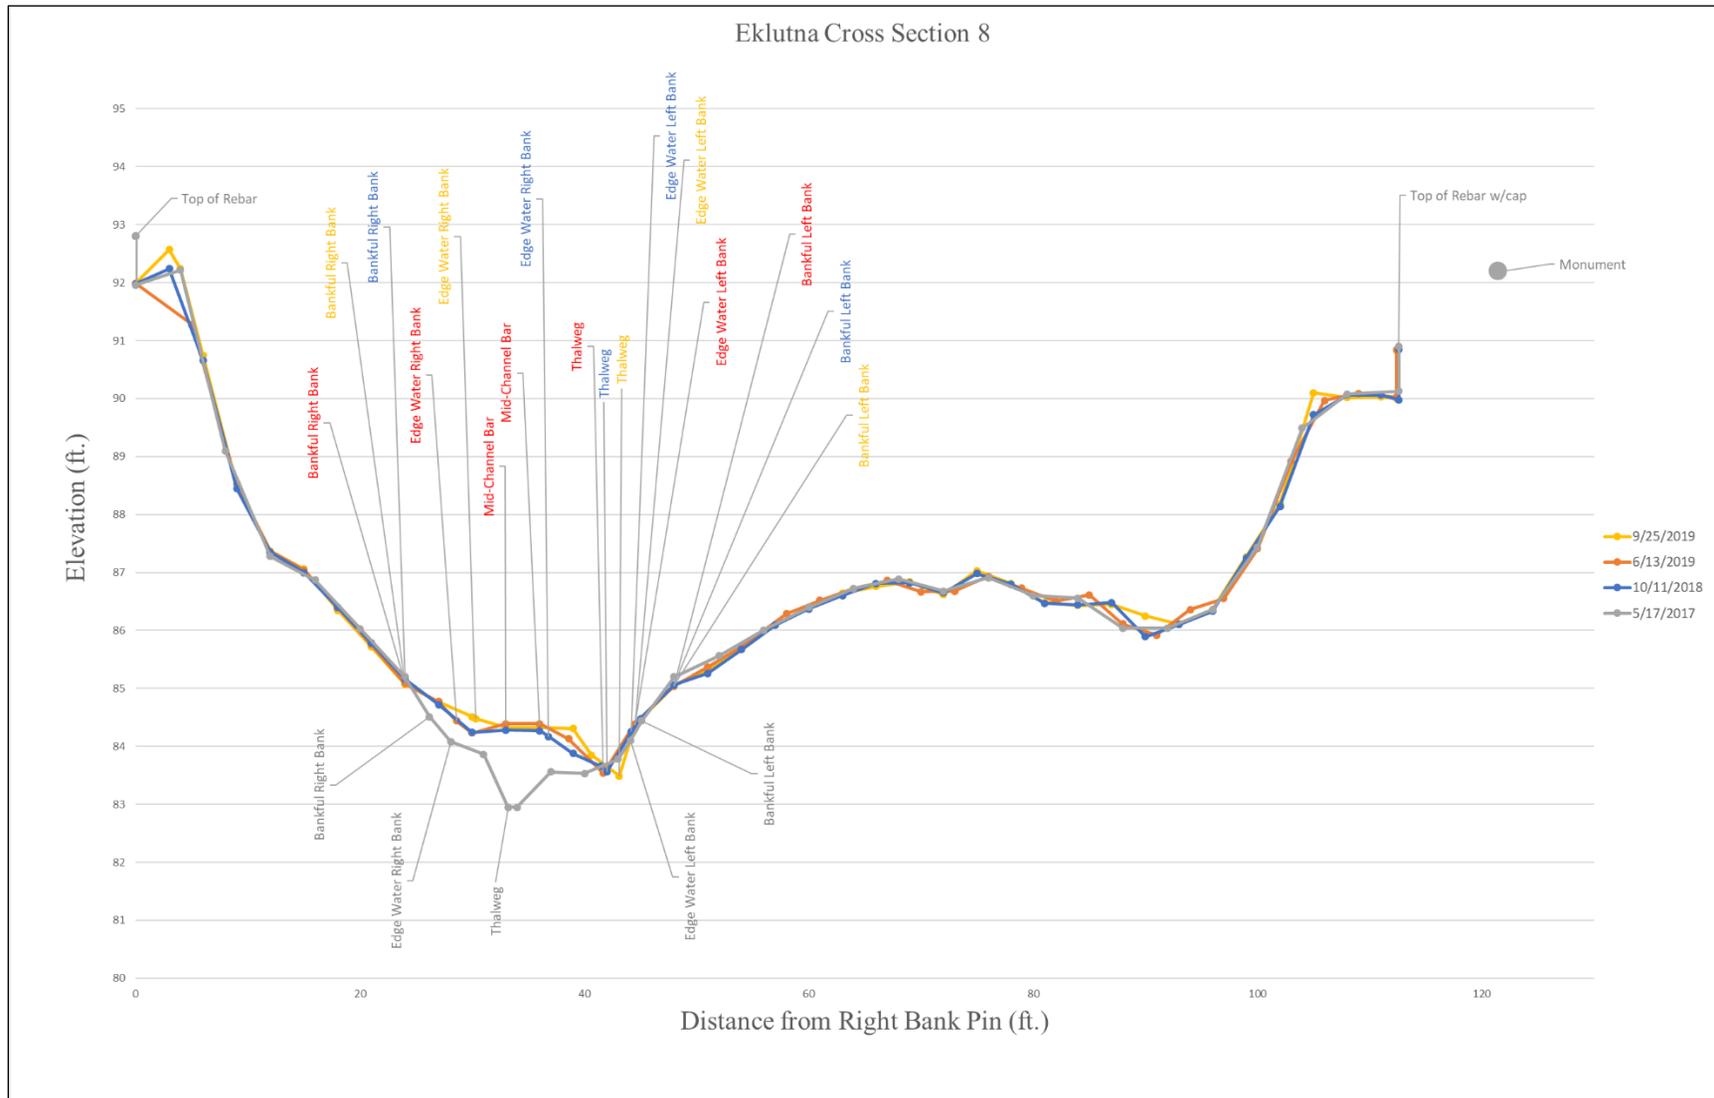
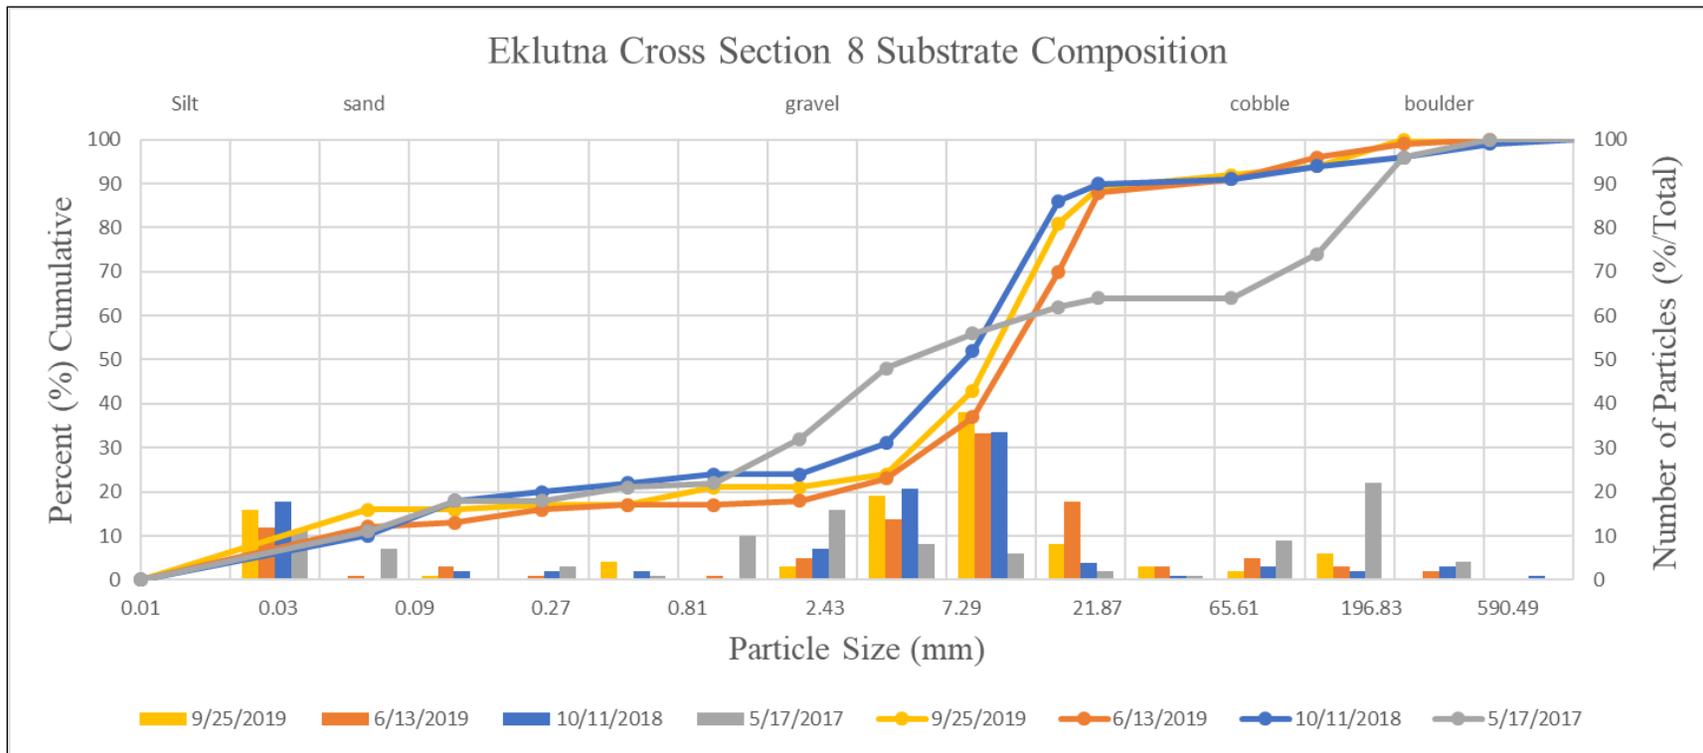
Appendix A2.–Eklutna 8 Channel Geometry and Substrate Composition.

We found channel geometry essentially unchanged. Similarly, substrate composition remained largely unchanged despite a slight decrease in the  $D_{84}$  to small cobble. Water quality variables were similar to previous visits.

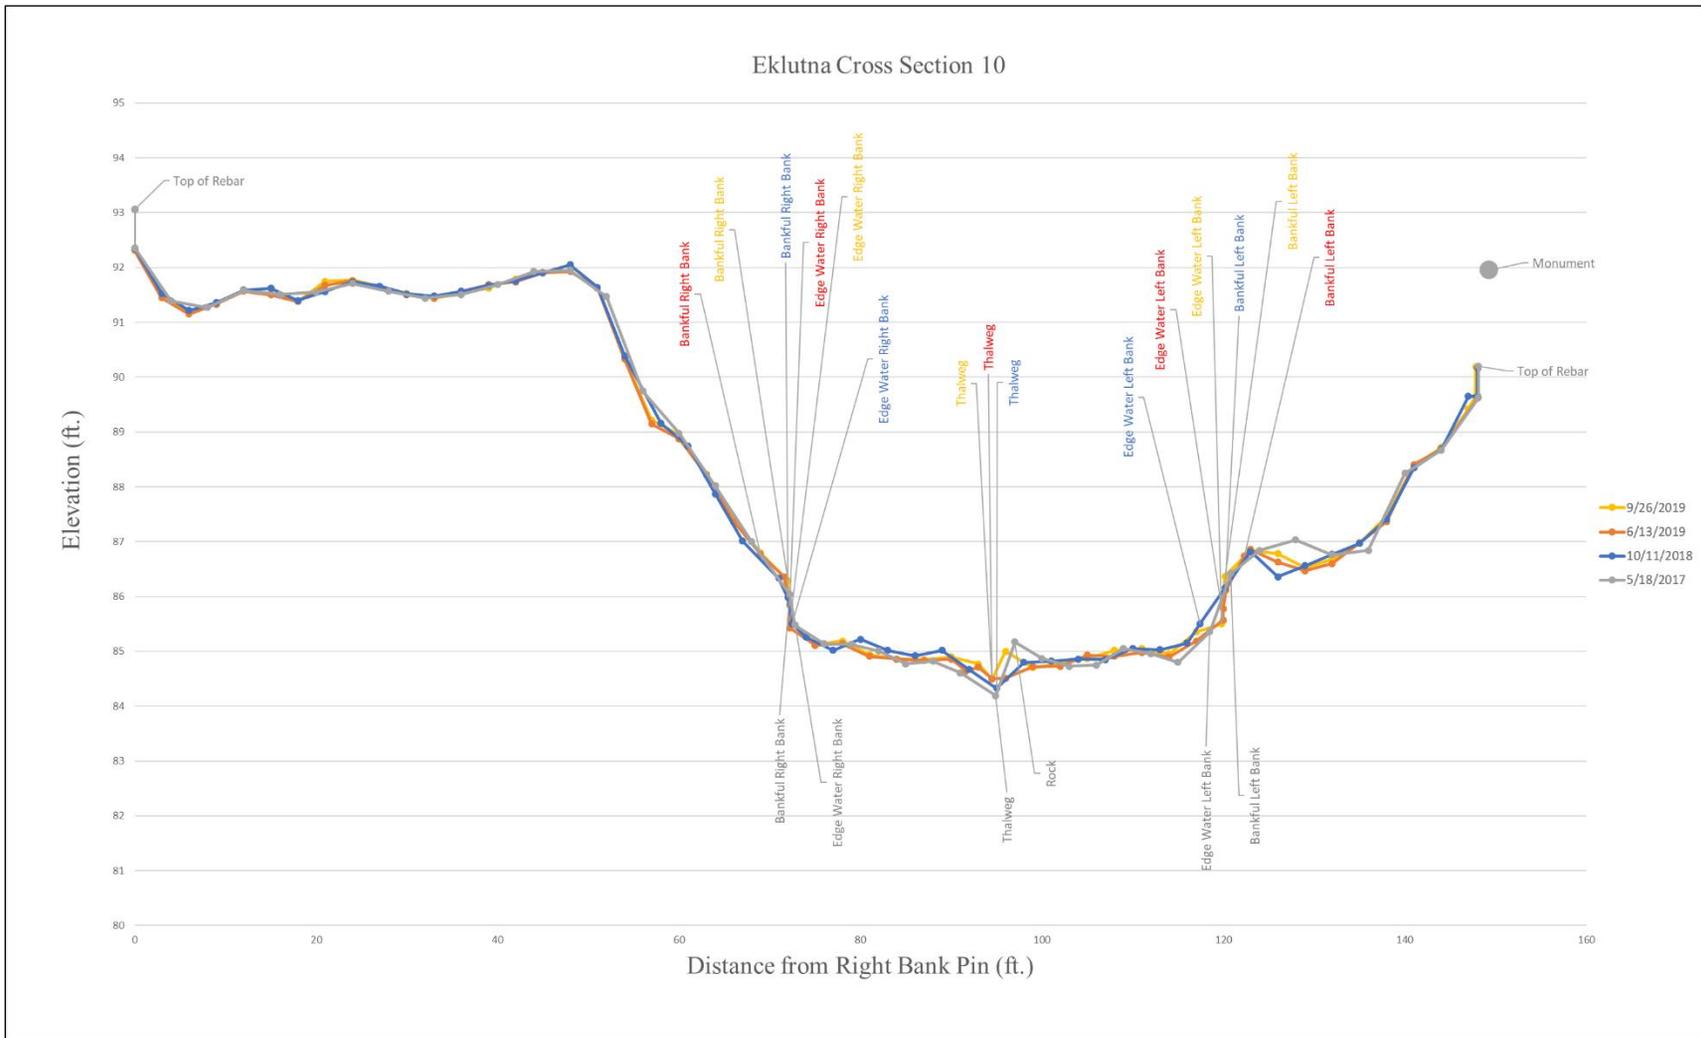
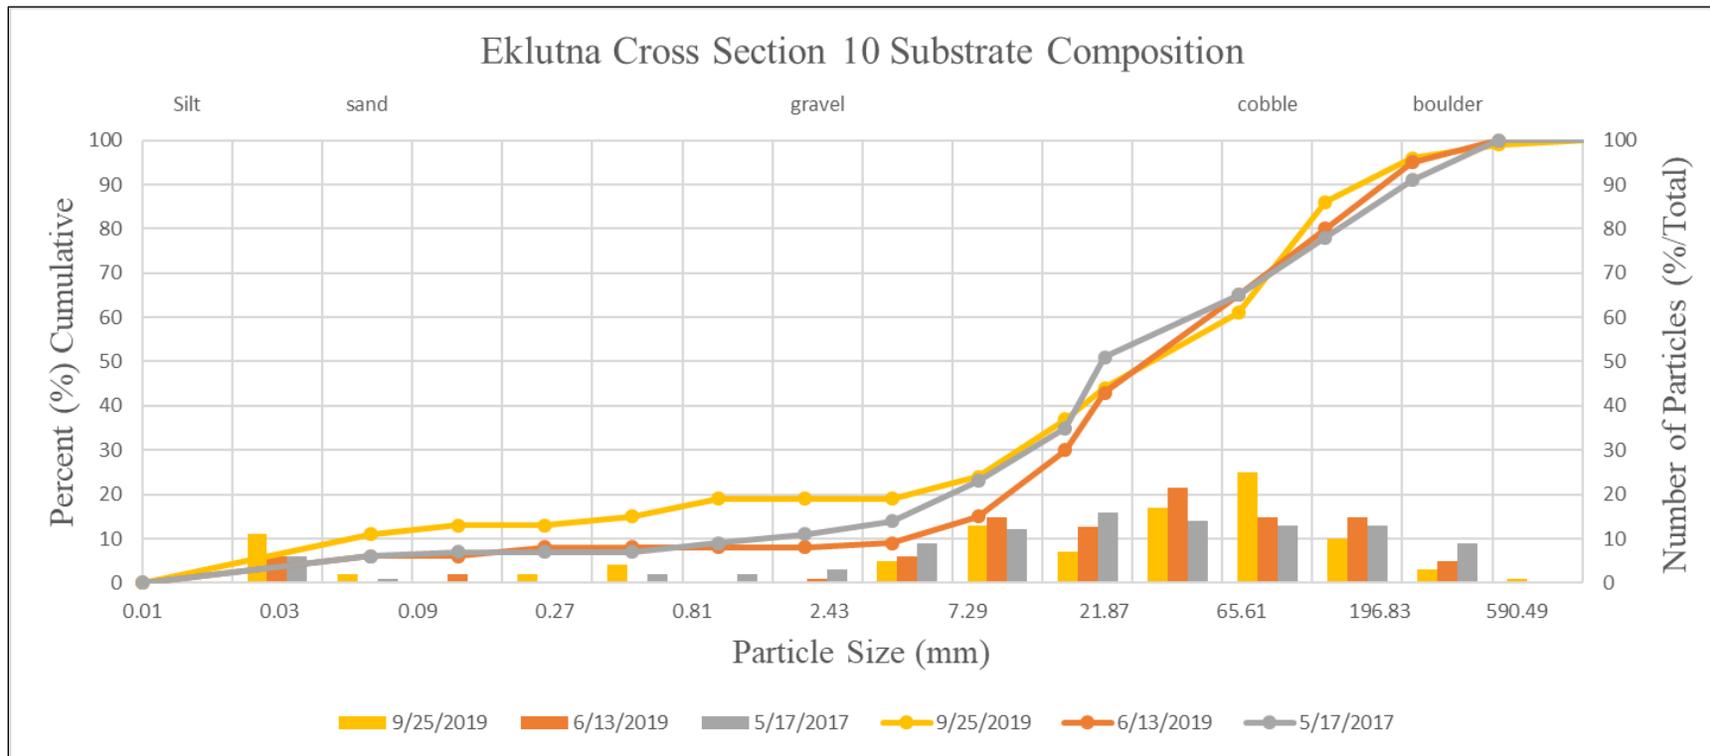
Appendix A3.–Eklutna 10 Channel Geometry and Substrate Composition.

Channel geometry remained very similar to the previous visit. Substrate composition was not recorded due to unsuitable stream conditions. Water quality variables were generally within expected ranges, except that dissolved oxygen readings were abnormally high. This was likely the result of a faulty sensor.
