1 Hydrology of the Eklutna River

1.1 Watershed Description and Historical Development

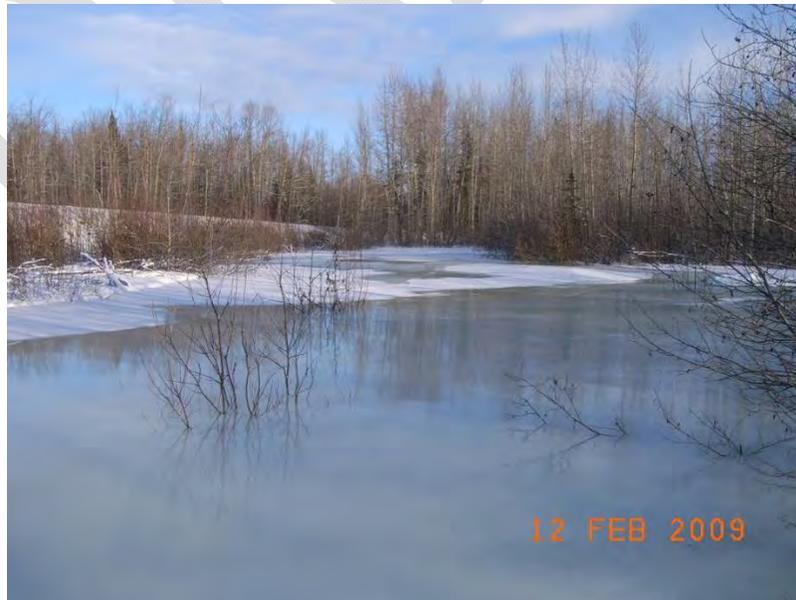
Figure 20 Aufeis upstream from Alaska Railroad Crossing

In the case of the Eklutna River, the aufeis and normal river ice disconnects the river upstream from the AKRR with the river below the AKRR. Very few areas of open water exist during the winter with a majority of the stream channel frozen completely to the ground. An example of aufeis upstream of the AKRR crossing is shown in Figure 20. It is unlikely that these conditions could be altered to provide connectivity between the areas above and below the AKRR crossing.

- Lack of surface water during the winter months. Several field investigations during the winter months have failed to detect significant winter flows downstream of the Alaska Railroad crossing. Extensive aufeis formation upstream of the railroad also indicates that little or no surface water passes through the Alaska Railroad Bridge during the winter months (see Figure 20).
