Eklutna Hydroelectric Project

Geomorphology and Sediment Transport

Year 2 Report

Prepared by:
Kathy Vanderwal Dubé
Watershed GeoDynamics

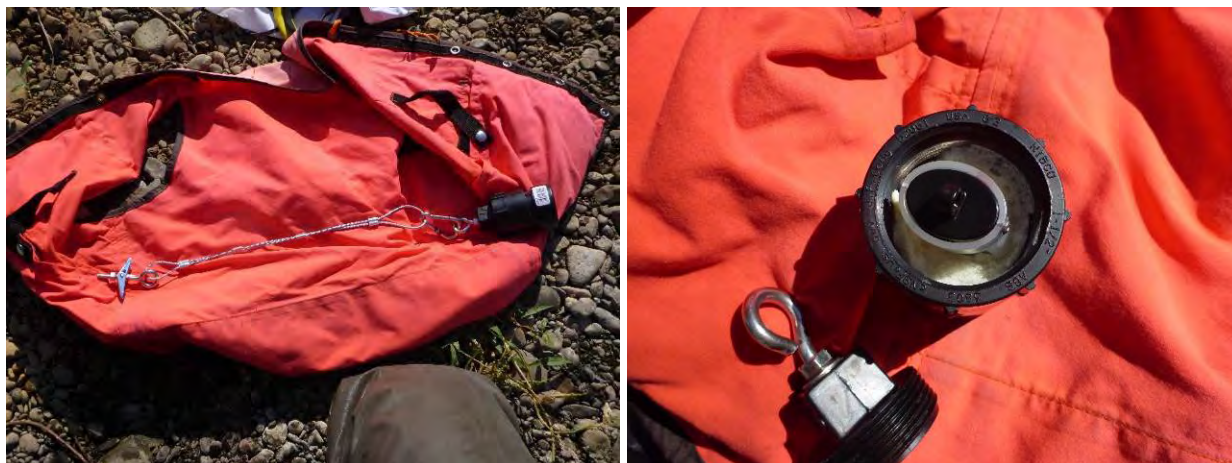
Figure 4.2-12. Accelerometer before deployment.

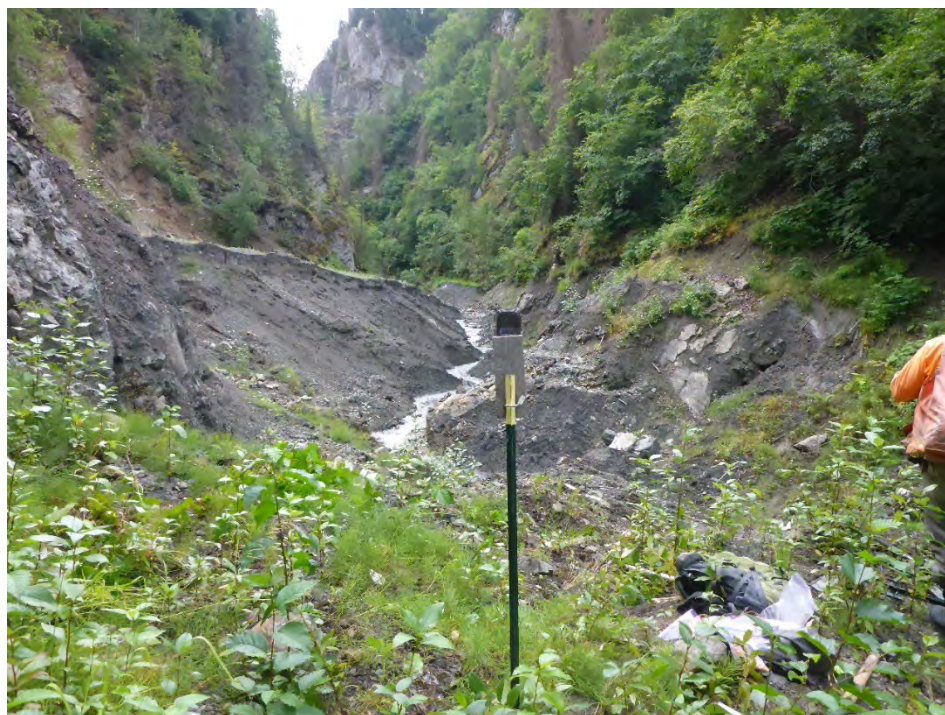
Figure 4.2-13. Timelapse camera installation prior to study flow releases.

Three timelapse cameras were installed in the old lower reservoir area (the area upstream from the lower dam site where sediment accumulated prior to removal of the dam) to record changes that took place during the study flow releases (see locations on Figure 4.2-5). Cameras were mounted on fence posts located on the top of the reservoir deposits and set to record every 10 minutes during daylight hours (Figure 4.2-13). Cameras were retrieved following the study flow releases.

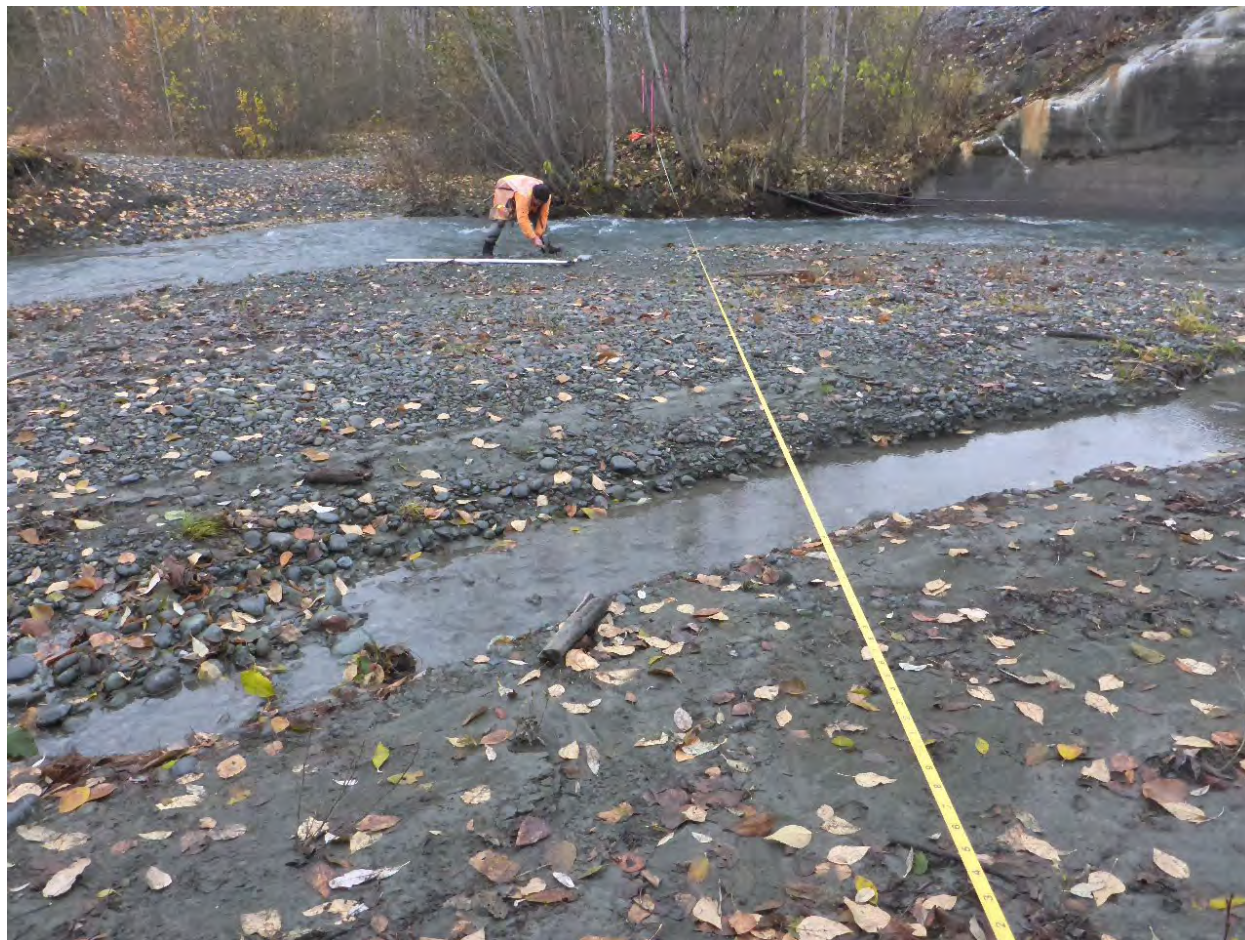
Figure 5.3-1. Transect 101, October 8, 2021.

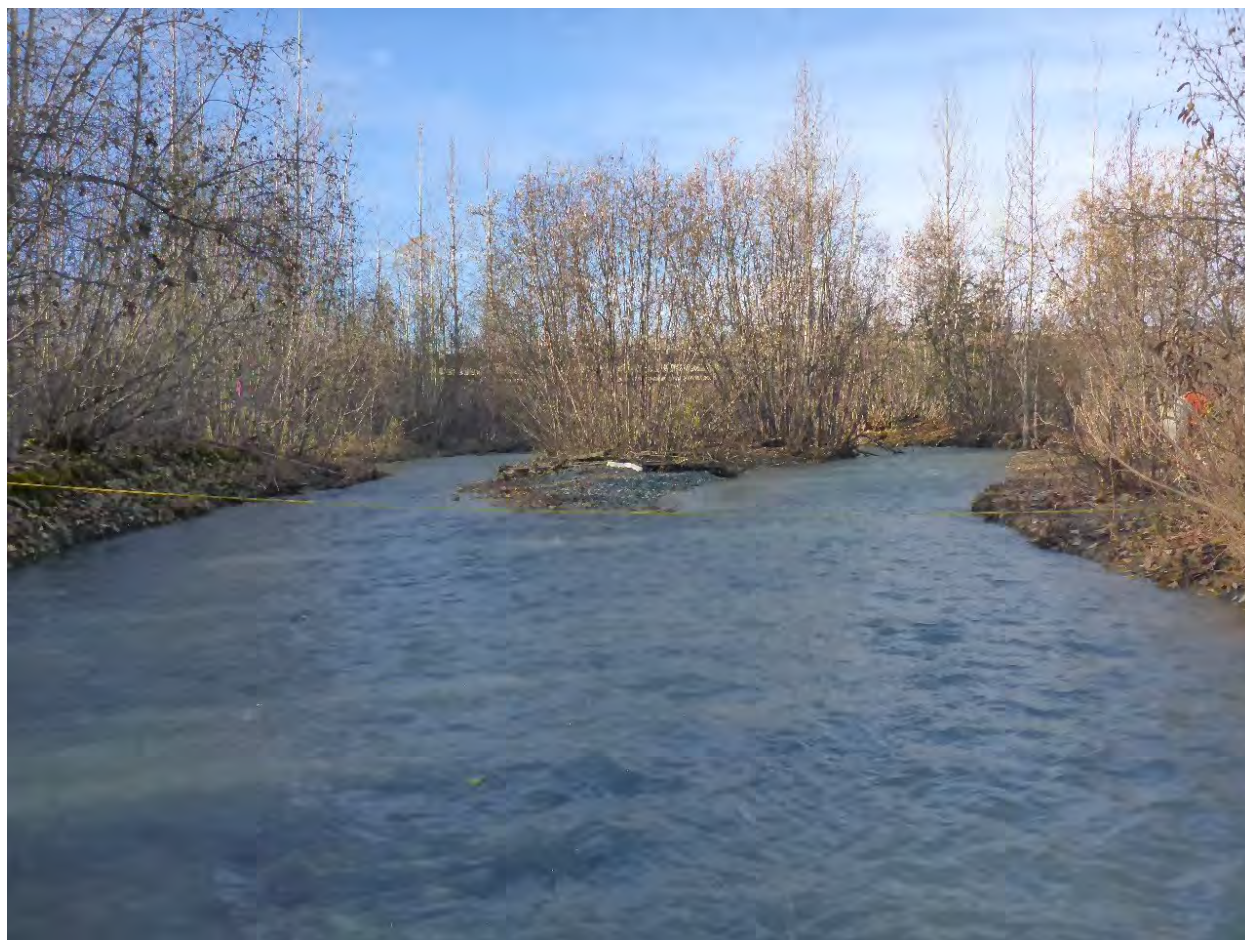
Figure 5.3-5. Transect G, October 12, 2021.

Transect G, at RM 2.15, is located just upstream of the New Glenn Highway bridges (**Figure 5.3-5**). This transect was established in September 2020 and included two pre-flow release measurements and one post-flow release measurement. The post-flow measurement showed deposition of 0.5 to 1 foot within the channel following the study flow releases (**Figure 5.3-6**). Grain size measurements were taken pre- and post-flow release across the transect (**Figure 5.3-7**). Substrate is predominantly gravel and showed an increase in median grain diameter from 13 to 23 mm following the study flow releases. An accelerometer and a sliding bead scour monitor were installed in August 2020. The sliding bead monitor was read in August and October 2021 and showed 3 inches of bed lowering between August 2020 and August 2021 followed by burial with 0.84 feet of gravel (up to 45 mm) in October 2021 following the study flow releases. The accelerometer was located, but not yet recovered post flow release due to deep, cold-water conditions in both 2021 and 2022. It is buried by 0.6 feet of gravel.

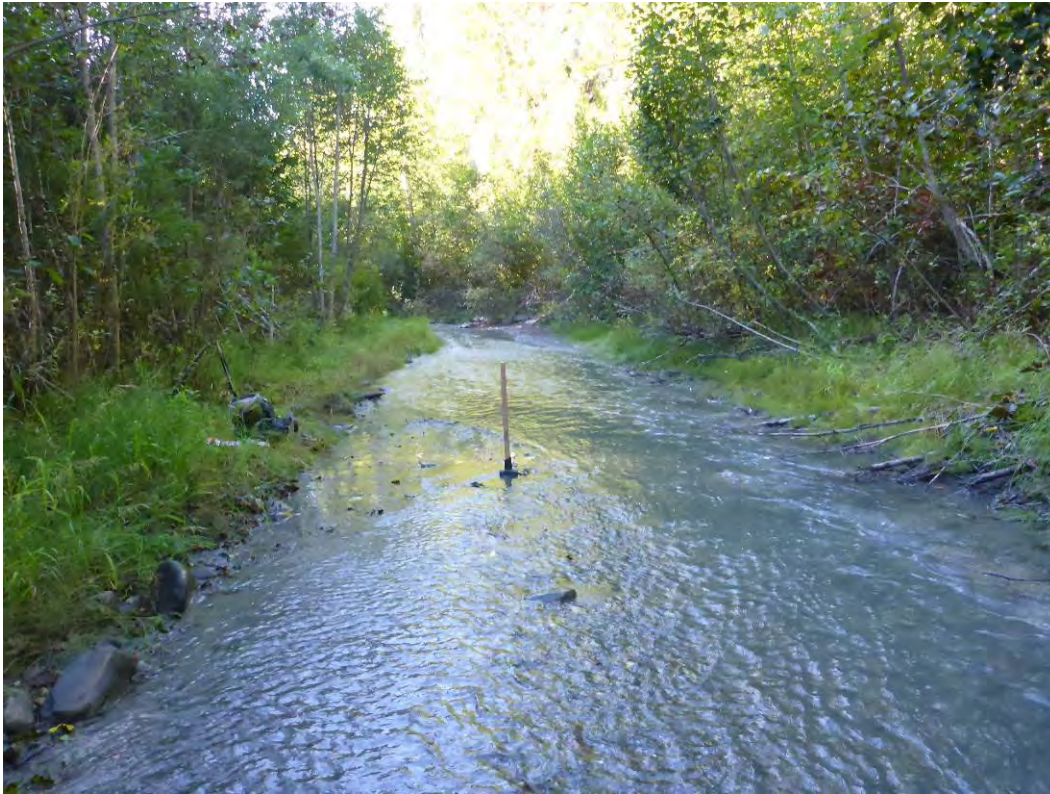
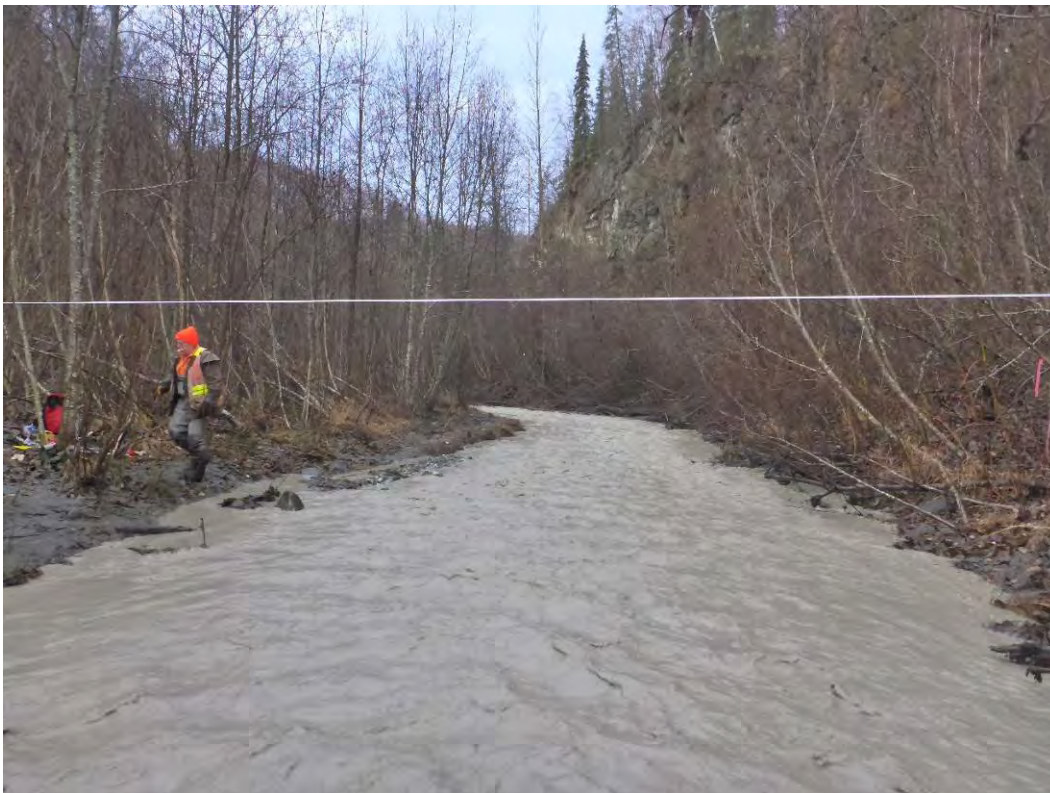
Figure 5.3-8. Transect ADFG8 Down pre-flow (top) and post-flow (bottom).

Transect ADFG8 Down at RM 2.9 was established in 2017 as part of the aquatic habitat monitoring effort post dam removal and is located just upstream of the confluence with Thunderbird Creek (**Figure 5.3-8**). This transect included two pre-flow release measurements made by ADFG staff and one post-flow release measurement made as part of the current study. The channel at this transect has had up to 1 foot of aggradation following dam removal followed by about 0.5 foot of erosion following the study flow releases (**Figure 5.3-9**). A sliding bead scour monitor was installed at this location in August 2020. The sliding bead monitor was read in August and October 2021 and showed 0.5 foot of bed lowering between August 2020 and August 2021 followed by 4 inches of scour and then 3-4 inches of fill following the study flow releases (October 2021 reading).

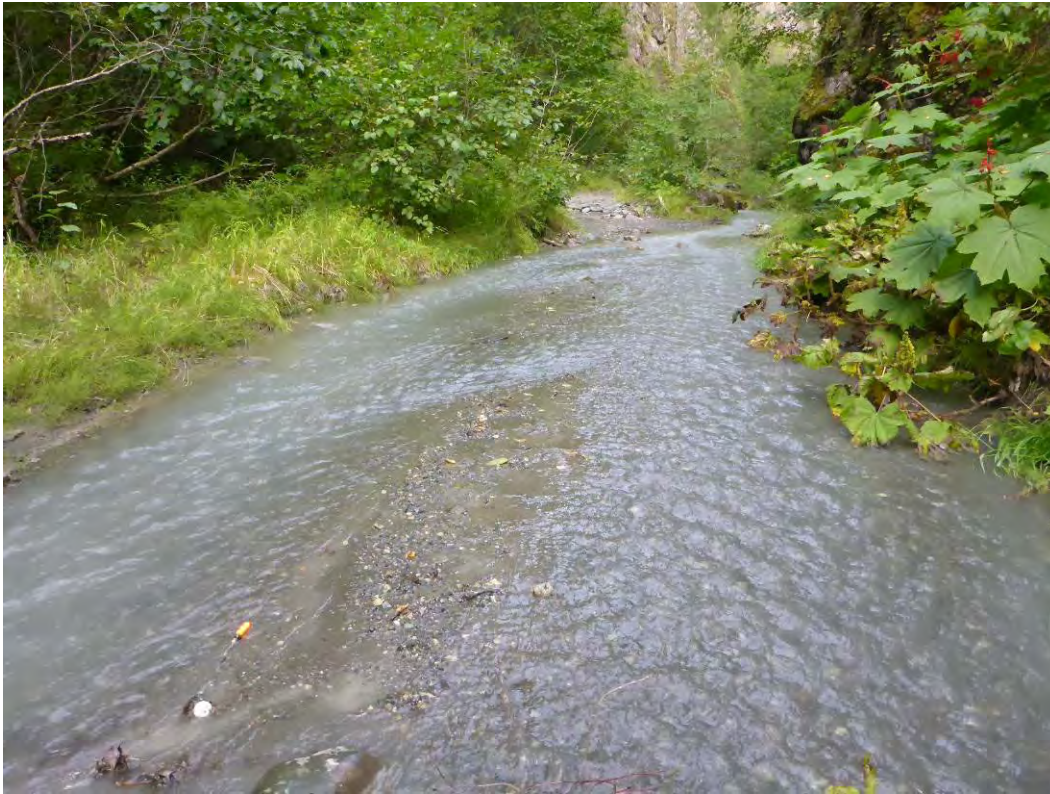
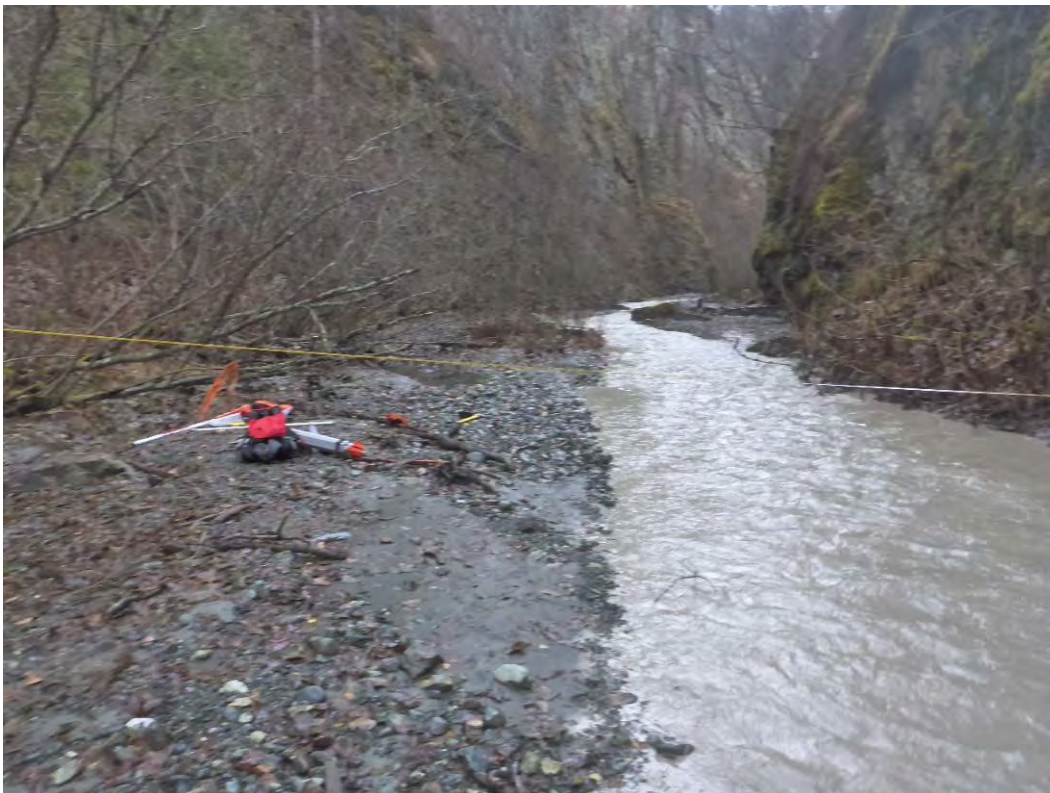
Figure 5.3-10. Transect ADFG6 Down pre-flow (top) and post-flow (bottom).

Transect ADFG6 Down at RM 3.3 was established in 2017 as part of the aquatic habitat monitoring effort post dam removal (**Figure 5.3-10**). This transect included two pre-flow release measurements made by ADFG staff and one post-flow release measurement made as part of the current study. Up to 0.5 feet of deposition was recorded between 2017 (pre dam removal) and 2020. The post-flow measurement showed deposition of up to 2 feet within the channel following the study flow releases (**Figure 5.3-11**). A sliding bead scour monitor was installed at this location in August 2021 but was not located in October 2021 following the study flow release due to deep, cold water conditions. In July, 2022 the sliding bead monitor was recovered and showed 6 inches of scour following by 1 foot of deposition at this location with deposition including particles of 64-90 mm size class.

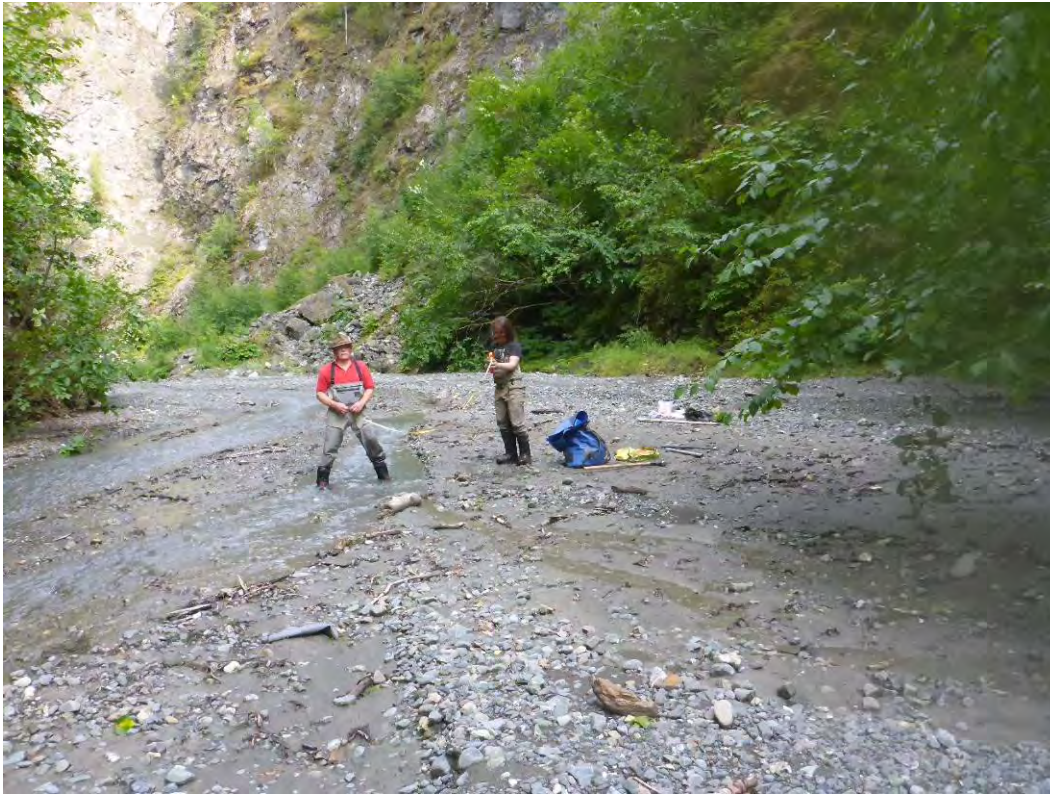
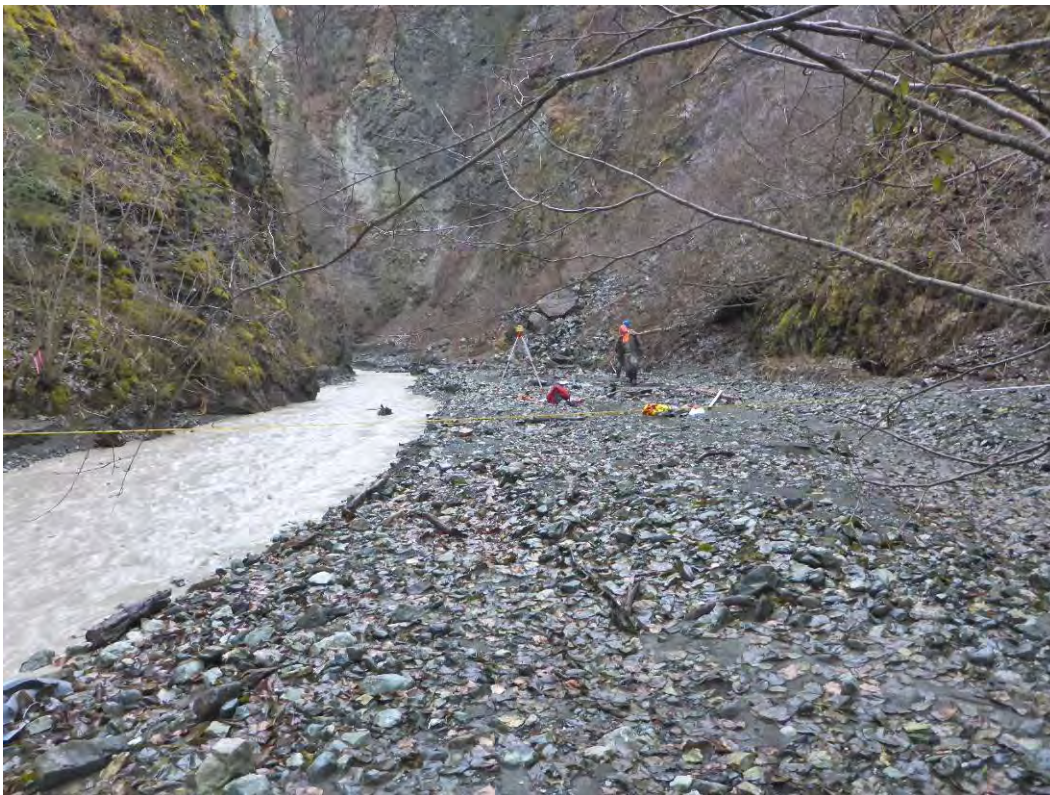
Figure 5.3-12. Transect ADFG2 Down pre-flow (top) and post-flow (bottom).

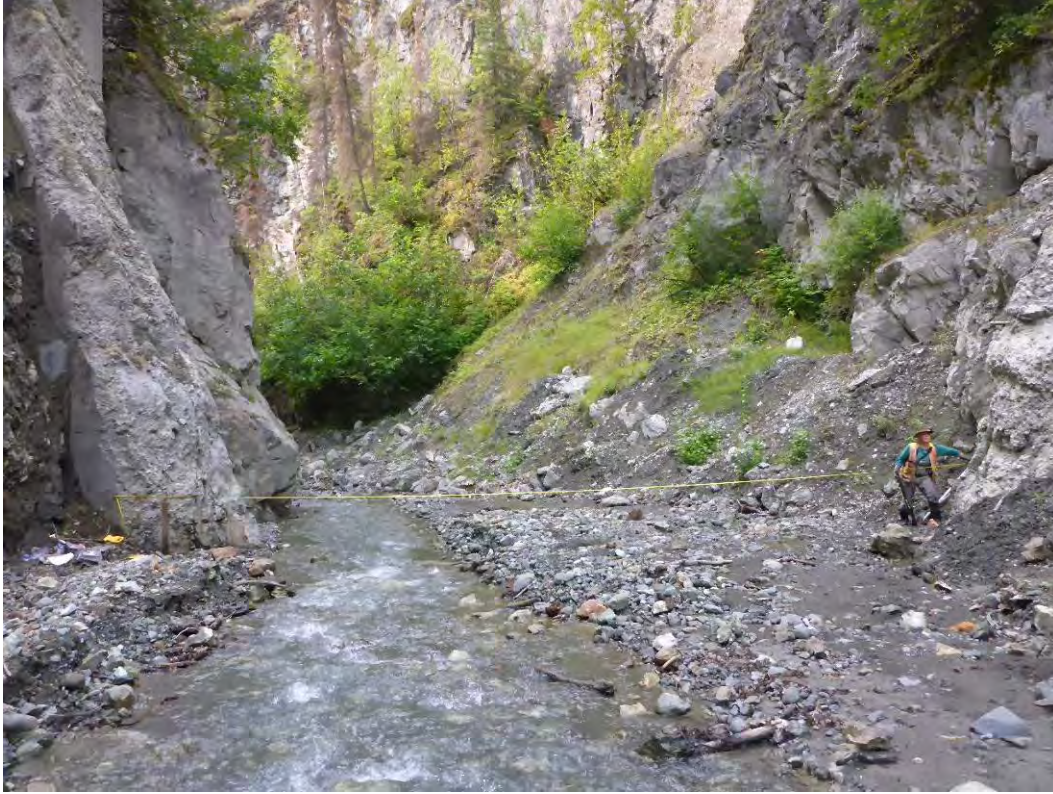
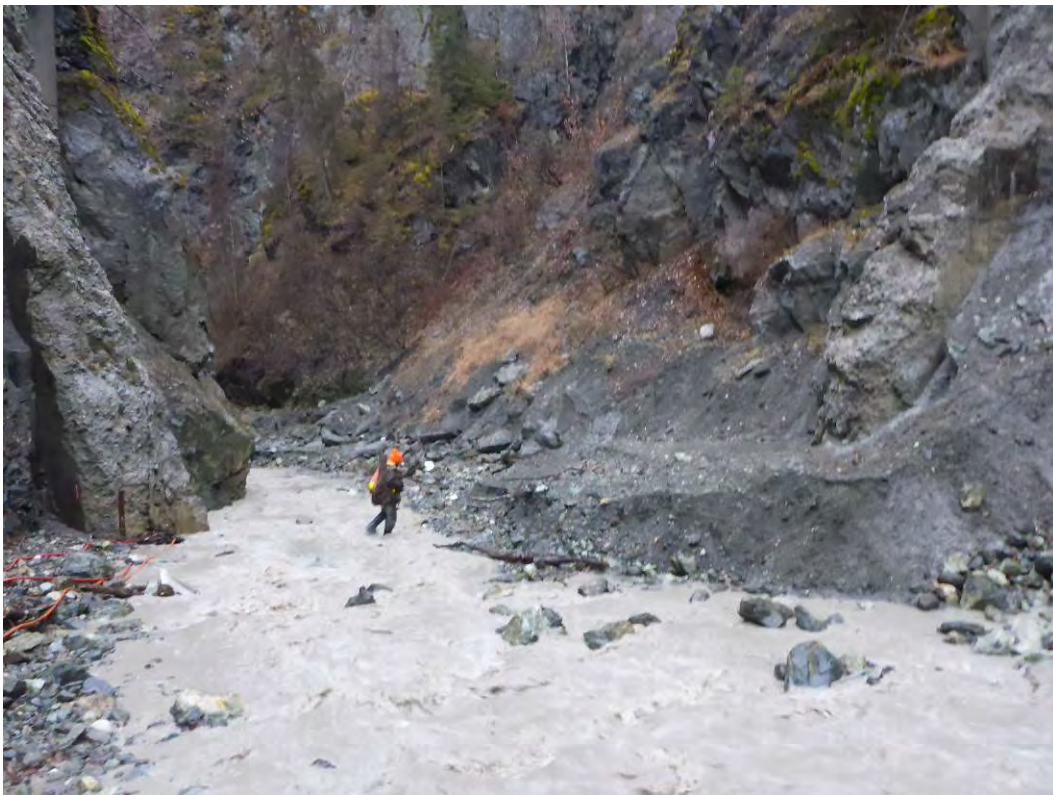
Figure 5.3-16. Transect 204 pre-flow (top) and post-flow (bottom).

Transect 204, at RM 3.95, is located at the old lower dam abutments (**Figure 5.3-16**). This transect was established in August 2021 and included one pre-flow release measurement and one post-flow release measurement. The post-flow measurement showed deposition of up to 3 feet of sediment within the channel following the flow releases, and then subsequent erosion of the deposited sediment back to nearly pre-flow release elevations (**Figure 5.3-17**).

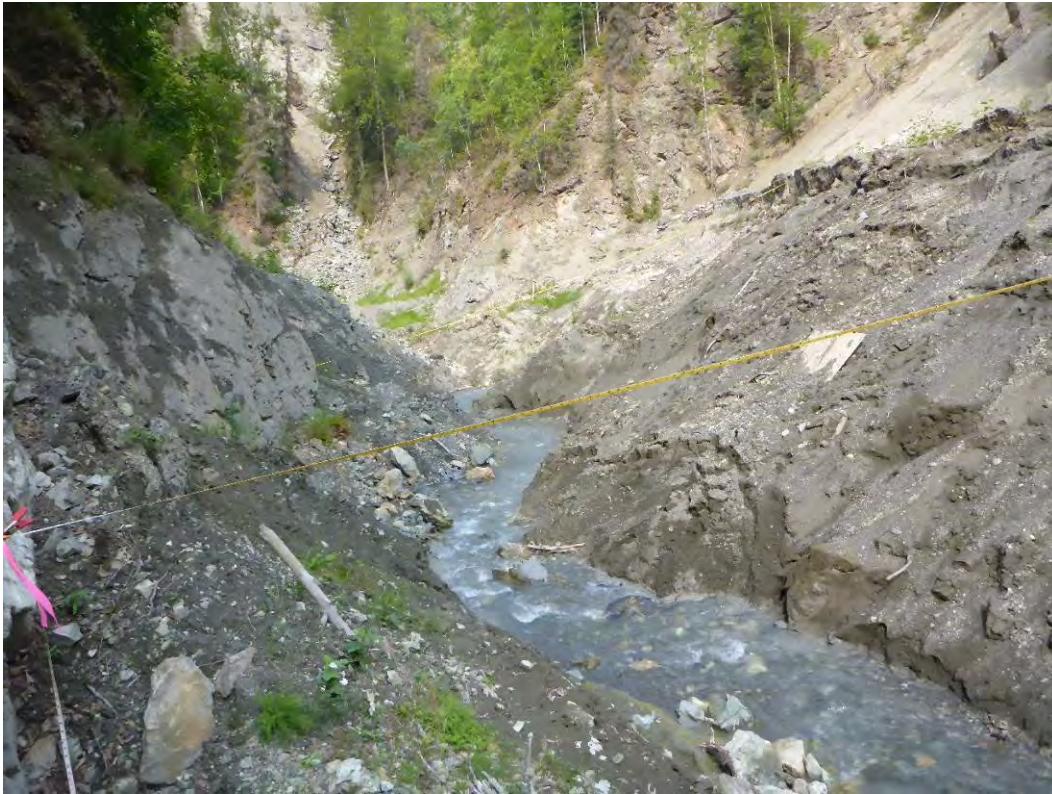
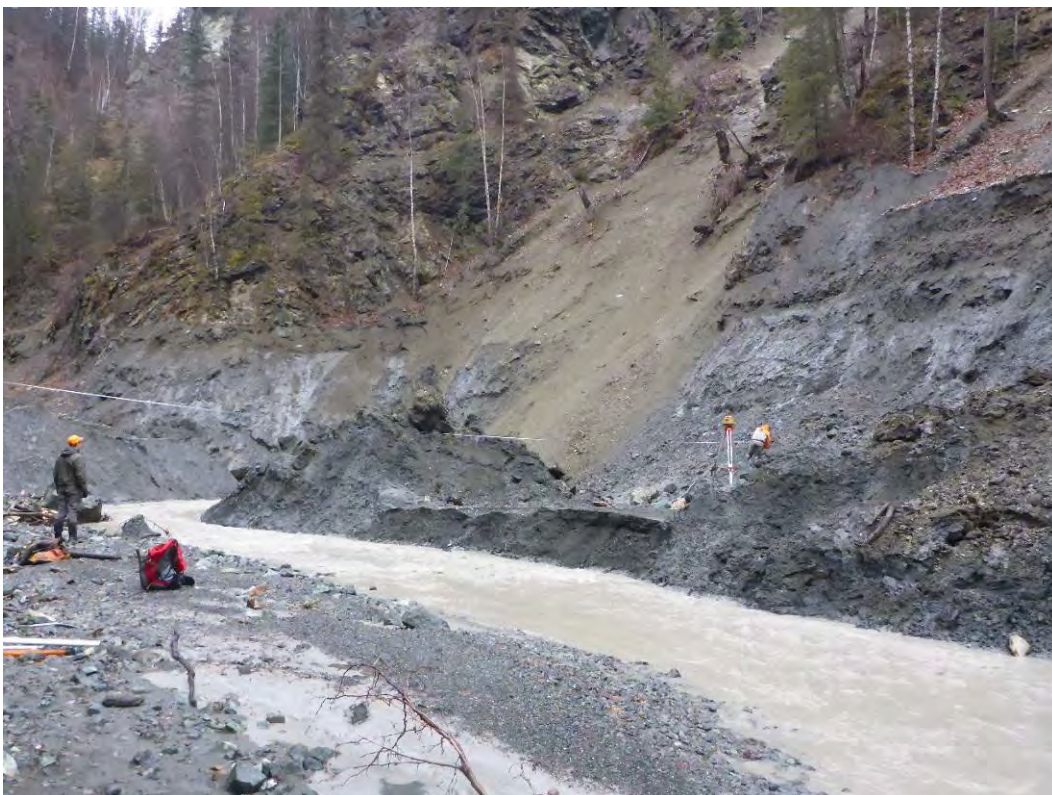
Figure 5.3-18. Transect 203 pre-flow (top) and post-flow (bottom).

Transect 20, at RM 4.05, is located in the old reservoir deposits (**Figure 5.3-18**). This transect was established in August 2021 and included one pre-flow release measurement and one post-flow release measurement. This transect showed major erosion of the old reservoir deposits, with up to 30 vertical feet of erosion of the accumulated reservoir sediments and up to 3 feet of thalweg lowering (**Figure 5.3-19**). Two mechanisms for this erosion were captured on timelapse videos (cameras G1 and G2): undercutting and toppling of the consolidated silt/clay banks; and a large slump that occurred and quickly removed a large portion of the deposits. A remnant of that slump block can be seen in the center of the post-flow photo in **Figure 5.3-18**.

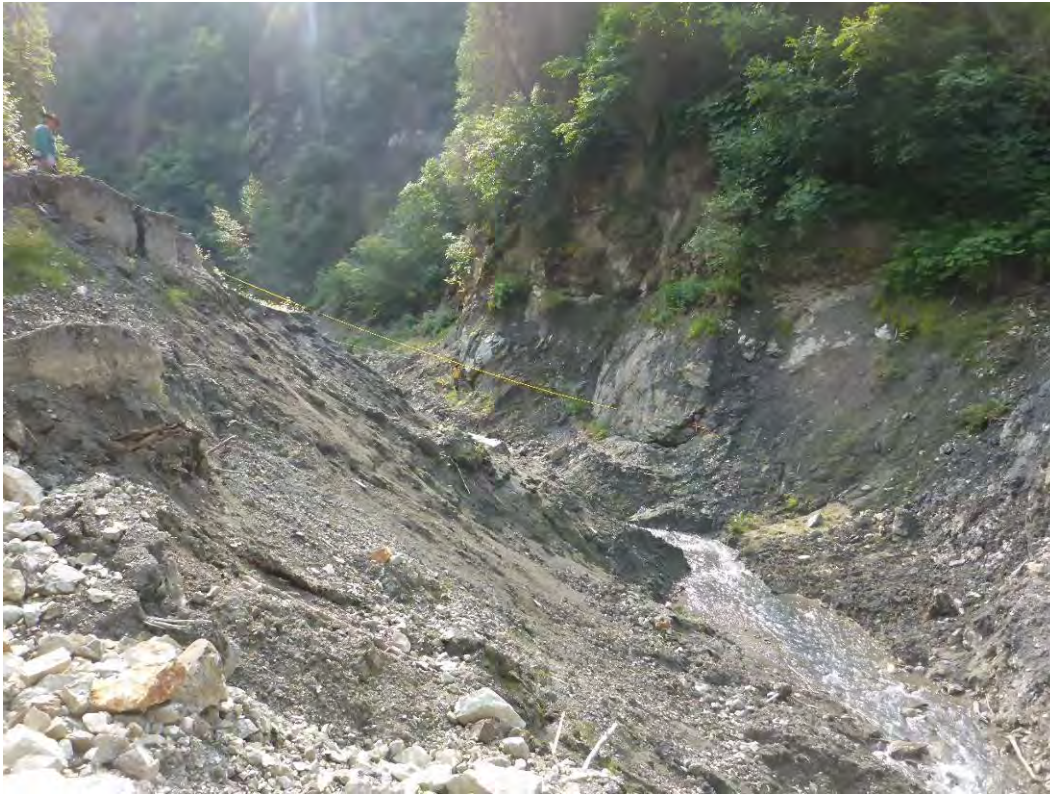
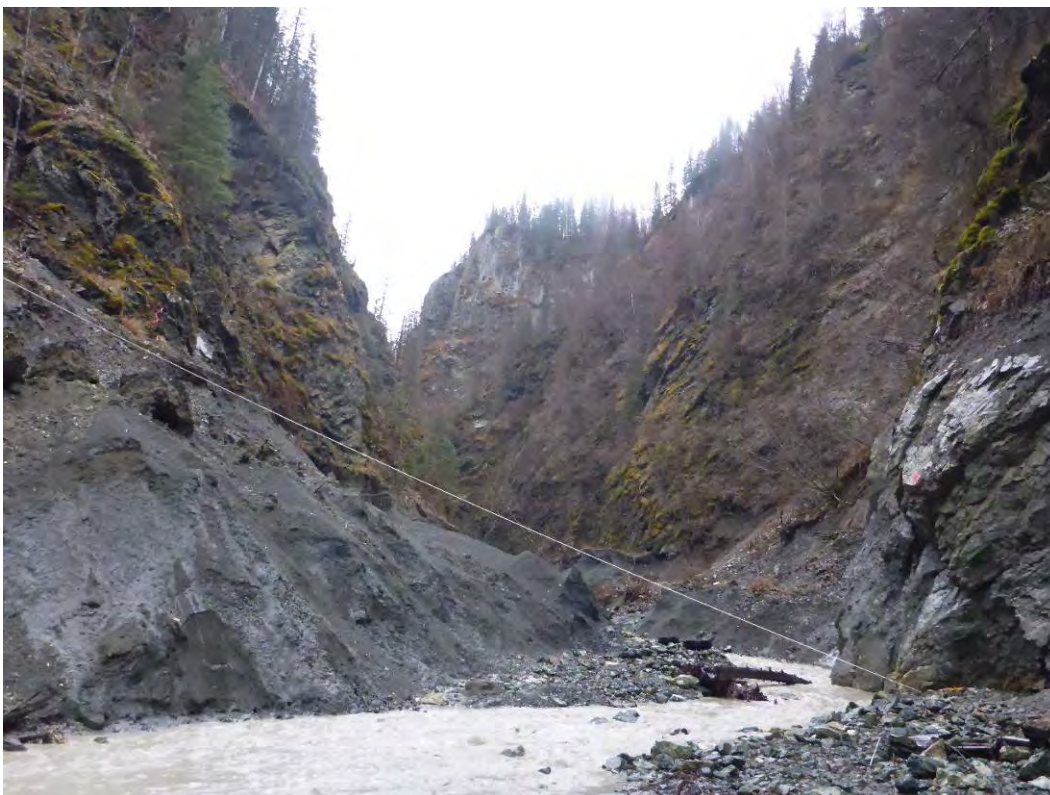
Figure 5.3-20. Transect 202 pre-flow (top) and post-flow (bottom).

Transect 204, at RM 4.06, is located in the old reservoir deposits (**Figure 5.3-20**). This transect was established in August 2021 and included one pre-flow release measurement and one post-flow release measurement. The post-flow measurement showed erosion of a large amount of reservoir sediment, particularly on the right bank where up to 14 feet of erosion occurred (station 0 is right bank; **Figure 5.3-21**). The thalweg lowered approximately 2 feet.

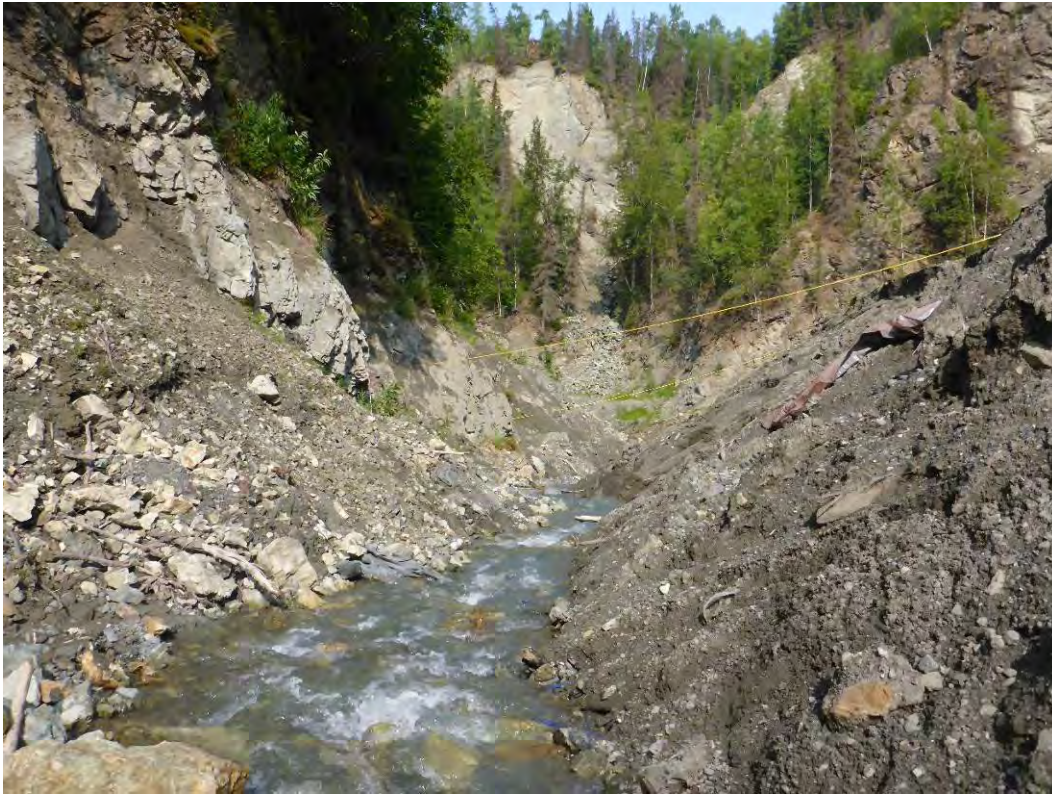
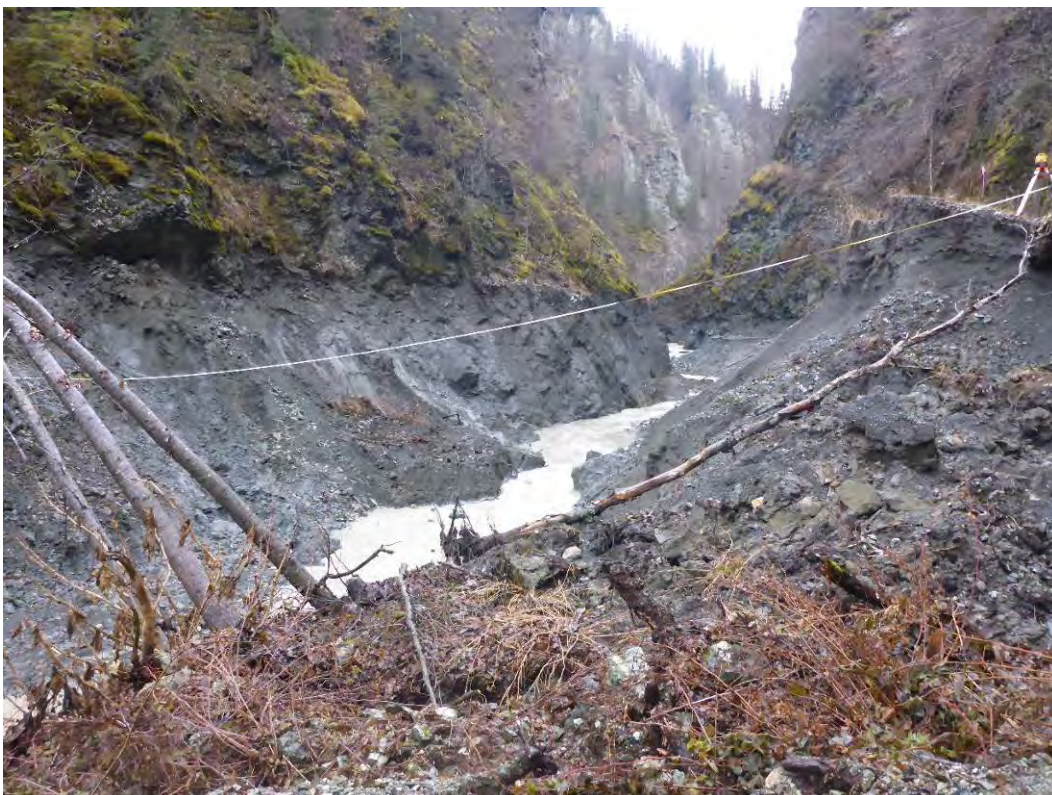
Figure 5.3-22. Transect 201 pre-flow (top) and post-flow (bottom).

Transect 201, at RM 4.1, is located at the upstream end of the old reservoir (**Figure 5.3-22**). This transect was established in August 2021 and included one pre-flow release measurement and one post-flow release measurement. The post-flow measurement showed erosion of up to 14 feet of the stored reservoir sediment and 9 feet of channel lowering following the study flow releases (**Figure 5.3-23**). A time-lapse video (camera G3) was located pointing upstream from this site and recorded erosion and headcutting during the study flow release. A sub-surface sample was taken at this site and is shown in **Figure 5.3-24**.

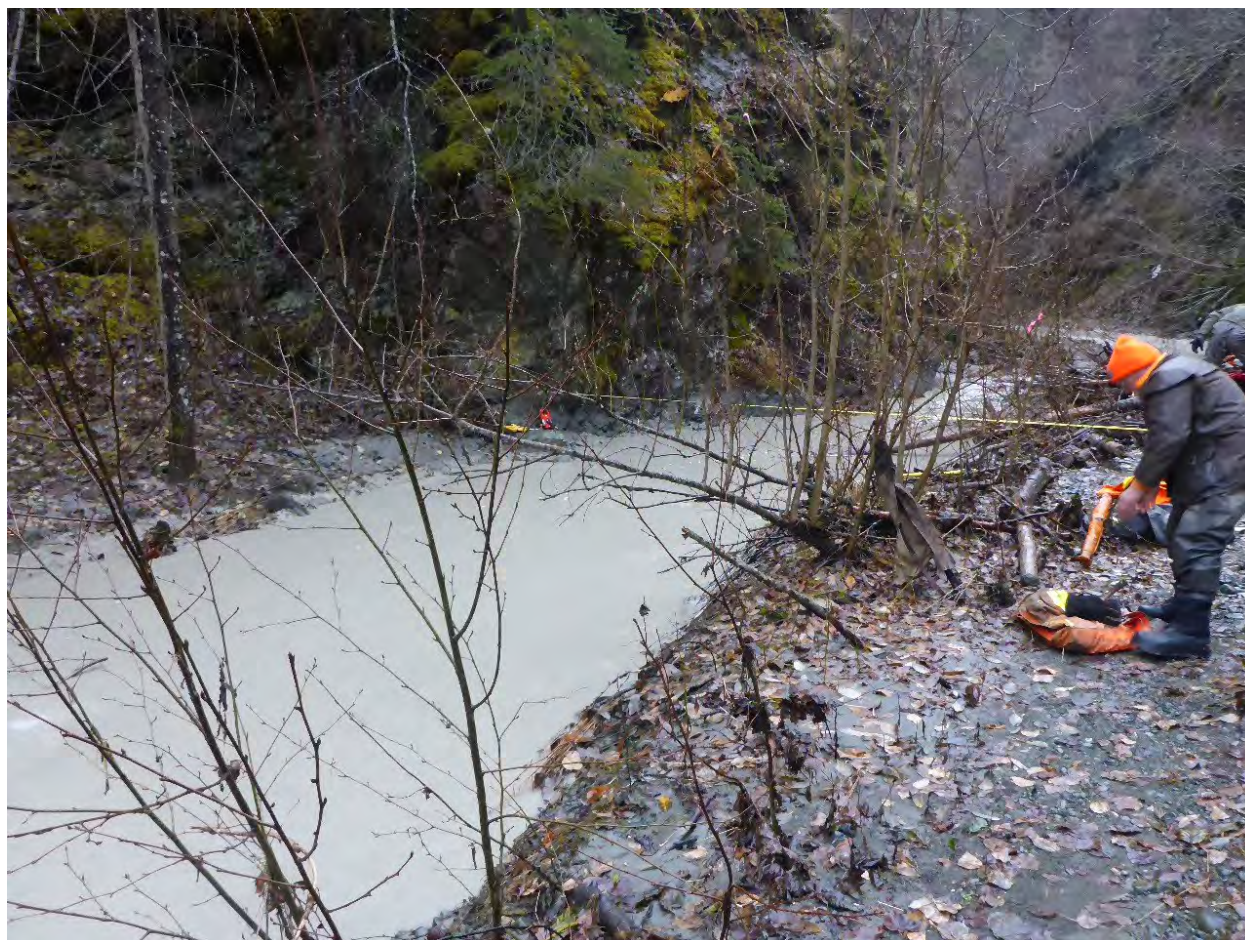
Figure 5.3-25. Transect ADFG4 Up, November 1, 2021.

Transect ADFG4 Up at RM 4.4 was established in 2017 as part of the aquatic habitat monitoring effort post dam removal and is located upstream of the old dam deposits (**Figure 5.3-25**). This transect included two pre-flow release measurements made by ADFG staff and one post-flow release measurement made as part of the current study. The post-flow measurement showed deposition of less than 0.5 feet on the left bank bar and erosion of nearly 1 foot within the channel following the study flow releases (**Figure 5.3-26**). Grain size measurements were taken pre-flow release across the transect and showed substrate was dominated by gravel with a median grain diameter of 13 mm (**Figure 5.3-27**). An accelerometer and sliding bead scour monitor were installed at this location in August 2021. The accelerometer was found in October 2021 following the flow releases. The accelerometer at ADFG4 Up recorded movement on September 14, 2021 starting at 0230 and major movement from 1730 through September 25 (**Figure 5.3-28**). The sliding bead monitor was recovered in July 2022 and showed 5.5 inches of erosion followed by 2 inches of deposition of fine-grained material.

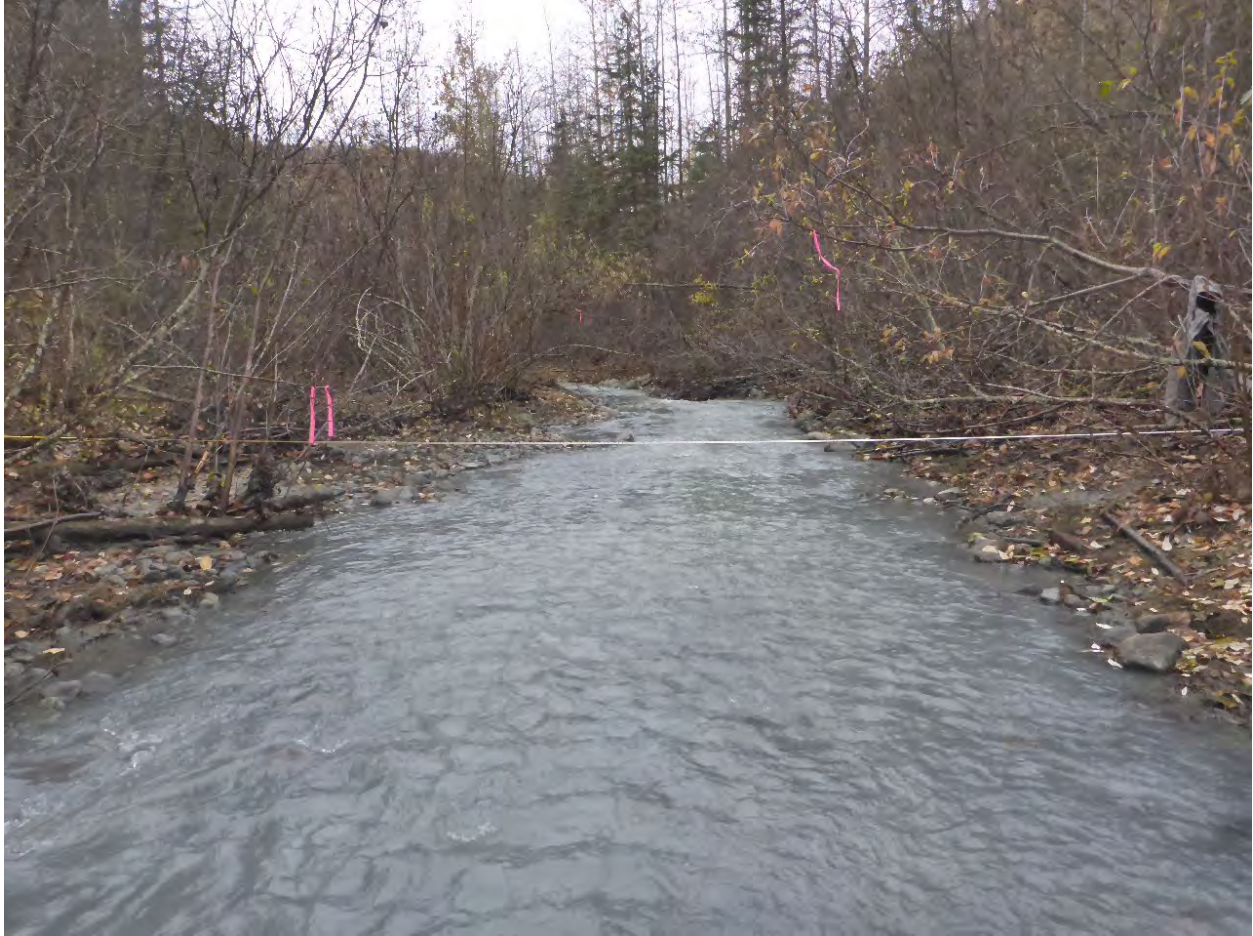
Figure 5.3-29. Transect 102.

Transect 102, at RM 5.3, is located at an instream flow transect (**Figure 5.3-29**). This transect was established in August 2021 and included one pre-flow release measurement and one post-flow release measurement. There was little change in the cross section from pre- to post-release (**Figure 5.3-30**). Grain size measurements were taken pre- and post-flow release across the transect and showed a mix of gravel and sand particles with little change following the study flow releases (**Figure 5.3-31**). A sliding bead scour monitor was installed in August 2020. The sliding bead monitor showed no change in October 2021 following the study flow releases.

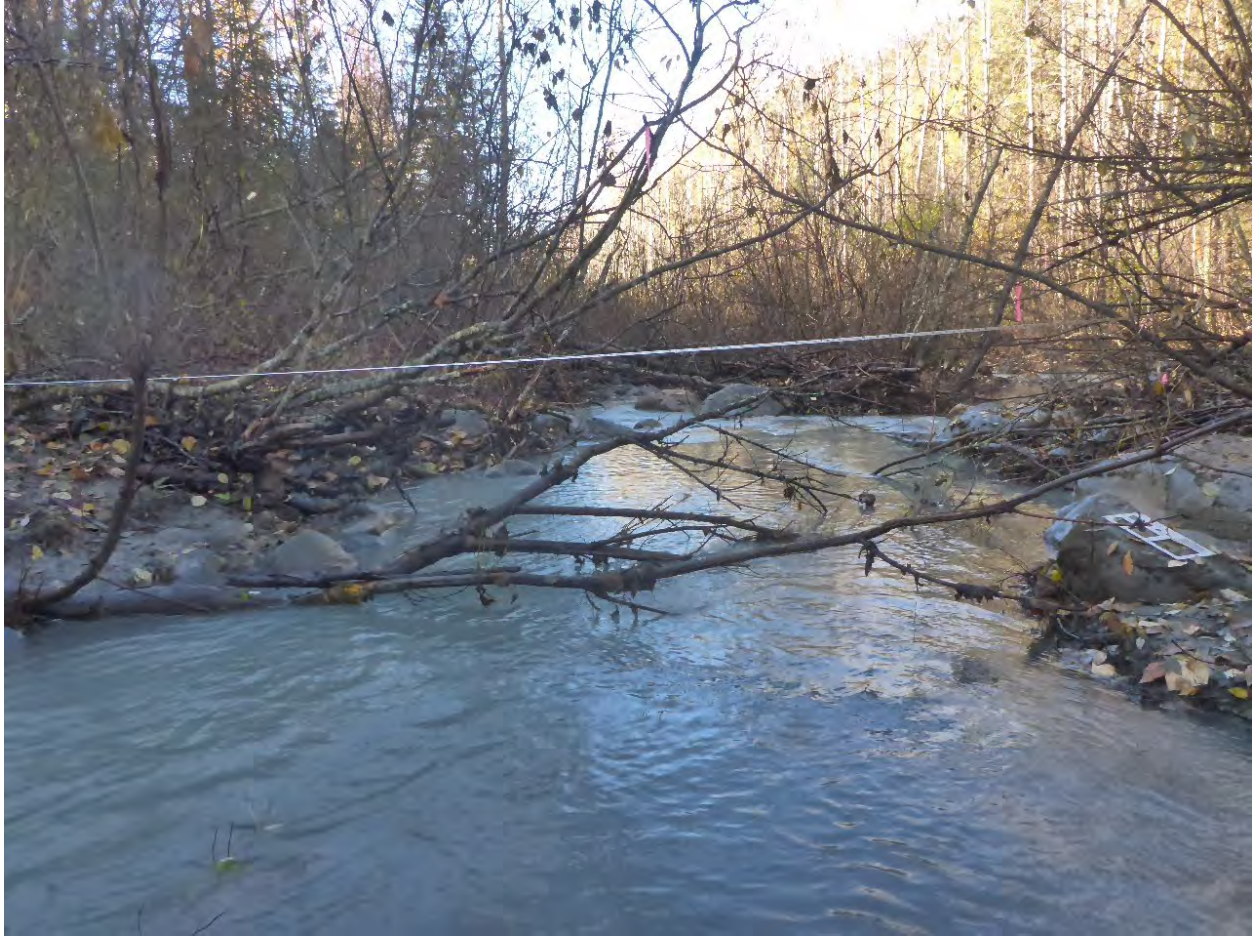
Figure 5.3-32. Transect F, October 10, 2021.

Transect F, at RM 5.4, is located in a pool at the downstream end of the AWWU access road (**Figure 5.3-32**). This transect was established in August 2020 and included two pre-flow release measurements and one post-flow release measurement. The fine sediment in this pool showed erosion of up to 0.5 feet between August 2020 and August 2021, with additional cut and fill following the study flow releases (**Figure 5.3-33**). Grain size measurements were taken pre- and post-flow release across the transect and showed little change to the fine-grained substrate during any of the measurements (**Figure 5.3-34**). A sliding bead scour monitor was installed in August 2020. The sliding bead monitor was read in August and October 2021 and showed 9 inches of bed lowering between August 2020 and August 2021 and little change in October 2021 following the study flow releases.

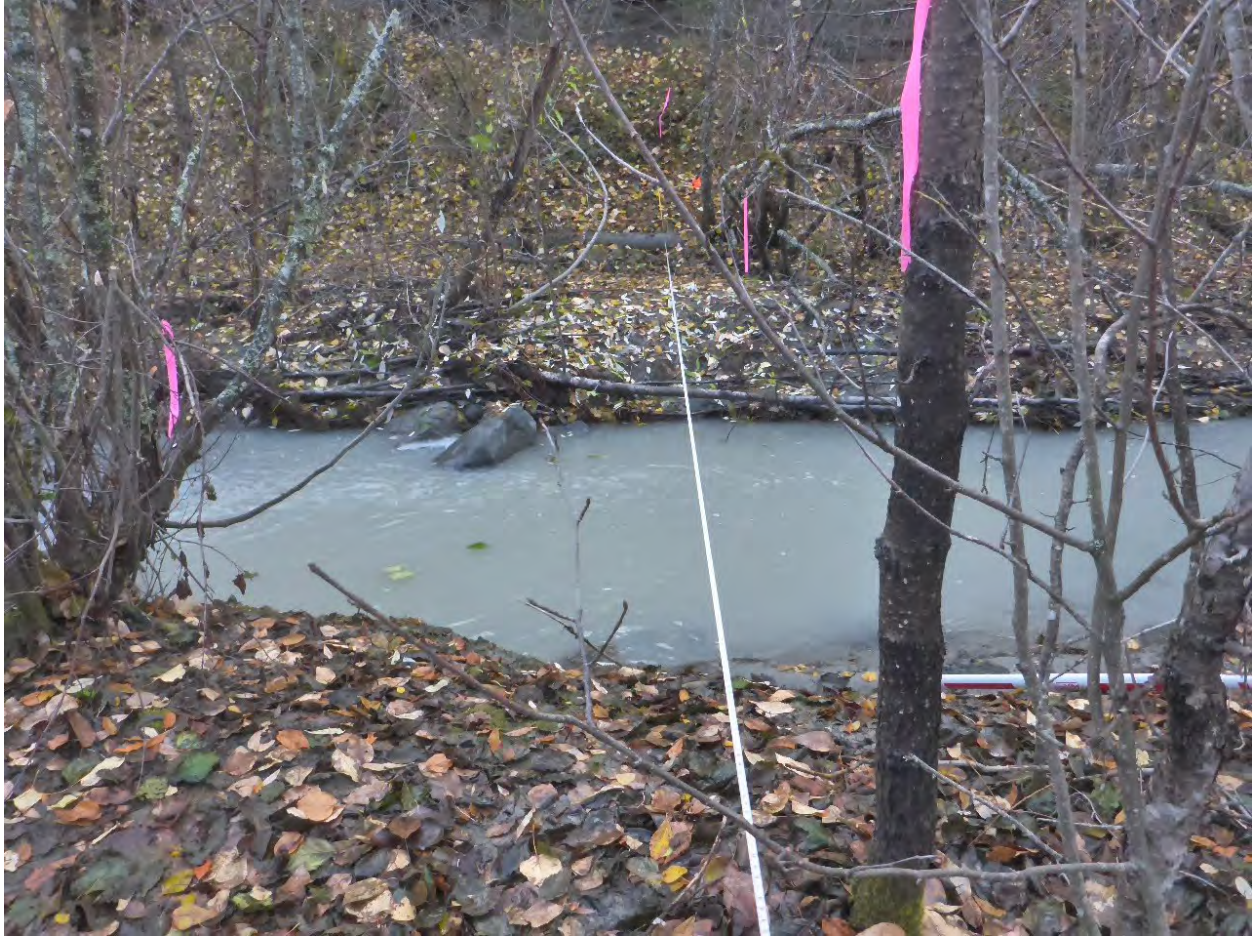
Figure 5.3-35. Transect 103, October 9, 2021.

Transect 103, at RM 6.3, is located near instream flow transects (**Figure 5.3-35**). This transect was established in August 2021 and included one pre-flow release measurement and one post-flow release measurement. The post-flow measurement showed up to 1 foot of scour within the channel following the flow releases (**Figure 5.3-36**). Grain size measurements were taken pre- and post-flow release across the transect (**Figure 5.3-37**). Substrate is predominantly fine sediment and showed a slight decrease in fine sediment following the study flow releases. A subsurface sample was taken at this site with a median (D_{50}) diameter of 1 mm (**Figure 5.3-38**). An accelerometer and a sliding bead scour monitor were installed in August 2021 about 10 feet downstream from the transect. The sliding bead monitor was not recovered, likely due to the estimated 2 feet of scour with subsequent fill at this location. The accelerometer was located and was buried under 1 foot of gravel/cobble material and recorded movement starting on September 13, 2021 at 1630 followed by battery failure which resulted in no additional data collection (**Figure 5.3-39**).
