Eklutna Hydroelectric Project

Geomorphology and Sediment Transport

Year 2 Report

Prepared by:
Kathy Vanderwal Dubé
Watershed GeoDynamics

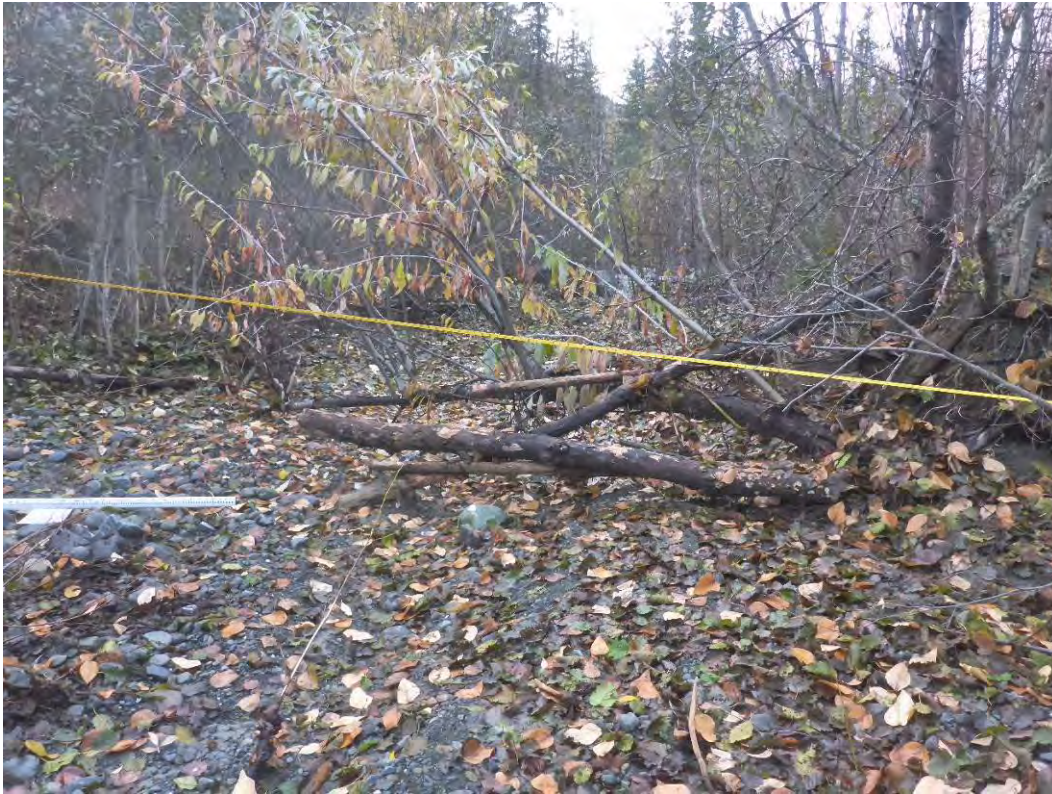
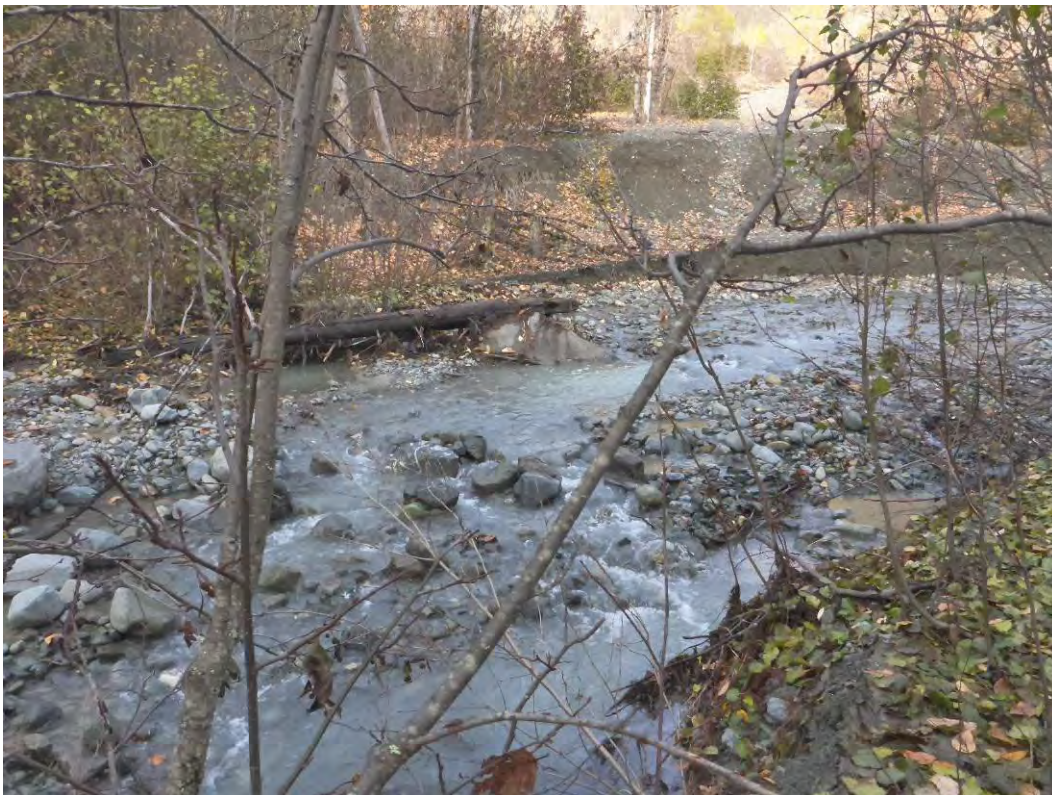
Figure 5.3-40. Transect E left bank channel (top) and new right bank channel (bottom), October 8, 2021.

Transect E, at RM 6.75, is located at a large alluvial fan sediment source (**Figure 5.3-40**). This transect was established in 2020 and included two pre-flow release measurements and one post-flow release measurement. This transect experienced major changes during the study flow releases as the river cut a new channel on the right bank by eroding the toe of the alluvial fan and abandoning the former channel/transect location. Based on terrace deposits, it appears that this phenomenon has occurred previously when the toe of the alluvial fan was eroded, presumably during a spill event, and the alluvial fan later filled the right bank channel resulting in the move to the left bank channel. Post-flow measurement showed deposition of up to 1 foot within the channel following the study flow releases and an estimated 2 feet of erosion in the right bank channel (**Figure 5.3-41**). Grain size measurements were taken pre- and post-flow release across the transect and showed the channel was dominated by gravel during all three measurements, with a progressive decrease in fine-grained sediment through time (**Figure 5.3-42**). A sliding bead scour monitor was installed in August 2020. The sliding bead monitor was read in August and October 2021 and showed 1.5 inches of bed lowering between August 2020 and August 2021 followed by burial with 0.5-1 foot of gravel and cobble (up to 128 mm) in October 2021 following the study flow releases.

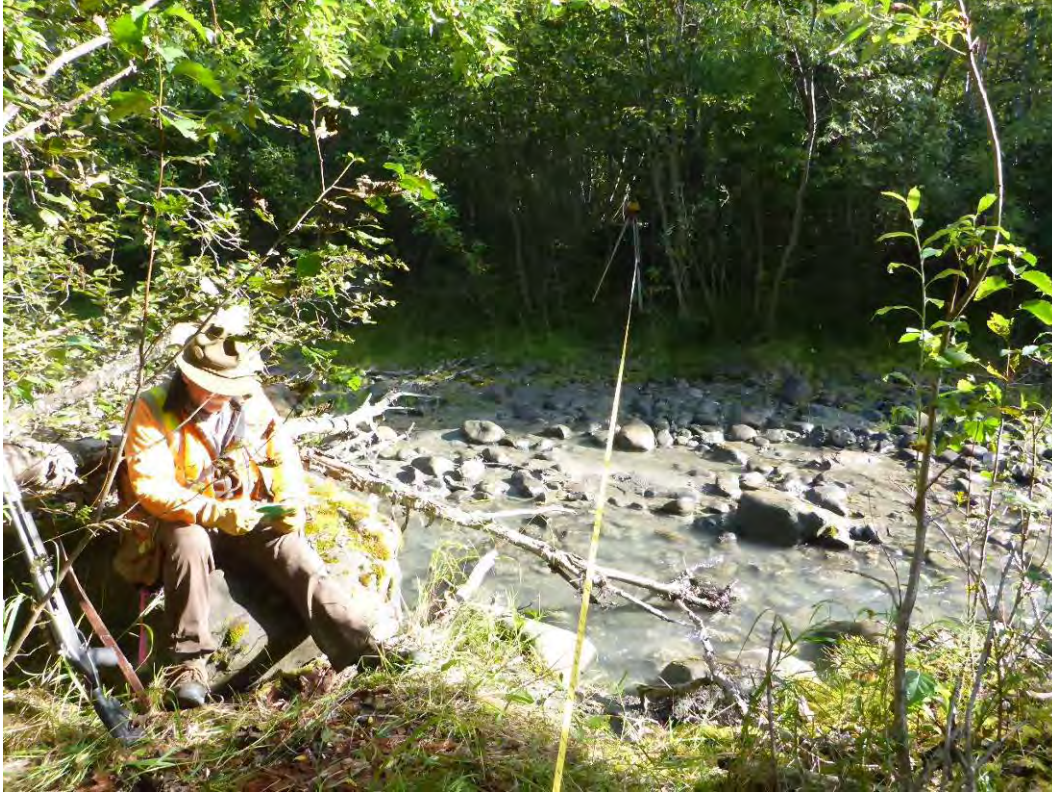
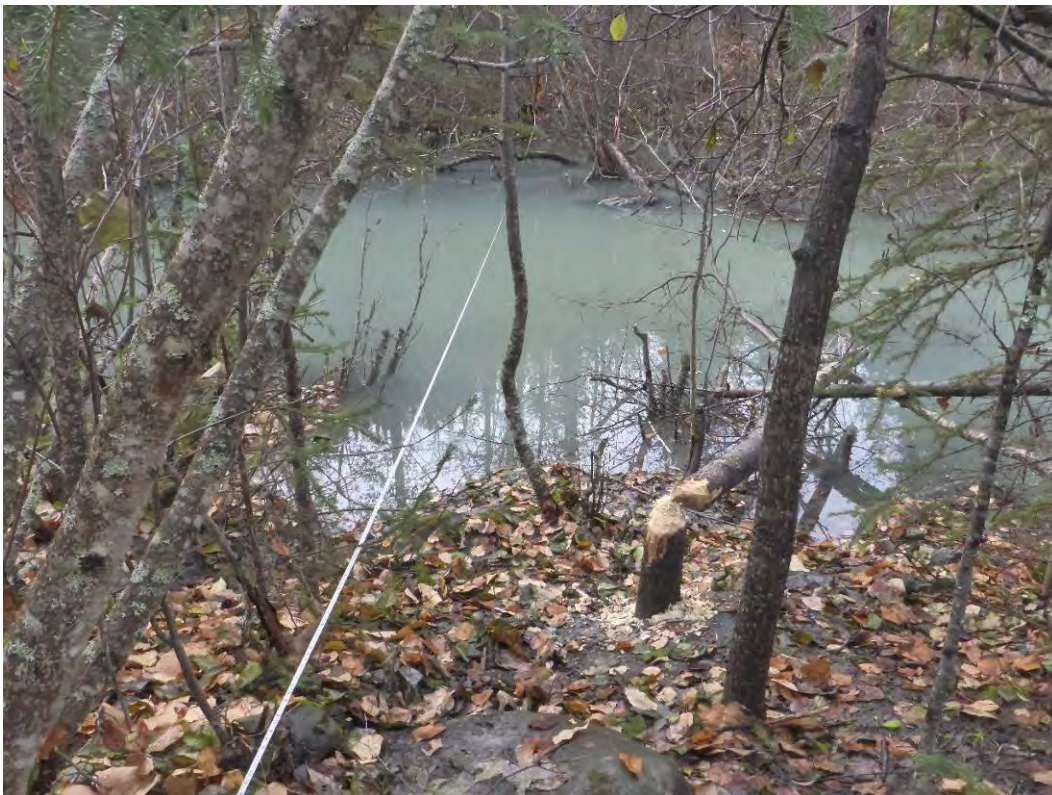
Figure 5.3-43. Transect D before (top) and after (bottom) inundation by beaver dam.

Transect D, at RM 7.2, is located upstream from two major sediment sources. This transect was established in August 2020 and included two pre-flow release measurements and one post-flow release measurement. Between August 2020 and August 2021, a series of beaver dams was established in the vicinity of this transect and resulted in the inundation of the transect during the 2021 measurements (**Figure 5.3-43**). Deposition of 0.5 to 1 foot within the channel following beaver dam construction was measured (**Figure 5.3-44**). Grain size measurements were taken pre- and post-flow release across the transect and showed that deposition of fine-grained sediment covered the original gravel/cobble bed (**Figure 5.3-45**).

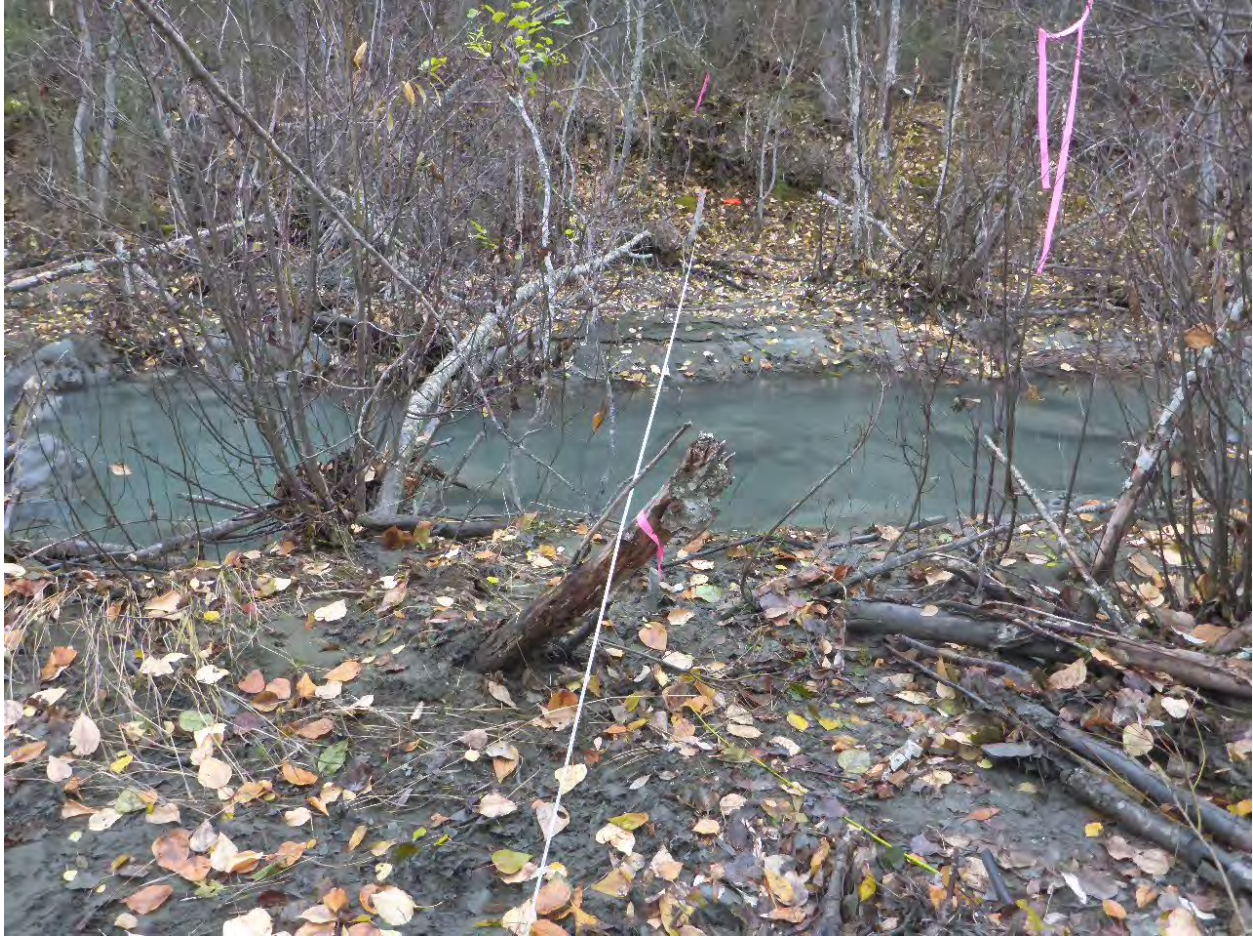
Figure 5.3-46. Transect 105, October 8, 2021.

Transect 105, at RM 8.7, is located several hundred feet downstream of the sixth AWWU access road crossing below Eklutna Lake Dam (**Figure 5.3-46**). This transect was established in August 2021 and included one pre-flow release measurements and one post-flow release measurement. The post-flow measurement showed up to 1.5 feet of erosion within the channel as well as overbank deposition of fine sediment on the left bank (in the lee of a log) following the study flow releases (**Figure 5.3-47**). Grain size measurements were taken pre- and post-flow release across the transect. Substrate is predominantly fine-grained and showed a slight decrease in fine sediment following the study flow releases (**Figure 5.3-48**).

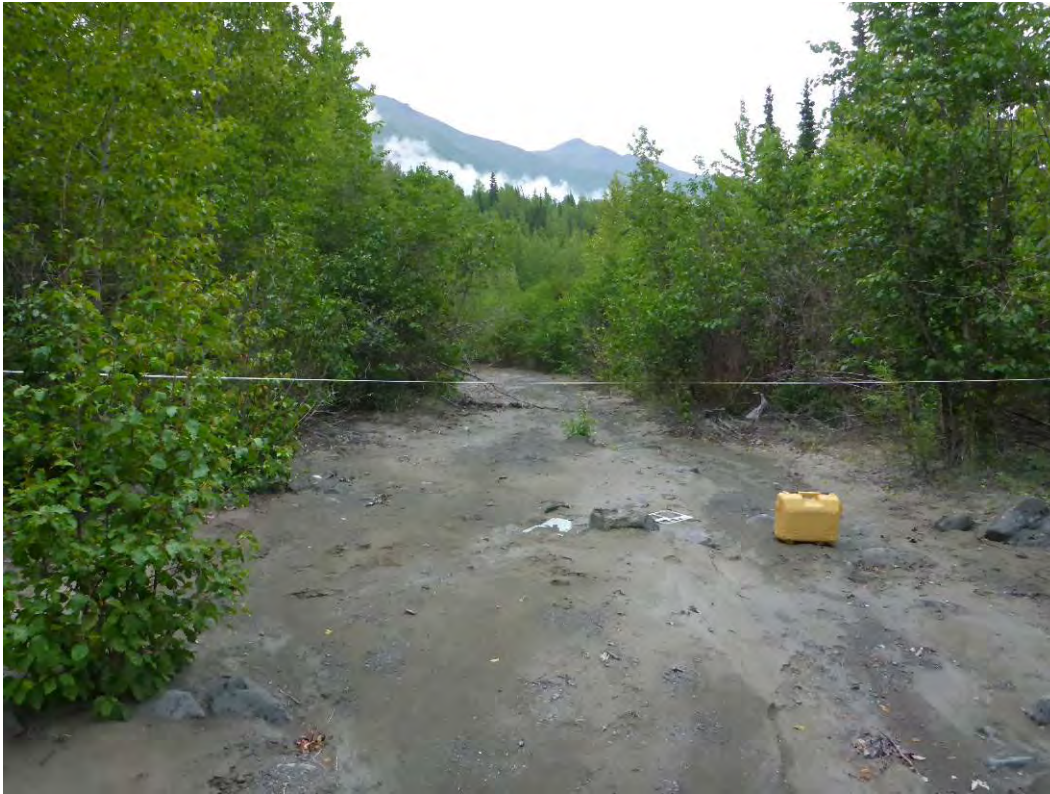
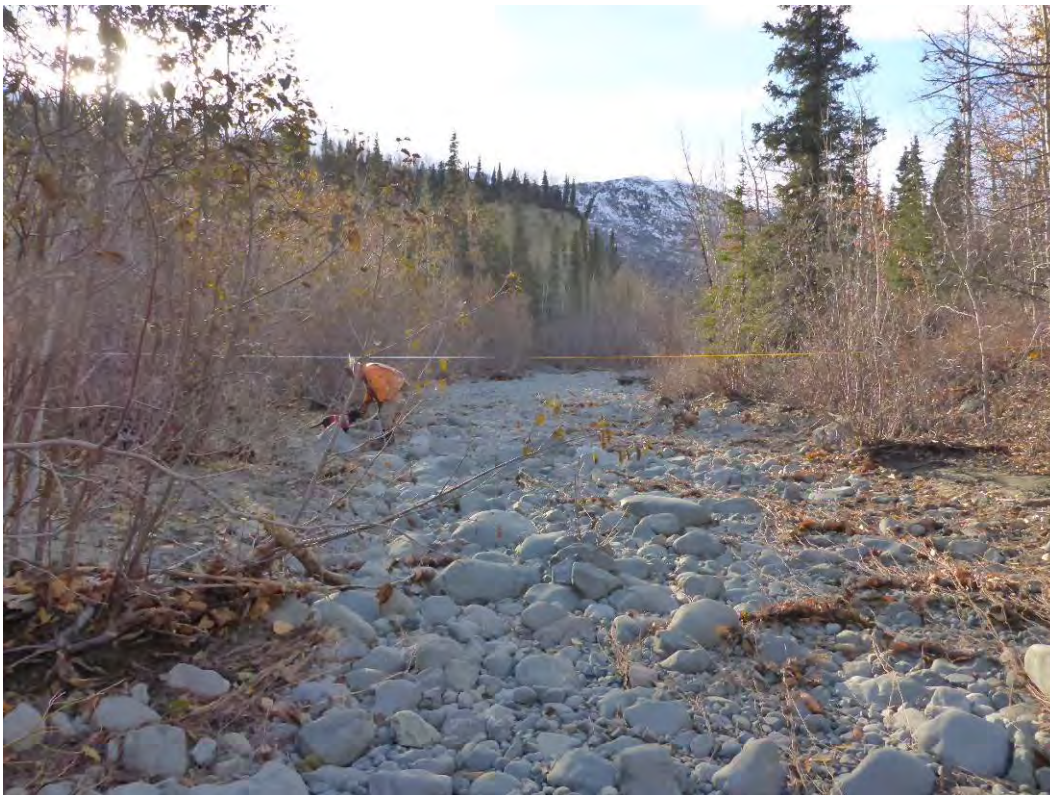
Figure 5.3-49. Transect C before (top) and after (bottom) flow release showing erosion of fine sediment and re-establishment of river channel.

Transect C, at RM 11.2, is located just downstream from the alluvial fan source at Transect B (**Figure 5.3-49**). This transect was established in August 2020 and included two pre-flow release measurements and one post-flow release measurement. The post-flow measurement showed erosion of up to 0.5 foot within the channel following the study flow releases (**Figure 5.3-50**). Grain size measurements were taken pre- and post-flow release across the transect (**Figure 5.3-51**). Substrate following the study flow releases was predominantly gravel (median grain diameter 2-3 mm prior to the flow release and 18 mm following the flow release) and showed a marked decrease in fine sediment as the original channel bed was uncovered.

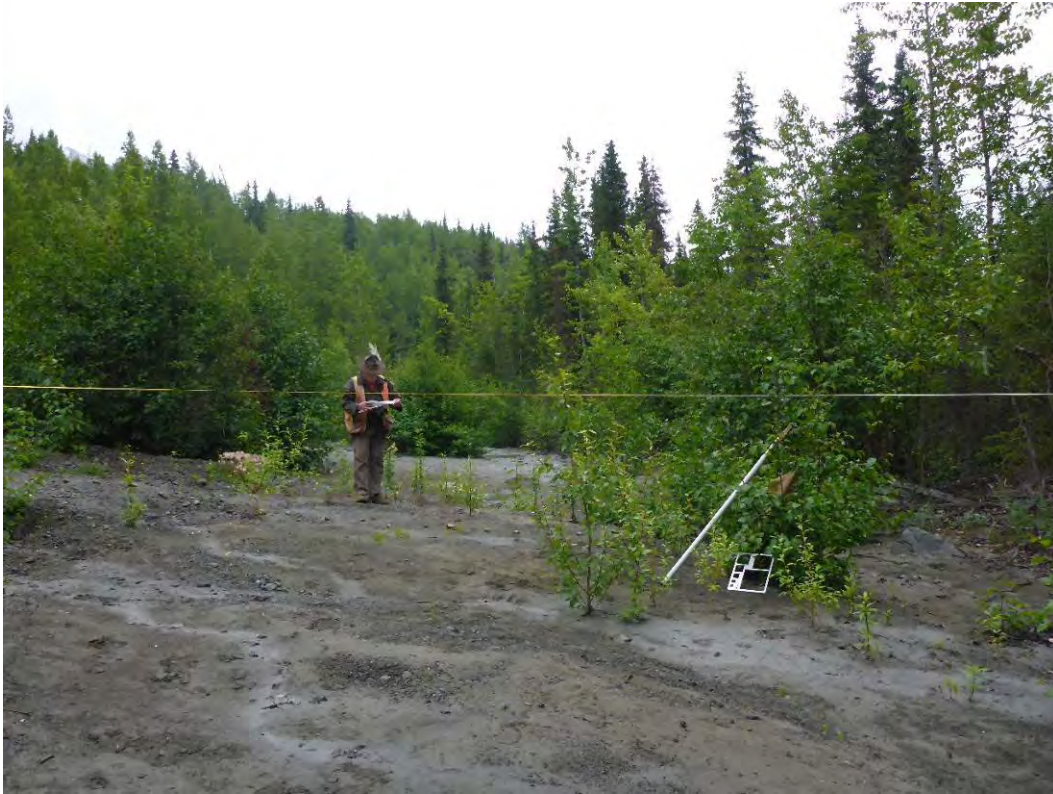
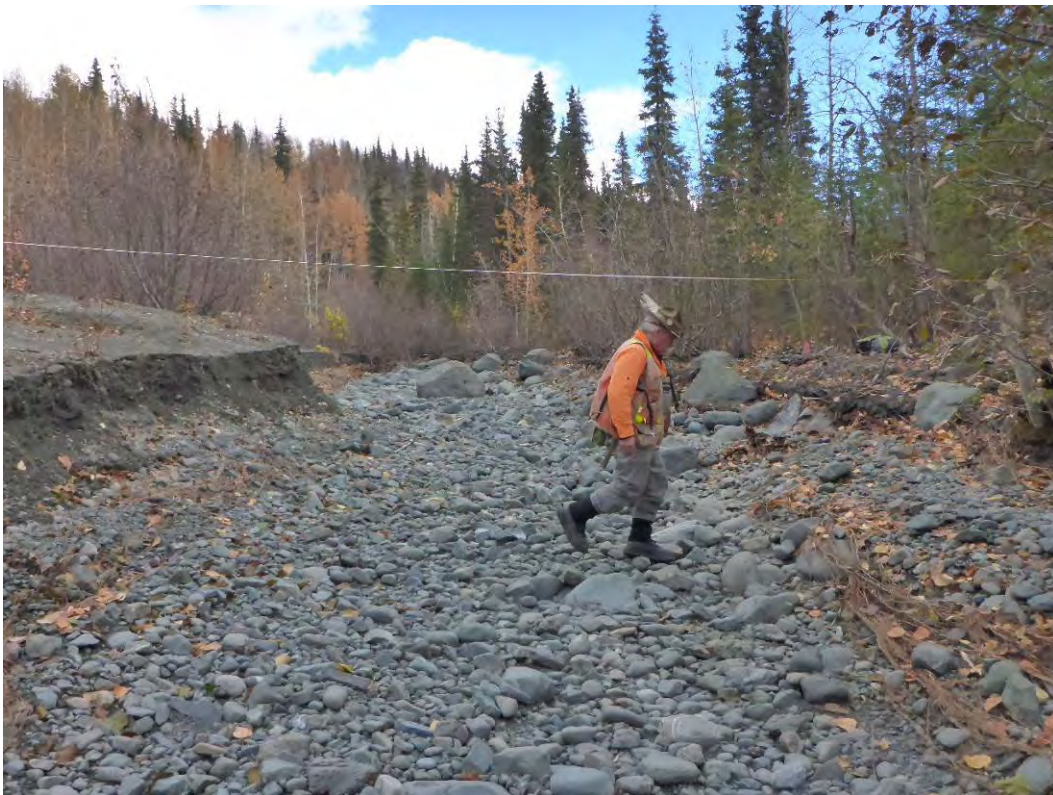
Figure 5.3-52. Transect B before (top) and after (bottom) flow release showing erosion of toe of alluvial fan deposits and re-establishment of river channel.

Transect B, at RM 11.25, is located between the two AWWU bridges at the toe of the first major sediment source downstream from Eklutna Lake Dam (**Figure 5.3-52**). This transect was established in September 2020 and included two pre-flow release measurements and one post-flow release measurement. The transect includes the toe of the alluvial fan sediment source. The post-flow measurement showed erosion of over 3 feet as the river re-established a channel by eroding the toe of the alluvial fan deposits (**Figure 5.3-53**). Grain size measurements were taken pre- and post-flow release across the transect and showed a change from nearly 100 percent fine sediment prior to the study flow releases to a median grain diameter of 51 mm (gravel) following the study flow releases as the underlying gravel, cobble, and boulder substrate was exposed (**Figure 5.3-54**).

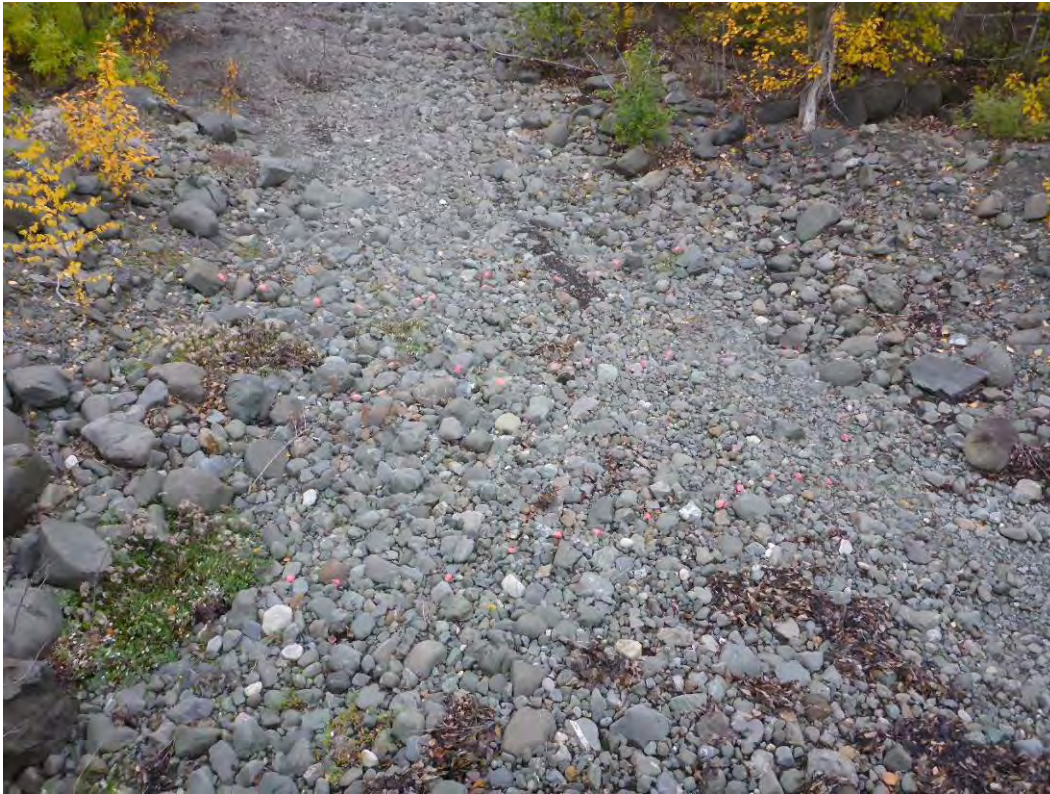
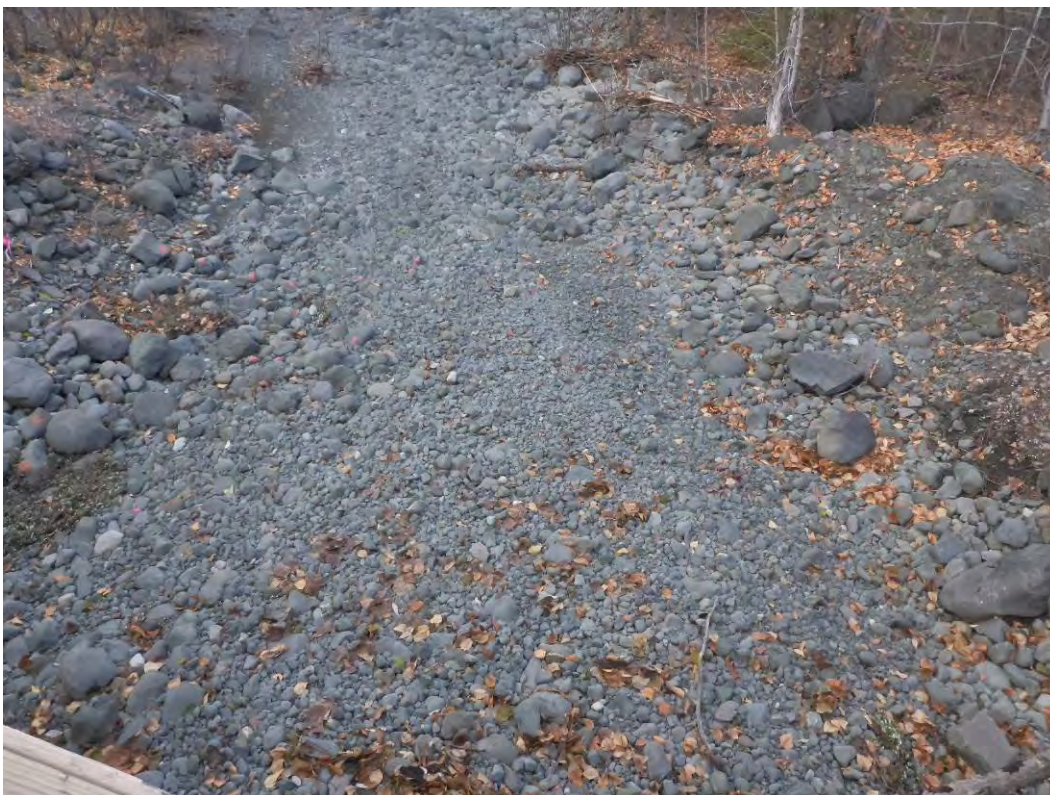
Figure 5.3-55. Painted Rocks Transect before (top) and after (bottom) flow release.

Painted rocks were deployed just downstream from the upper AWWU bridge (RM 11.3) just prior to the study flow releases. Three rows with 13 painted rocks each were deployed across the streambed, one row of 32 mm particles, one row of 64 mm, and one row of 128 mm particles (**Figure 5.3-55**). Following the flow releases, 2 of the 32 mm particles remained on the streambed, 8 of the 64 mm particles (several of the central 64 mm particles were buried by gravel) and all of the 128 mm particles remained with one covered by gravel. A transect was surveyed following the study flow releases (**Figure 5.3-56**).

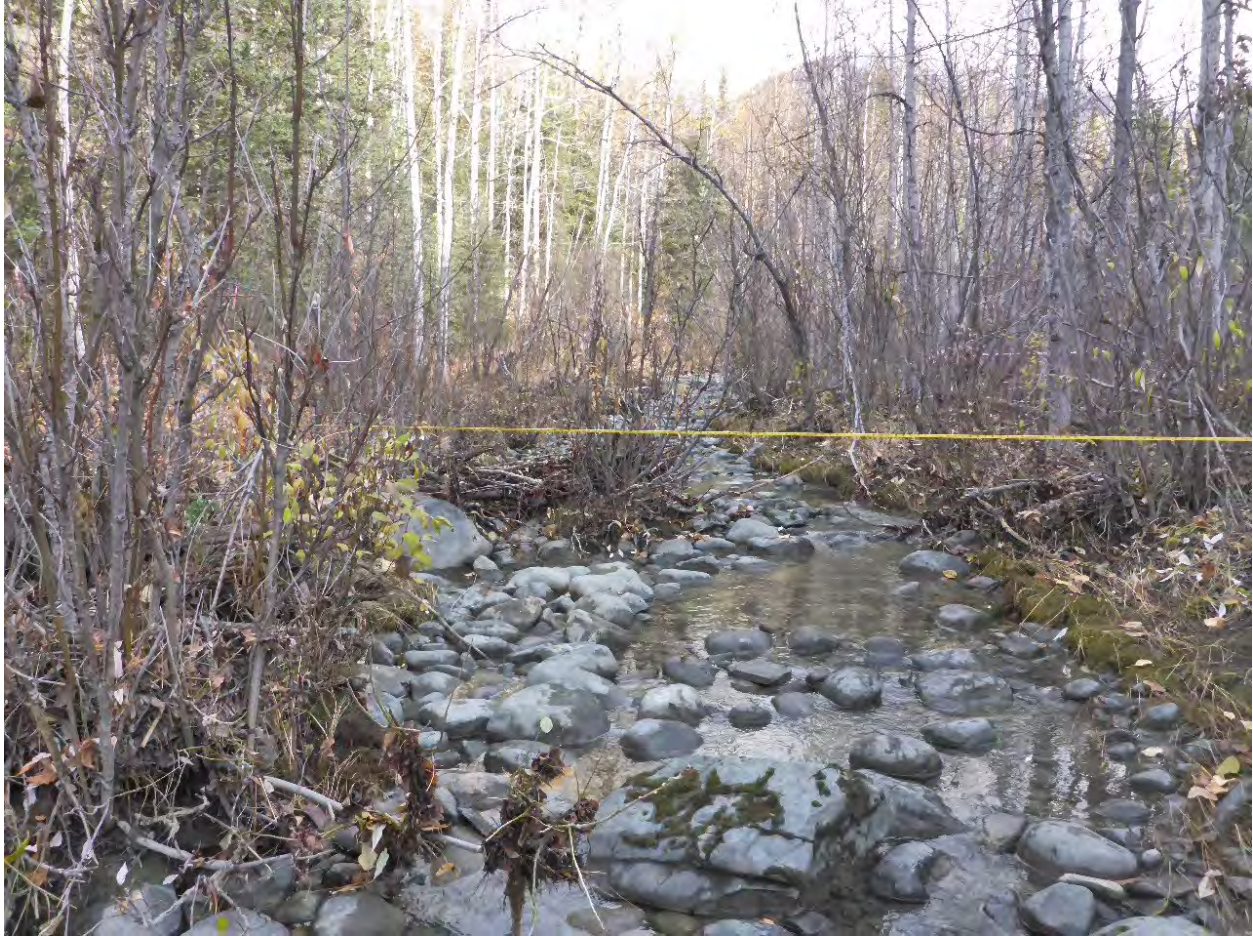
Figure 5.3-57. Transect A, October 7, 2021.

Transect A, at RM 11.75, is located downstream from the Eklutna Lake Dam near the site of the USFWS 2019 study transects and near the upper instream flow study transects (**Figure 5.3-57**). This transect was established in August 2020 and included two pre-flow release measurements and one post-release measurement. The post-flow measurement showed little change in channel cross section (**Figure 5.3-58**). Grain size measurements were taken pre- and post-flow release across the transect and showed little change (**Figure 5.3-59**). Substrate is predominantly gravel and cobble (median grain diameter 67-78 mm).
