Eklutna Hydroelectric Project

Wetlands and Wildlife Habitat

Study Report

June 2023

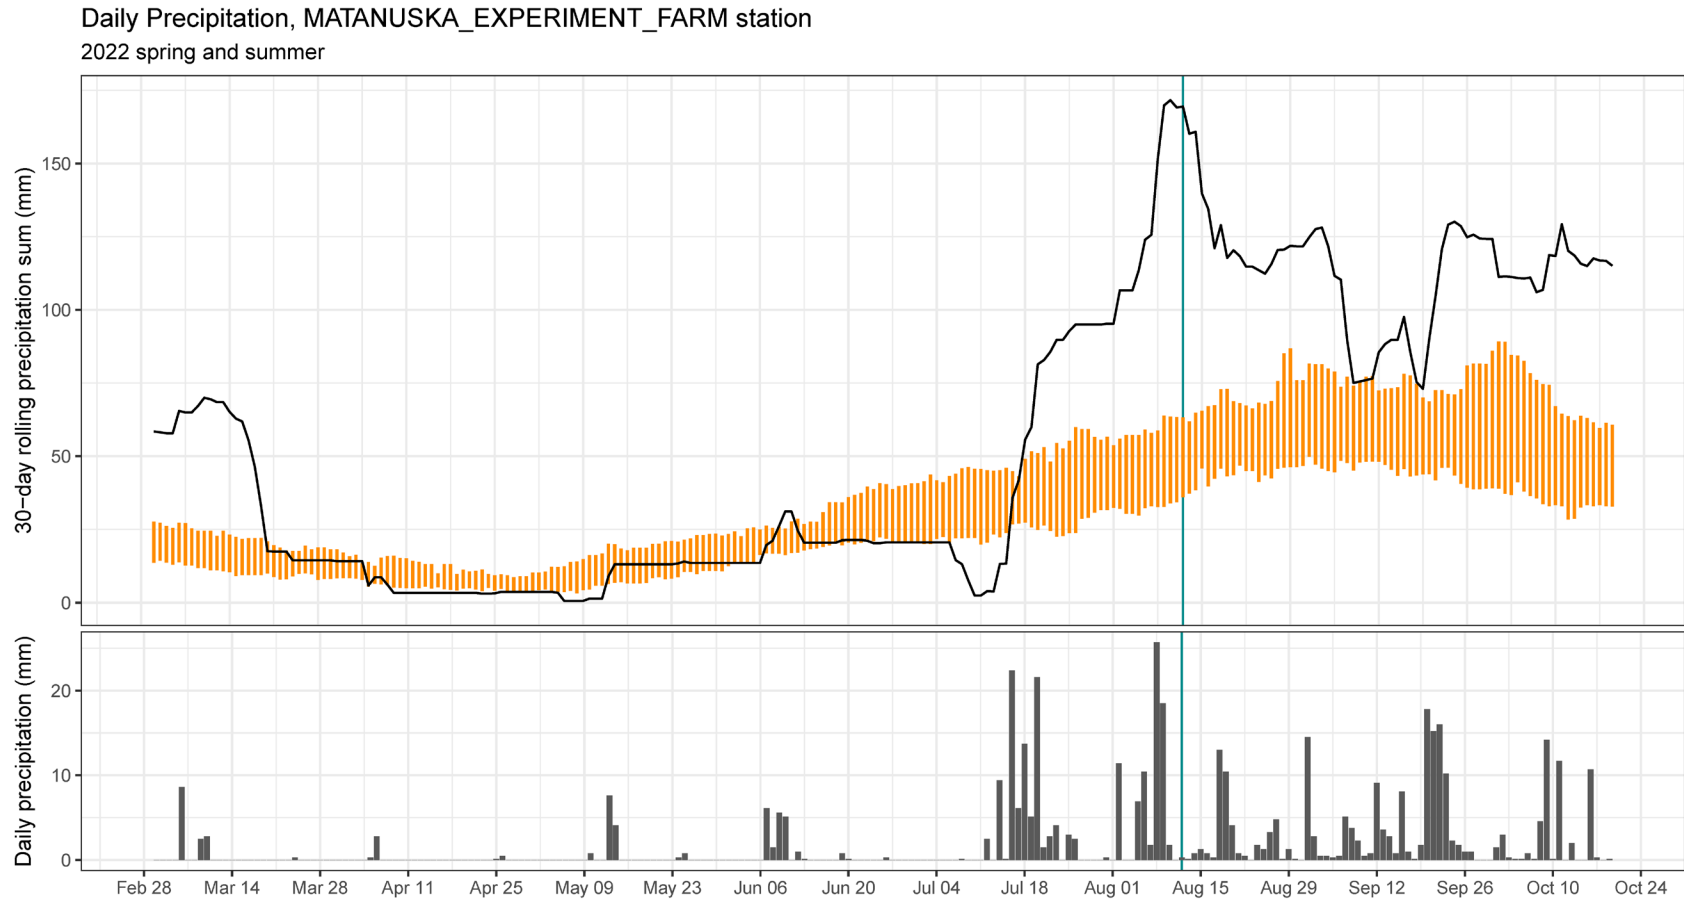
Figure 5.1-1. Antecedent Precipitation for the Wetlands and Wildlife Habitat Study area, Eklutna Hydroelectric Project, 2022.

To place the hydrological conditions in the study area at the time of sampling in mid-August 2022 in context, we performed a precipitation analysis similar to the USACE’s APT (Figure 5.1-1). The Matanuska Experiment Farm station provides 96% of the long-term data for the APT. Two stations in Eagle River (Eagle River 5 SE and Eagle River Nature Center, stations USC00502656 and USC00502642, respectively) were used to gapfill most of the missing records. Figure 5.1-1 suggests that hydrologic conditions were wetter than normal immediately preceding and during the field visit from 9–12 August 2022, and direct observations of wetland hydrology could be expected for any wetlands within the study area.

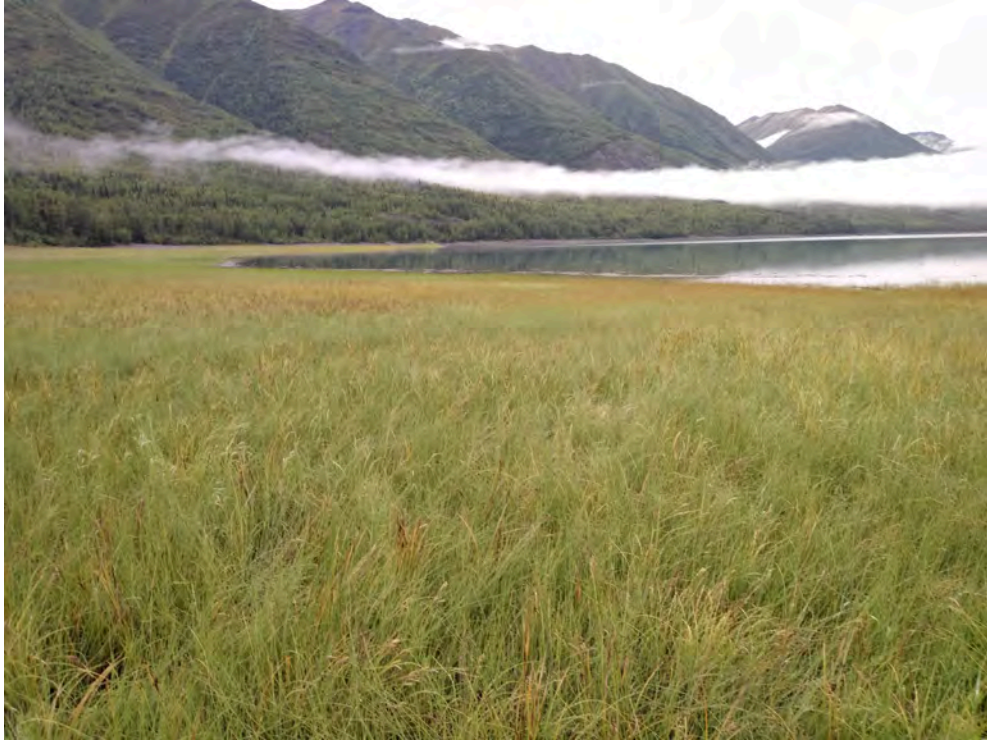
NWI classification: PEM1E

Hydric Soil Indicators: Other (explain in remarks), Histic Epipedon (A2), Hydrogen Sulfide (A4)

Wetland Hydrology Indicators: Surface Water (A1), Hydrogen Sulfide Odor (C1), Saturation (A3), FAC-Neutral Test (D5), Other (explain in remarks), High Water Table (A2)

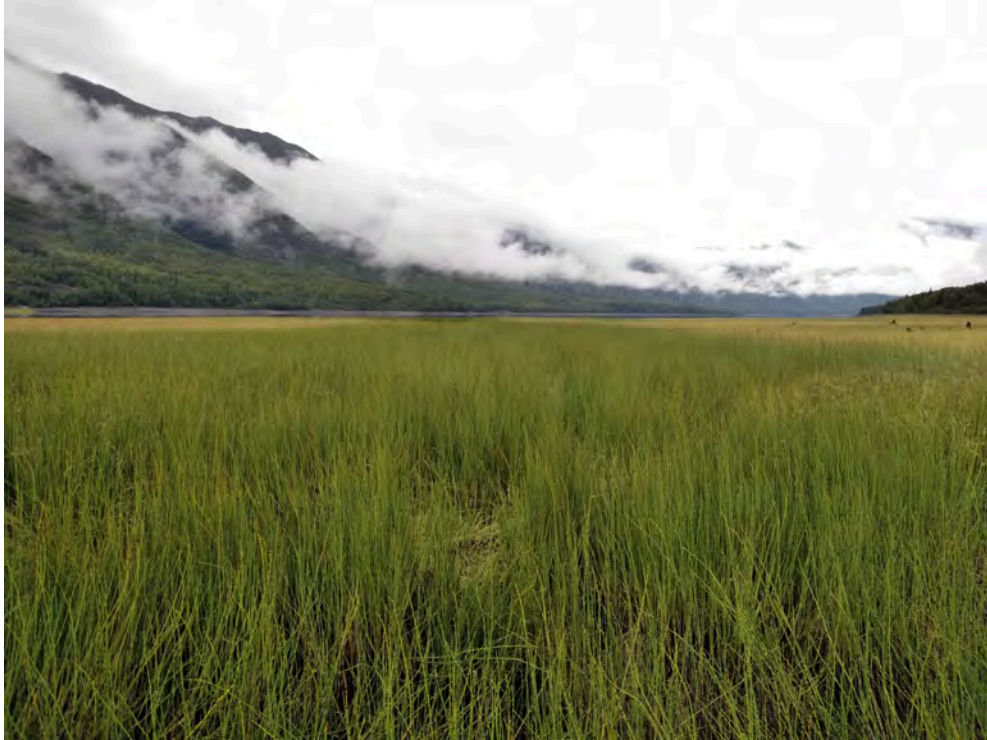
NWI classification: PEM1E

Hydric Soil Indicators: Histosol or Histel (A1)

Wetland Hydrology Indicators: High Water Table (A2), Sediment Deposits (B2), Presence of Reduced Iron (C4), Saturation (A3), FAC-Neutral Test (D5), Geomorphic Position (D2)

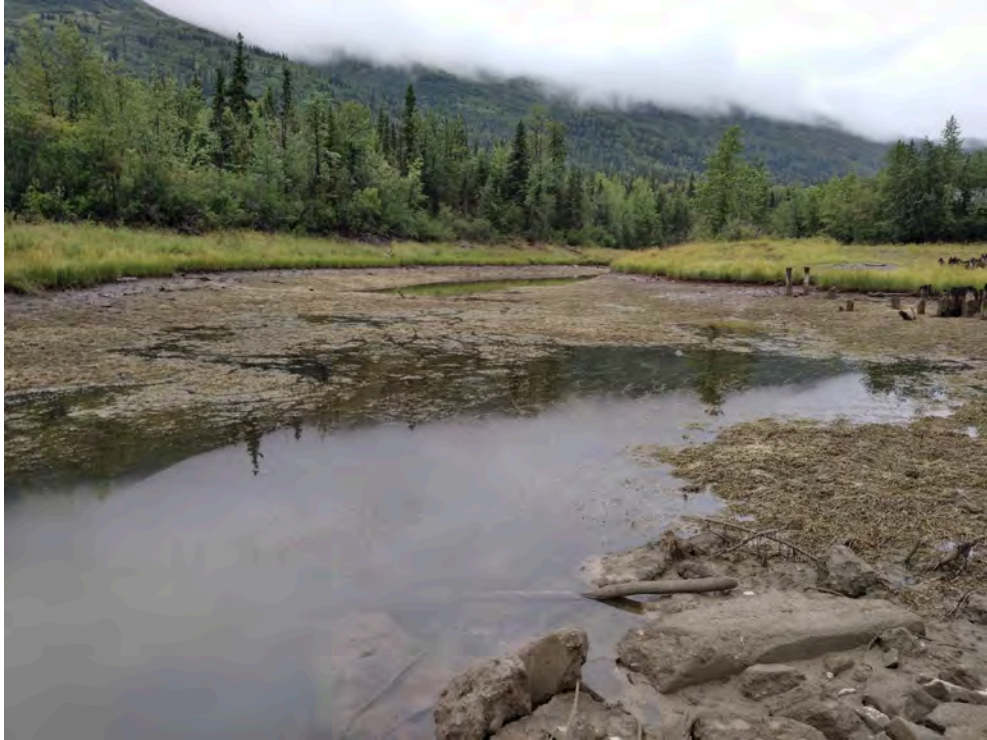
Sampling Point: eklutna-06

NWI classification: PUBH

Hydric Soil Indicators: Other (explain in remarks)

Wetland Hydrology Indicators: FAC-Neutral Test (D5), Geomorphic Position (D2), Surface Water (A1)

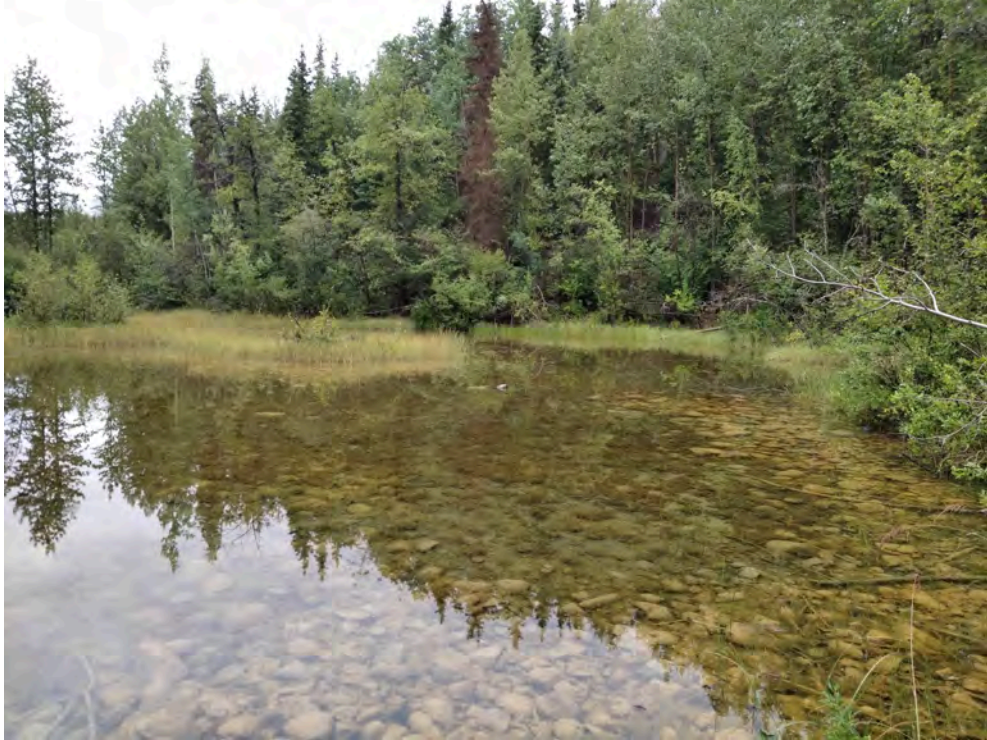
Sampling Point: eklutna-07

NWI classification: PUBH

Hydric Soil Indicators: Other (explain in remarks)

Wetland Hydrology Indicators: Surface Water (A1), Inundation Visible in Aerial Imagery (B7), Geomorphic Position (D2)

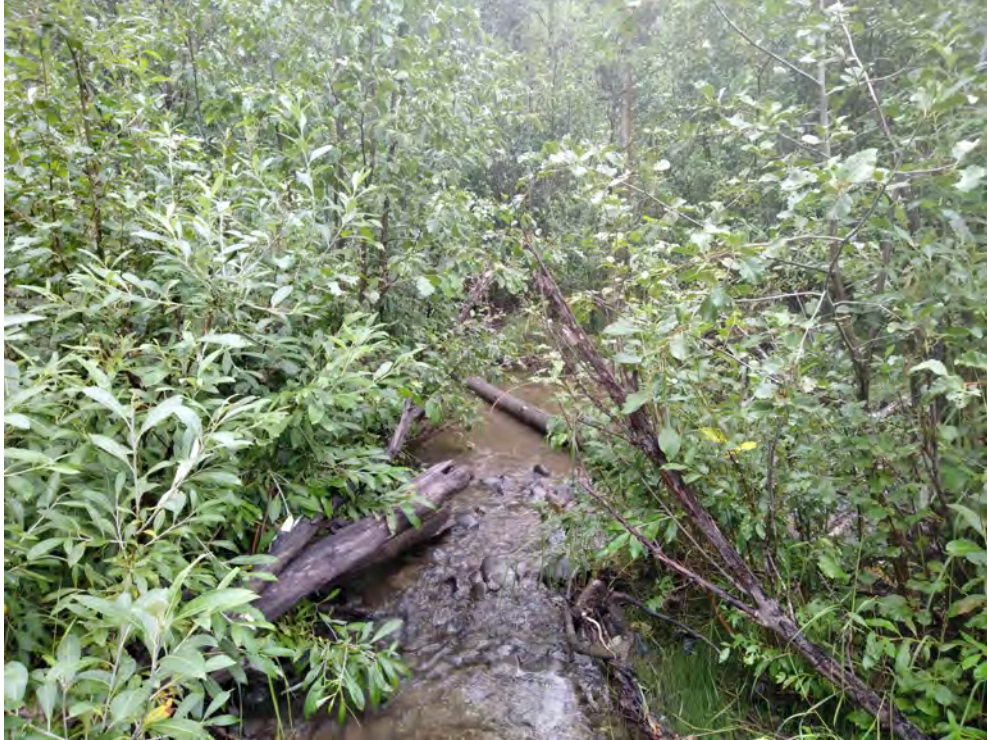
Sampling Point: eklutna-08

NWI classification: R4SBC

Hydric Soil Indicators: Other (explain in remarks)

Wetland Hydrology Indicators: Surface Water (A1), Geomorphic Position (D2)

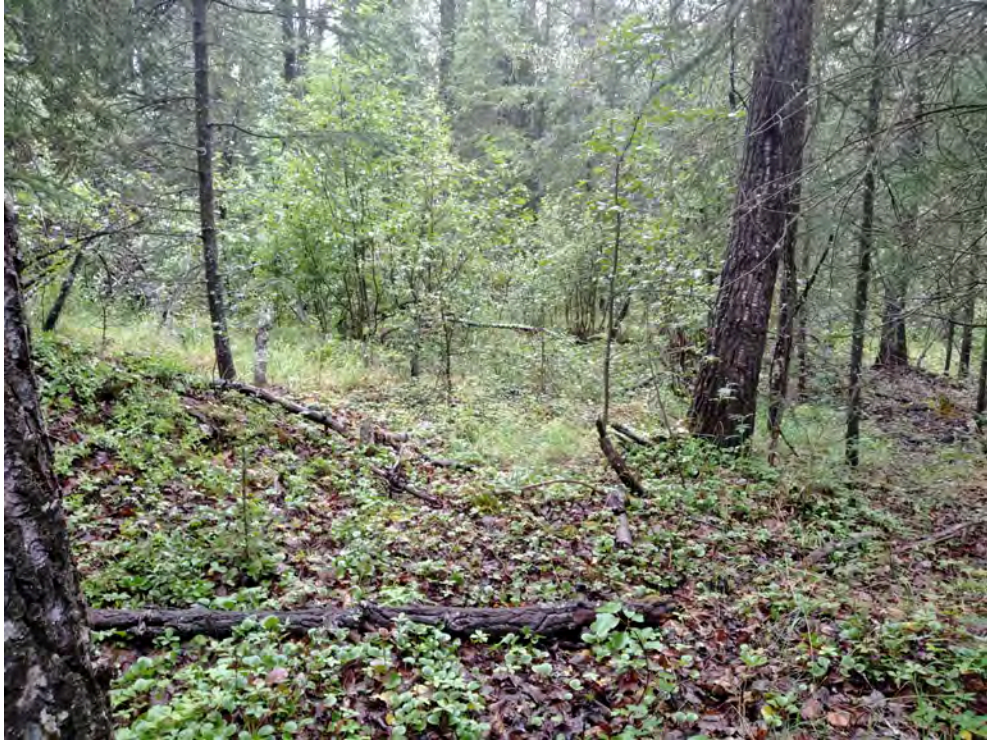
Sampling Point: eklutna-09

NWI classification: U

Hydric Soil Indicators: None

Wetland Hydrology Indicators: None

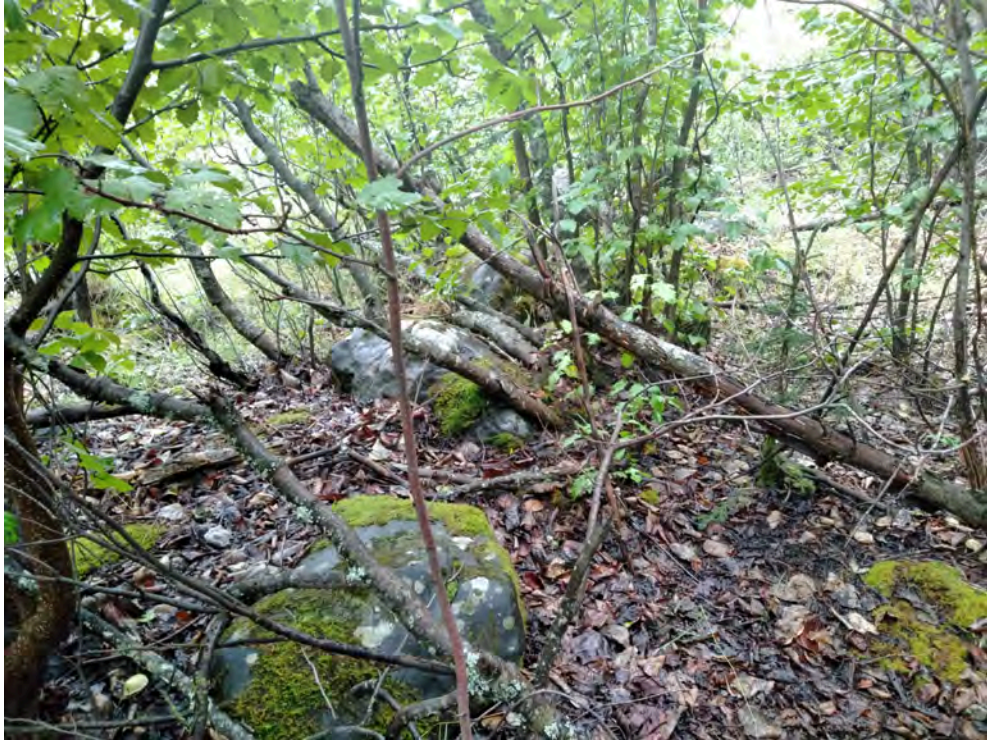
Sampling Point: eklutna-10

NWI classification: U

Hydric Soil Indicators: None

Wetland Hydrology Indicators: None

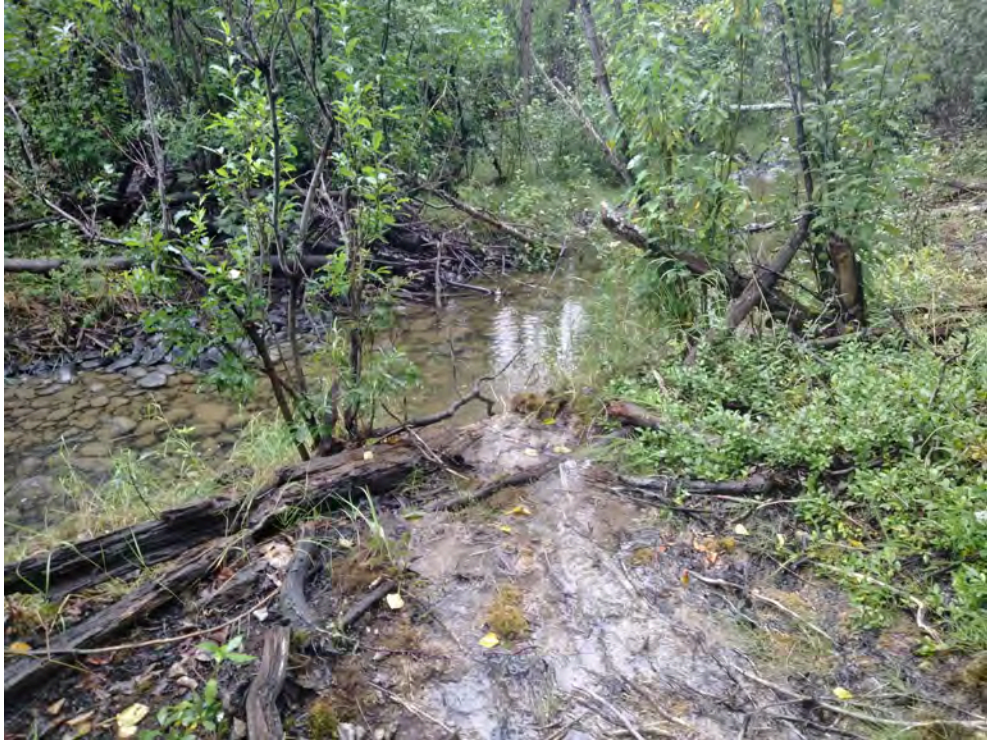
NWI classification: PMLD

Hydric Soil Indicators: Other (explain in remarks)

Wetland Hydrology Indicators: Surface Water (A1), Marl Deposits (B15)

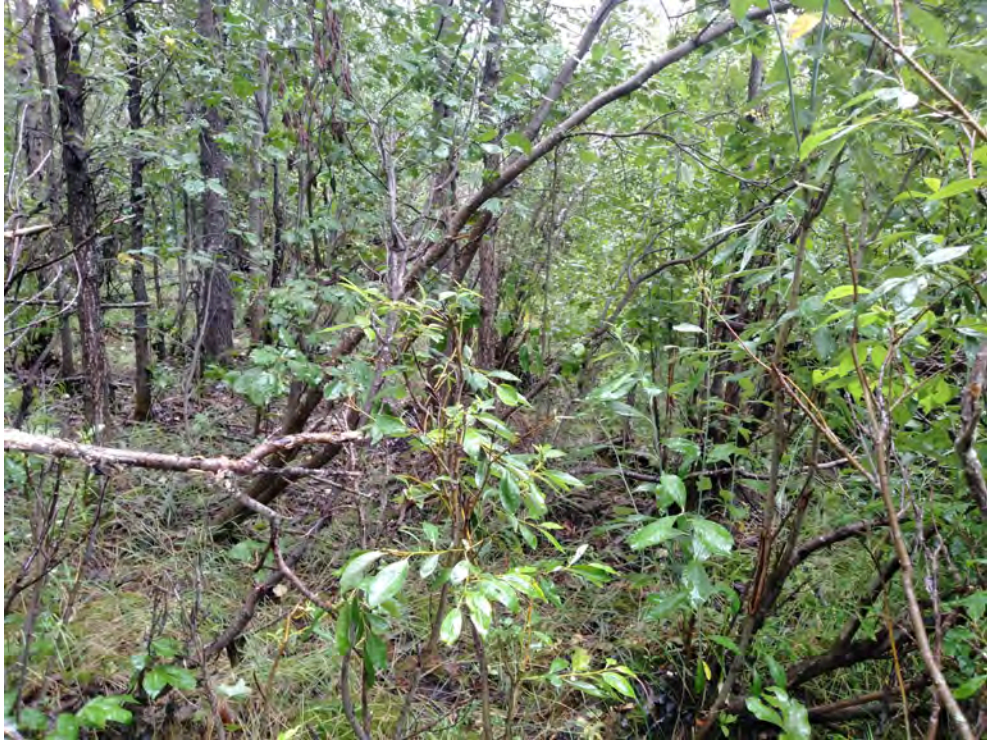
Sampling Point: eklutna-13

NWI classification: PSS1C

Hydric Soil Indicators: Other (explain in remarks)

Wetland Hydrology Indicators: Geomorphic Position (D2), Drift Deposits (B3)

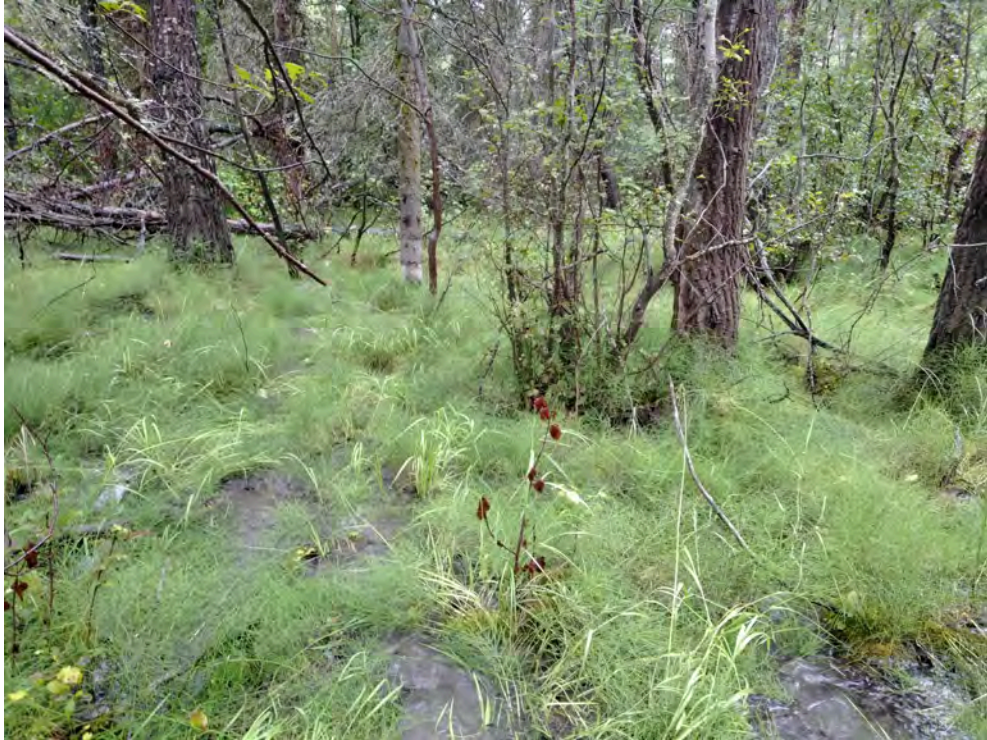
NWI classification: PSS1E

Hydric Soil Indicators: Other (explain in remarks), Hydrogen Sulfide (A4)

Wetland Hydrology Indicators: High Water Table (A2), Presence of Reduced Iron (C4), Hydrogen Sulfide Odor (C1), Saturation (A3), Surface Water (A1)

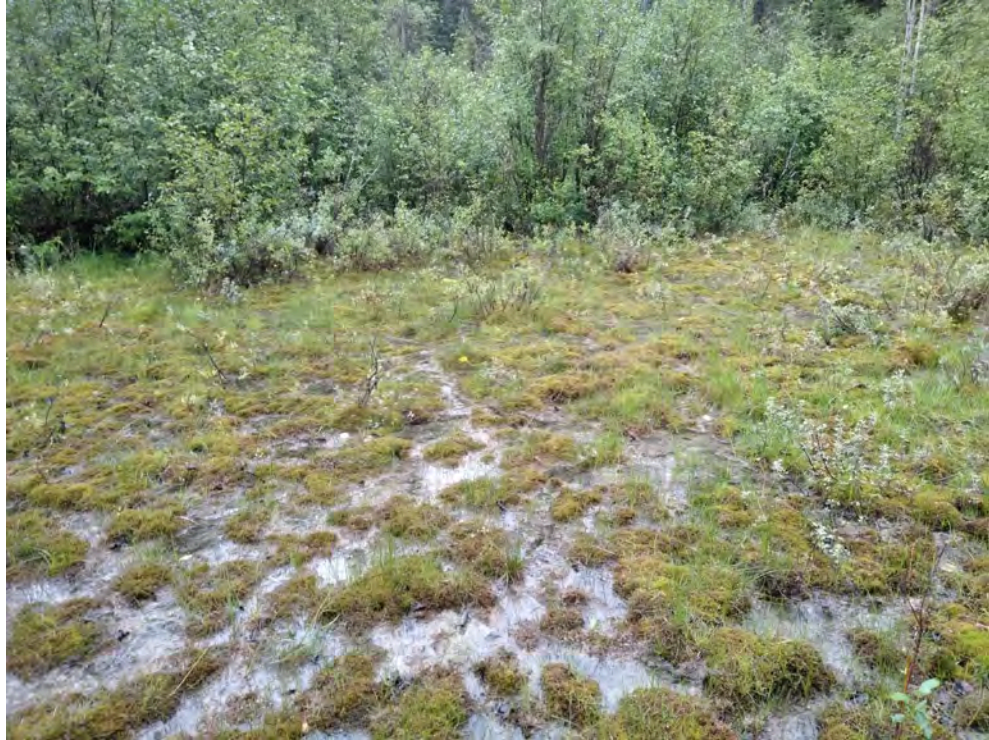
Sampling Point: eklutna-17

NWI classification: PMLD

Hydric Soil Indicators: Other (explain in remarks), Alaska Gleyed without Hue 5Y or Redder Underlying Layer

Wetland Hydrology Indicators: High Water Table (A2), Surface Water (A1), Marl Deposits (B15), Saturation (A3), Geomorphic Position (D2), FAC-Neutral Test (D5)

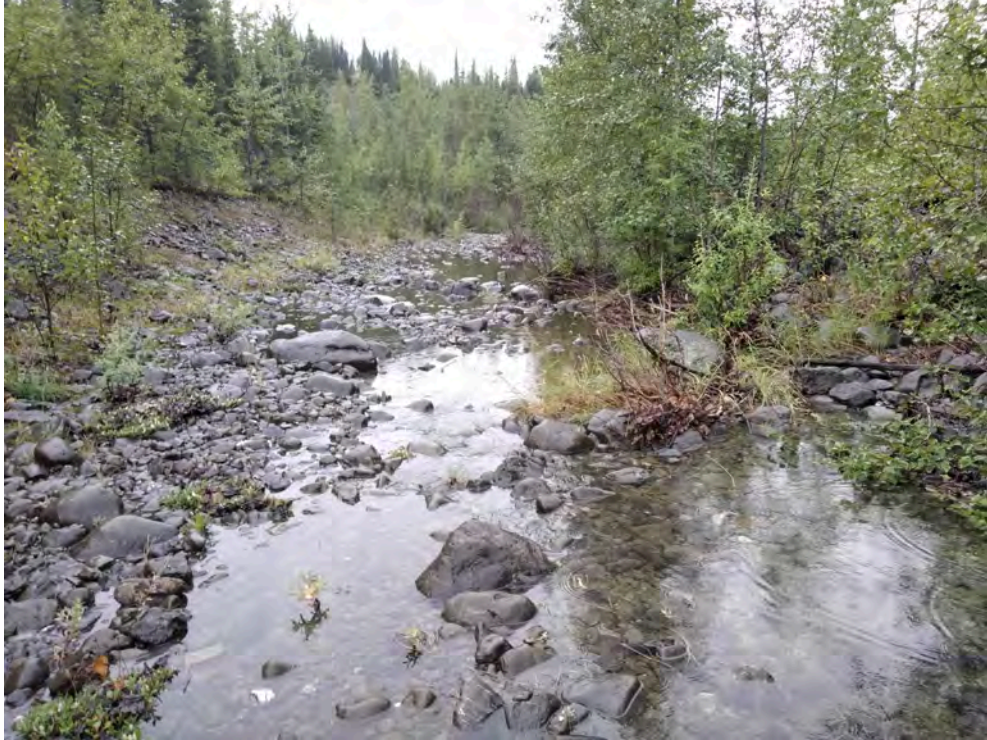
Sampling Point: eklutna-20

NWI classification: R4SBC

Hydric Soil Indicators: Other (explain in remarks)

Wetland Hydrology Indicators: Surface Water (A1)

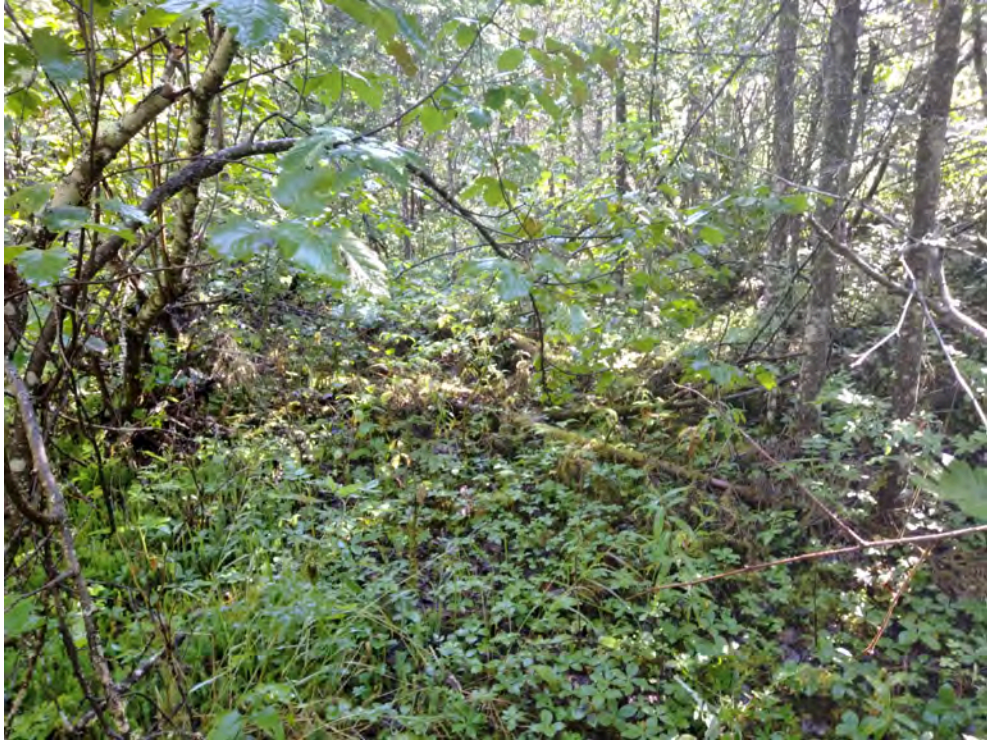
Sampling Point: eklutna-21

NWI classification: U

Hydric Soil Indicators: None

Wetland Hydrology Indicators: Geomorphic Position (D2)

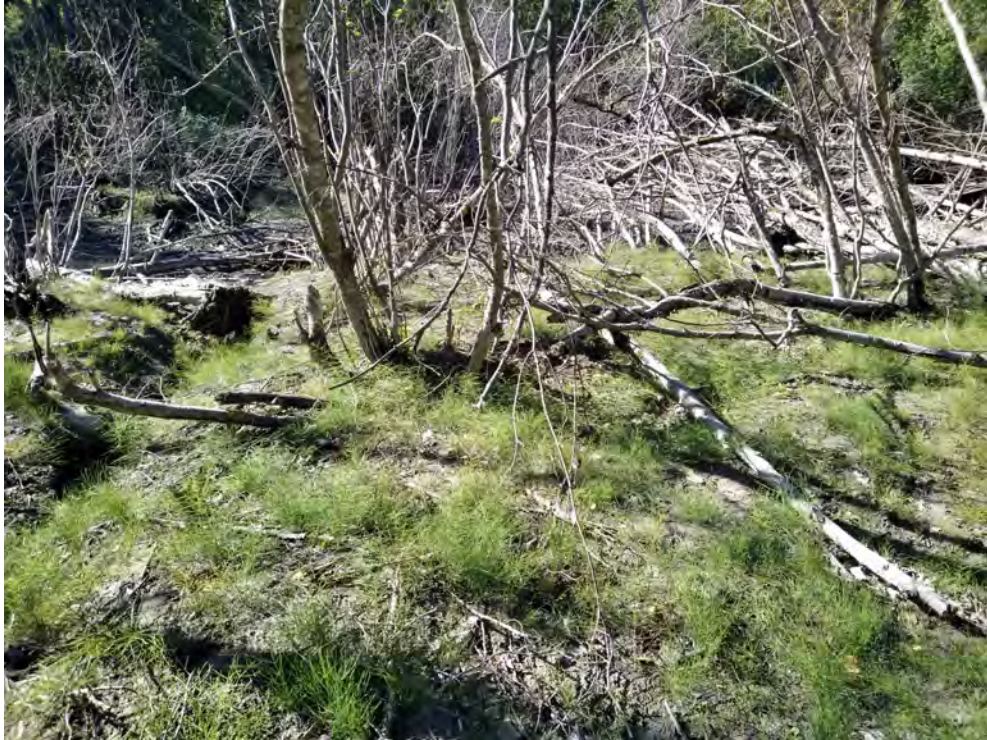
Sampling Point: eklutna-23

NWI classification: PUBHb

Hydric Soil Indicators: Alaska Redox (A14), Alaska Gleyed without Hue 5Y or Redder Underlying Layer

Wetland Hydrology Indicators: Drift Deposits (B3), Sediment Deposits (B2), Water Marks (B1)

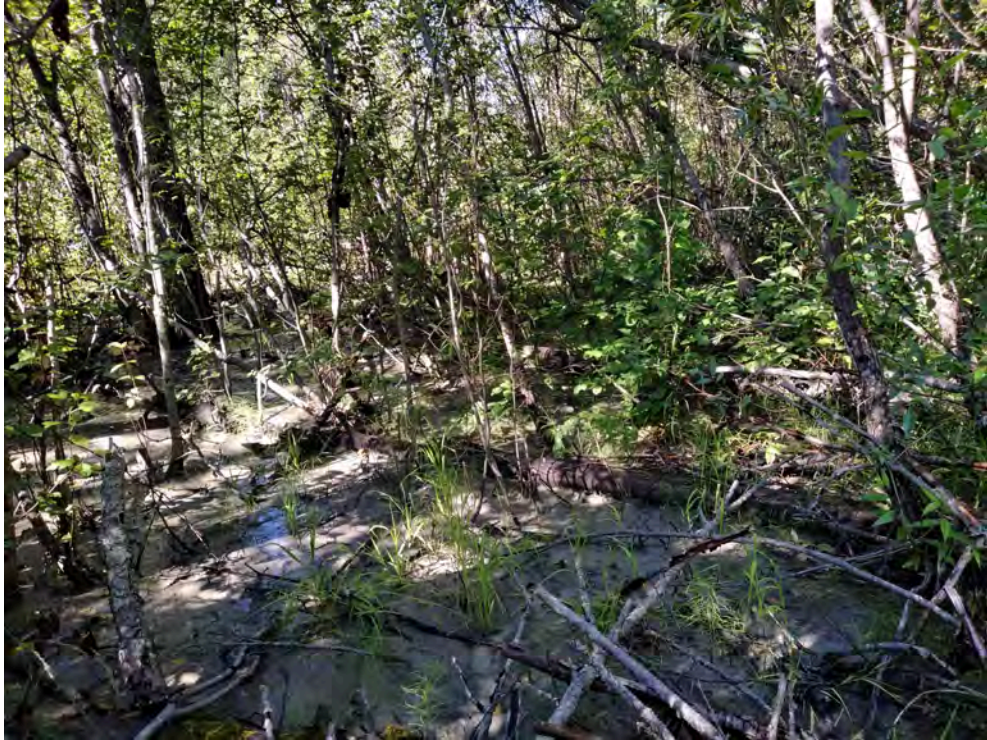
Sampling Point: eklutna-25

NWI classification: PSS1E

Hydric Soil Indicators: Alaska Gleyed without Hue 5Y or Redder Underlying Layer, Other (explain in remarks)

Wetland Hydrology Indicators: Geomorphic Position (D2), Sediment Deposits (B2), Presence of Reduced Iron (C4), Surface Water (A1)

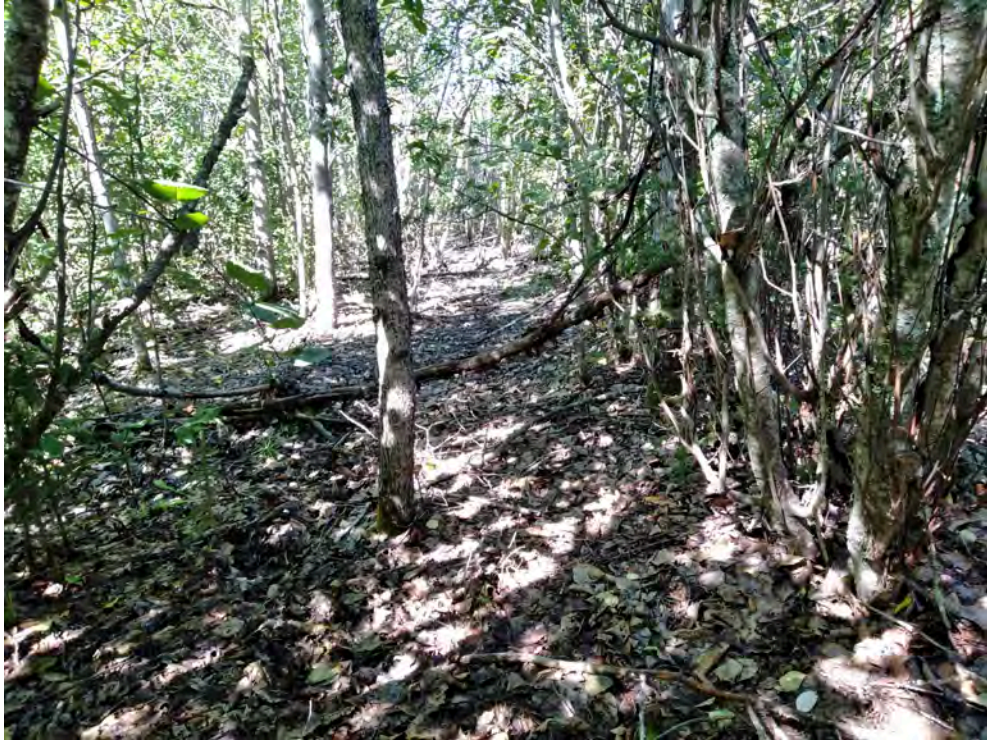
Sampling Point: eklutna-26

NWI classification: U

Hydric Soil Indicators: None

Wetland Hydrology Indicators: None

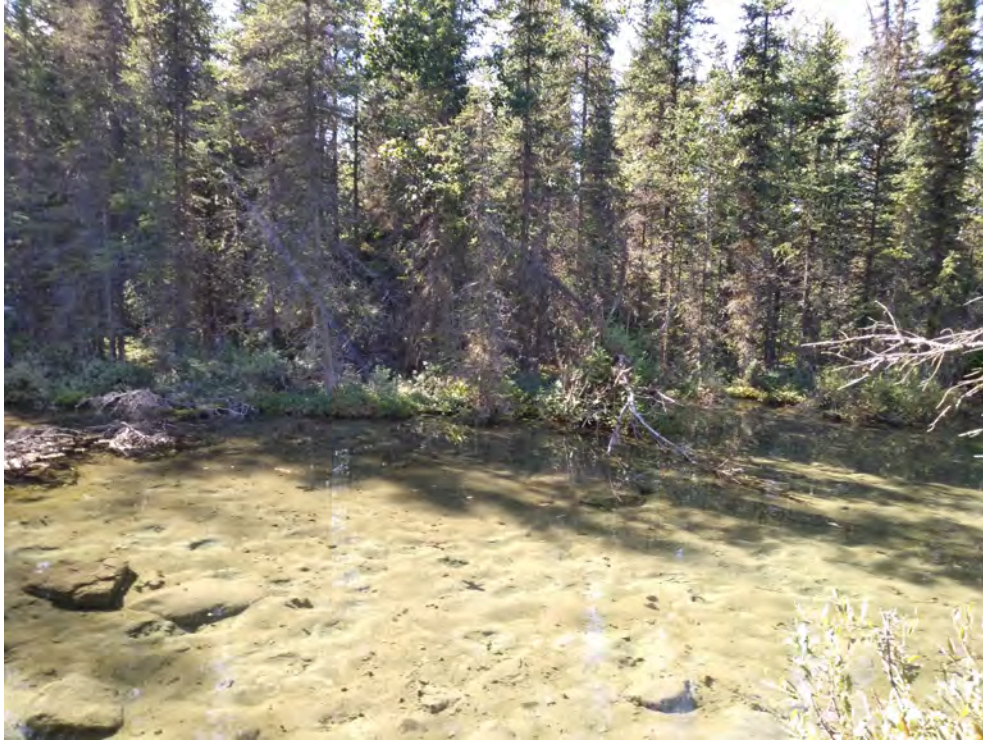
Sampling Point: eklutna-33

NWI classification: PUBH

Hydric Soil Indicators: Other (explain in remarks)

Wetland Hydrology Indicators: Saturation (A3), Surface Water (A1), High Water Table (A2), Geomorphic Position (D2)

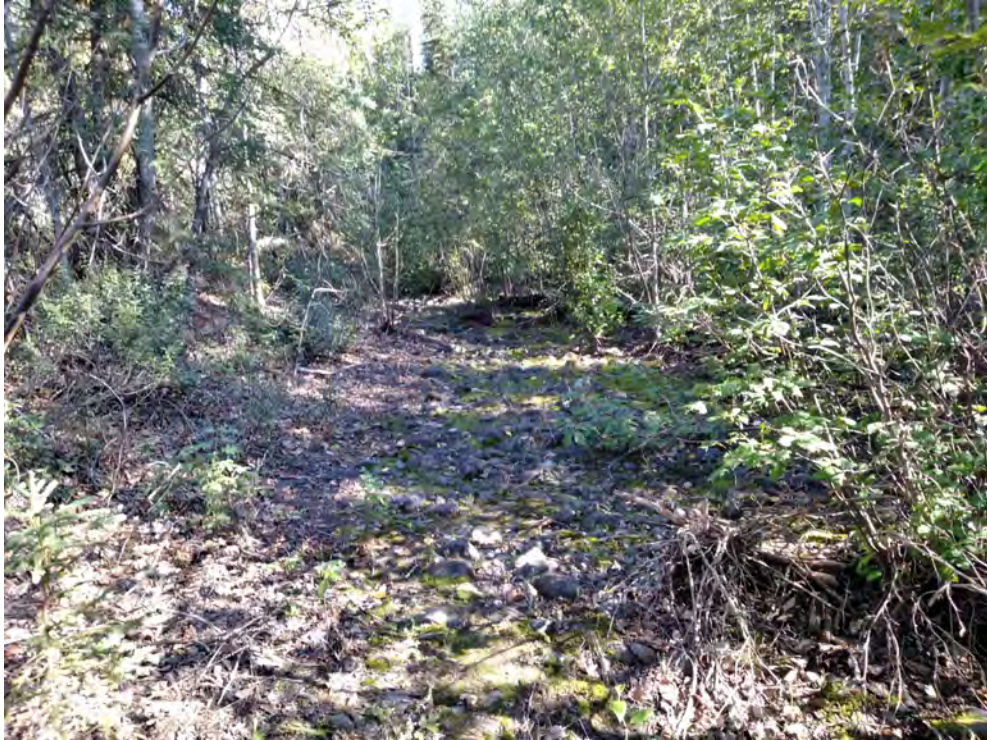
Sampling Point: eklutna-35

NWI classification: PSS1C

Hydric Soil Indicators: Other (explain in remarks)

Wetland Hydrology Indicators: Geomorphic Position (D2), Drift Deposits (B3), Sediment Deposits (B2)

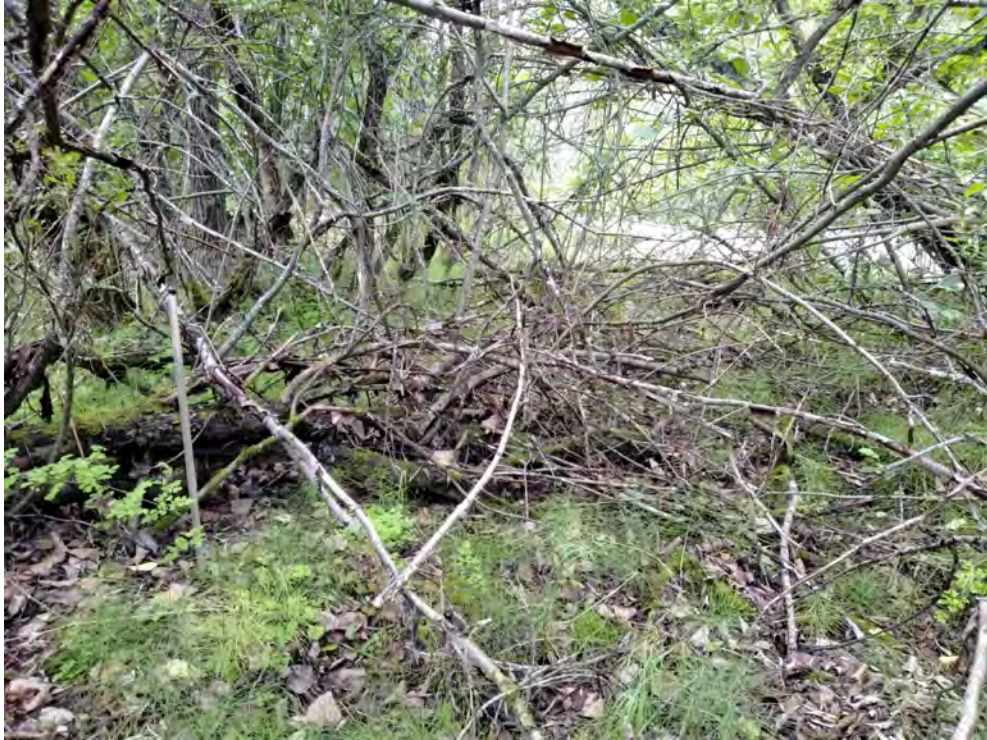
Sampling Point: eklutna-37

NWI classification: PSS1C

Hydric Soil Indicators: Other (explain in remarks)

Wetland Hydrology Indicators: Drift Deposits (B3), FAC-Neutral Test (D5), Geomorphic Position (D2)

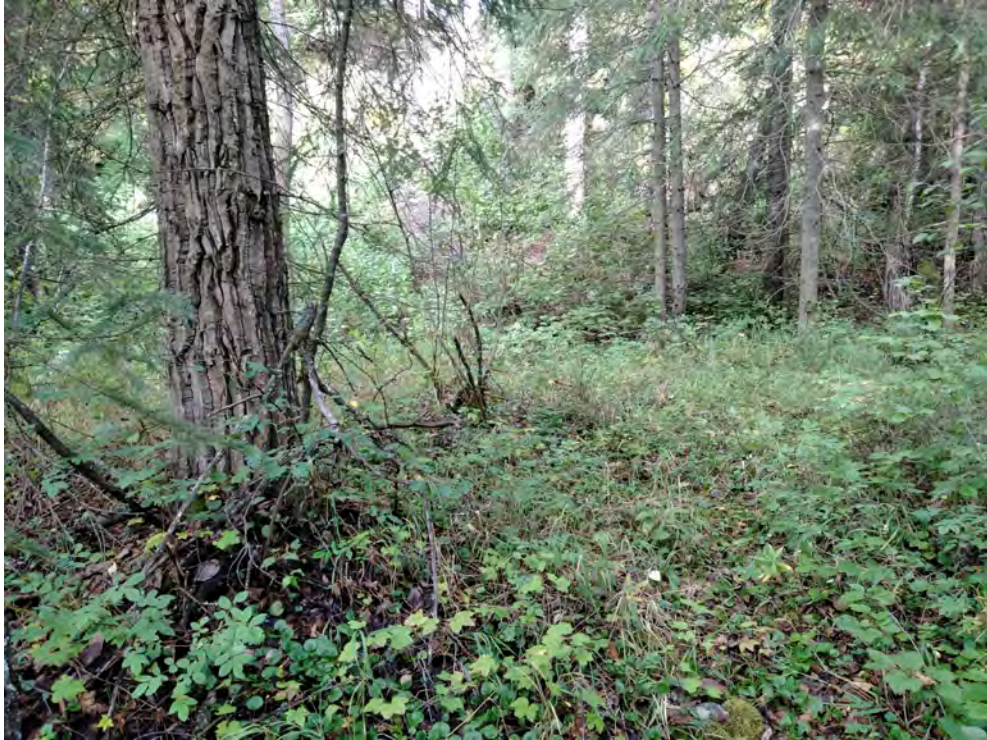
Sampling Point: eklutna-38

NWI classification: U

Hydric Soil Indicators: None

Wetland Hydrology Indicators: None

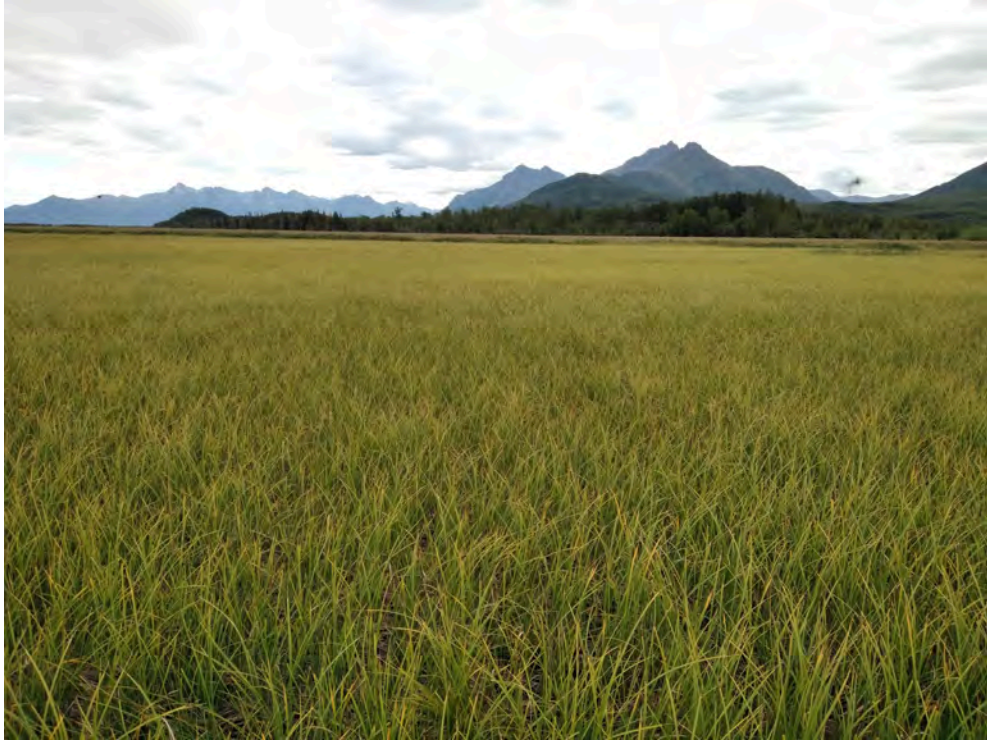
Sampling Point: eklutna-39

NWI classification: E2EM1P

Hydric Soil Indicators: Alaska Gleyed without Hue 5Y or Redder Underlying Layer, Histic Epipedon (A2)

Wetland Hydrology Indicators: FAC-Neutral Test (D5), Presence of Reduced Iron (C4), Saturation (A3), High Water Table (A2), Surface Water (A1), Geomorphic Position (D2)

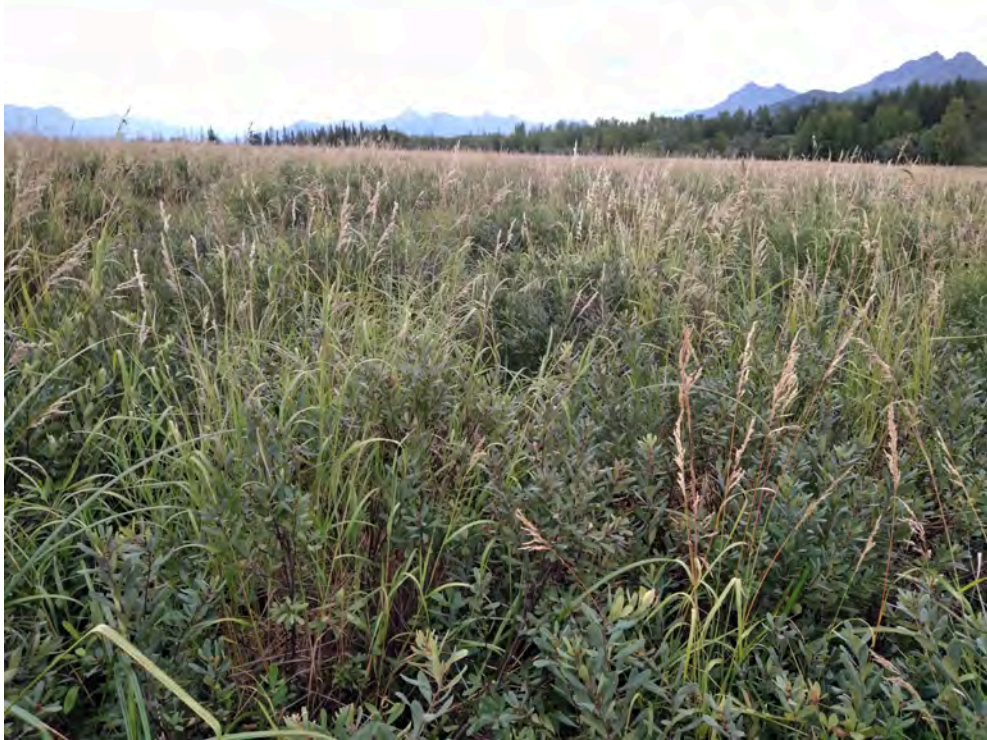
Sampling Point: eklutna-40

NWI classification: E2SS1P

Hydric Soil Indicators: Other (explain in remarks)

Wetland Hydrology Indicators: High Water Table (A2), Microtopographic Relief (D4), FAC-Neutral Test (D5), Surface Water (A1), Geomorphic Position (D2), Saturation (A3)

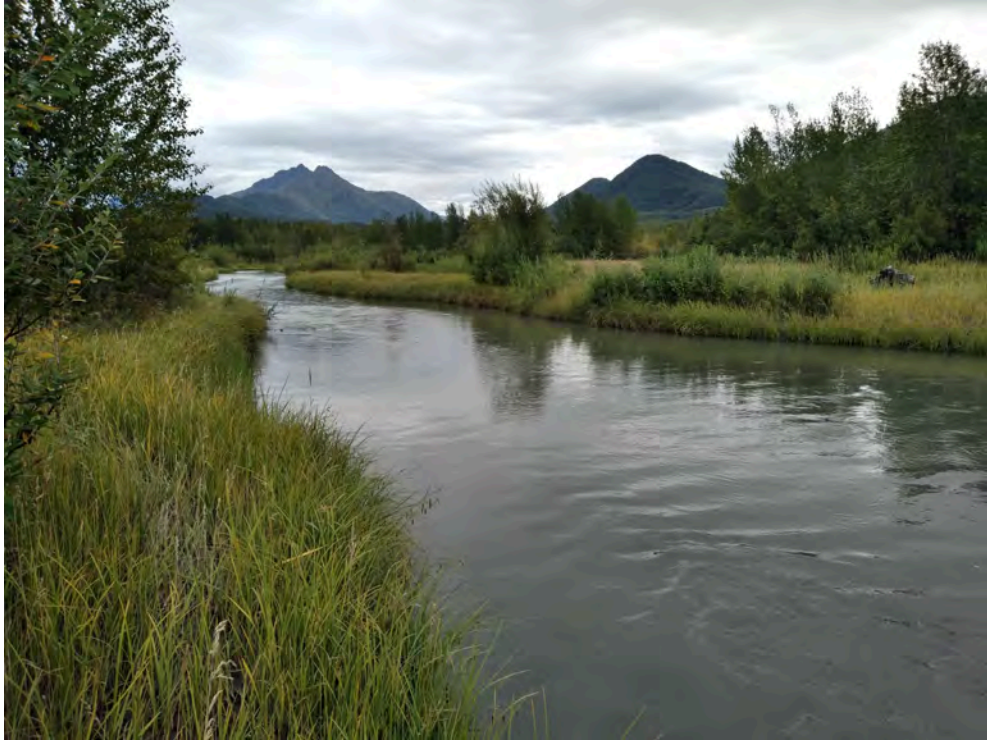
Sampling Point: eklutna-43

NWI classification: R1USQ

Hydric Soil Indicators: Other (explain in remarks)

Wetland Hydrology Indicators: Surface Water (A1)

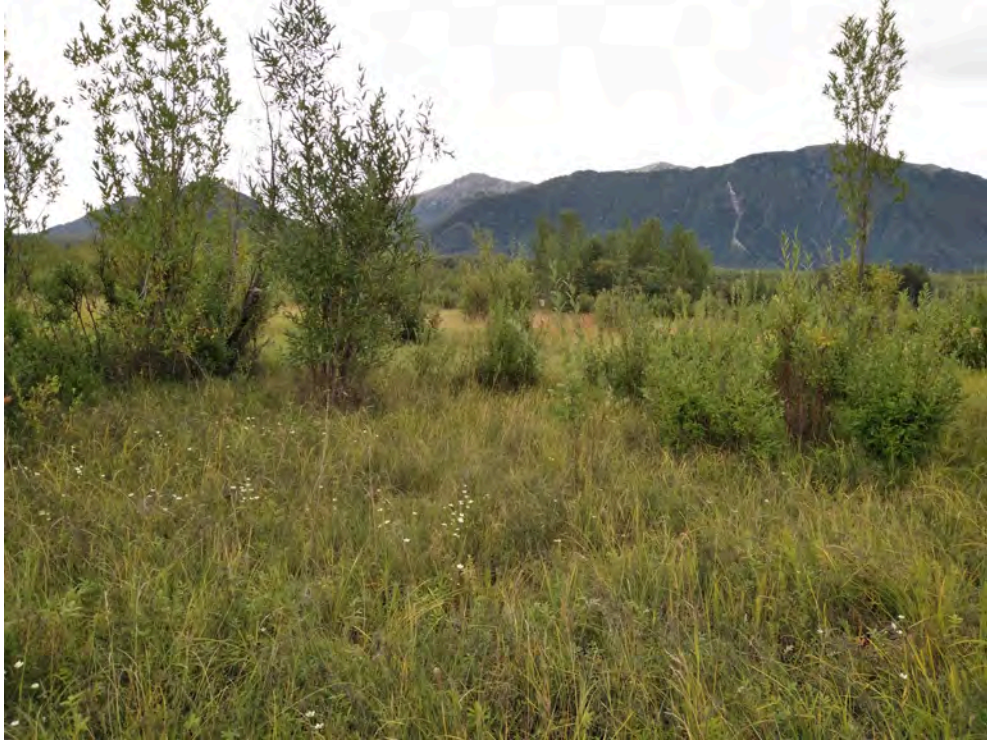
Sampling Point: eklutna-44

NWI classification: E2SS1P

Hydric Soil Indicators: Alaska Gleyed without Hue 5Y or Redder Underlying Layer

Wetland Hydrology Indicators: Saturation (A3), High Water Table (A2), FAC-Neutral Test (D5), Sediment Deposits (B2), Geomorphic Position (D2)

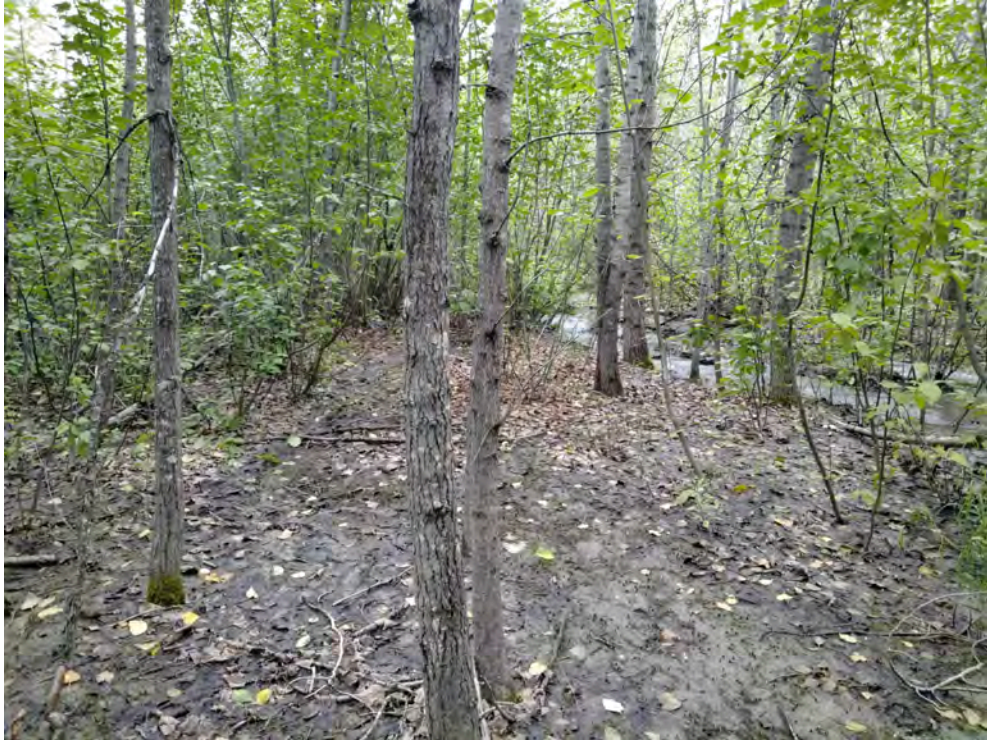
Sampling Point: eklutna-46

NWI classification: PFO1C

Hydric Soil Indicators: Other (explain in remarks)

Wetland Hydrology Indicators: Presence of Reduced Iron (C4), Sediment Deposits (B2), Drift Deposits (B3), Surface Water (A1)

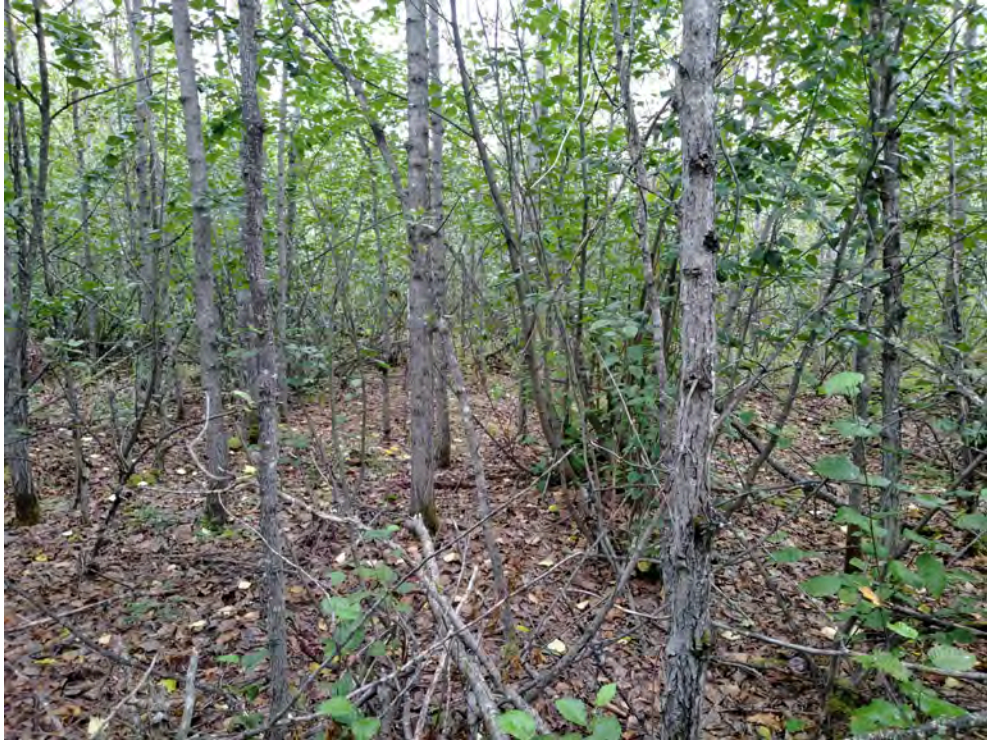
Sampling Point: eklutna-48

NWI classification: U

Hydric Soil Indicators: None

Wetland Hydrology Indicators: None

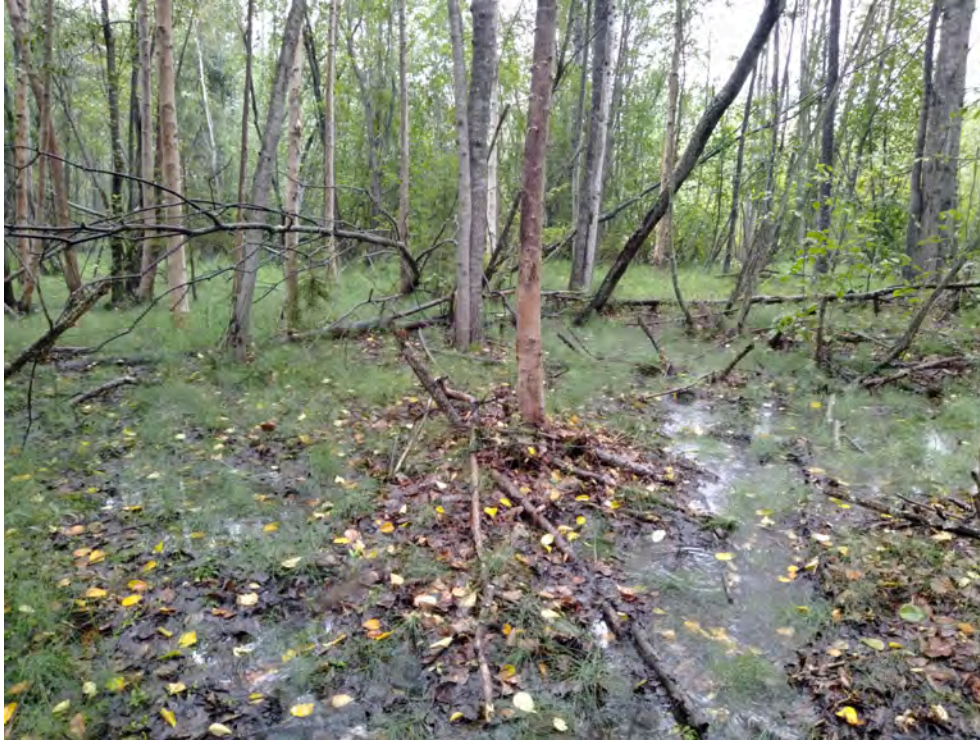
Sampling Point: eklutna-49

Remarks: Similar to flooded forest between highway and railroad. Sheet flow through cottonwood forest. Equisetum and Galium rooted in water, so these conditions are not permanent, but rafted debris along tree trunks indicated the area does flood.

NWI classification: PFO1C

Hydric Soil Indicators: Other (explain in remarks)

Wetland Hydrology Indicators: Surface Water (A1), Drift Deposits (B3), Water Marks (B1)
