Eklutna Hydroelectric Project

Wetlands and Wildlife Habitat

Study Report

June 2023

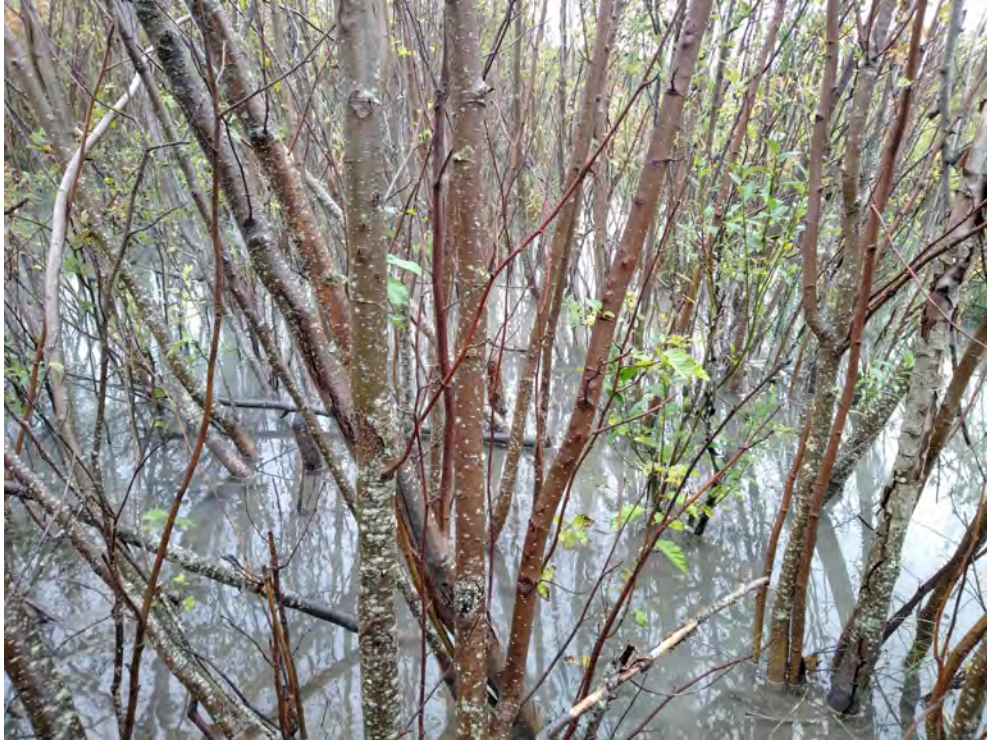
Sampling Point: eklutna-52

Remarks: Closed canopy alder in imagery, but current cover substantially less. Alders and willows in 10in silty water and in poor condition with chlorotic and sparse leaves. Anticipate high (total?) mortality and transition to E1UBL in near future.

Remarks: Cannot extract soil plug due to surface water and loose, saturated silty soils, but soils from 2 inches below ground are positive for alpha alpha dipyrindyl.

NWI classification: E1UBL

Hydric Soil Indicators: Other (explain in remarks)

Wetland Hydrology Indicators: Surface Water (A1)

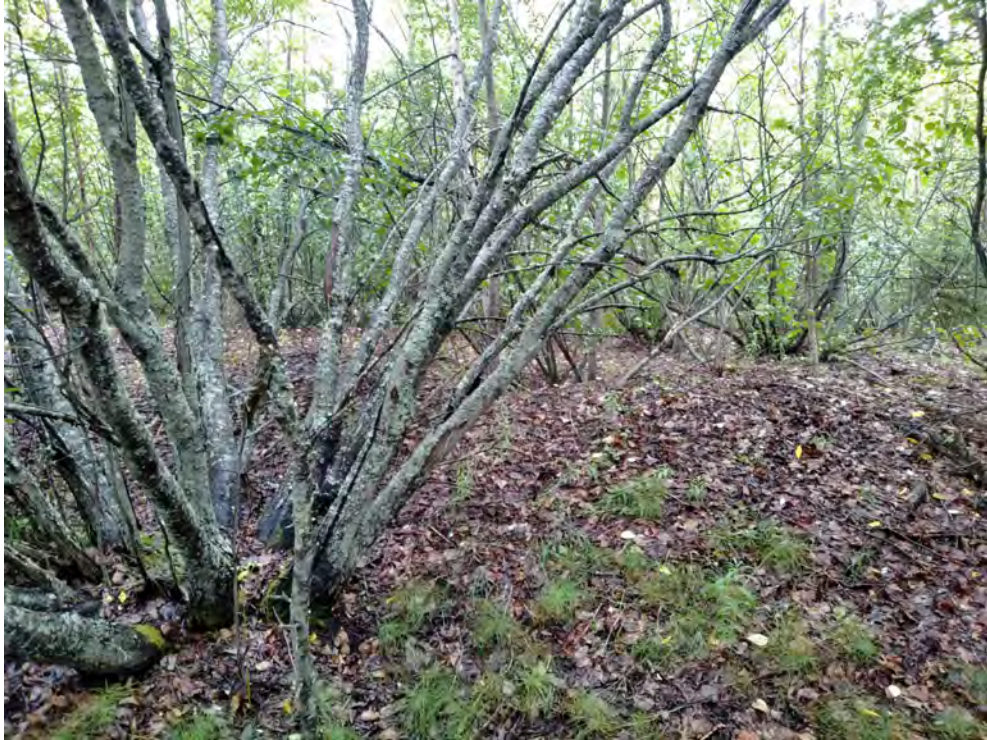
Sampling Point: eklutna-53

NWI classification: U

Hydric Soil Indicators: None

Wetland Hydrology Indicators: None

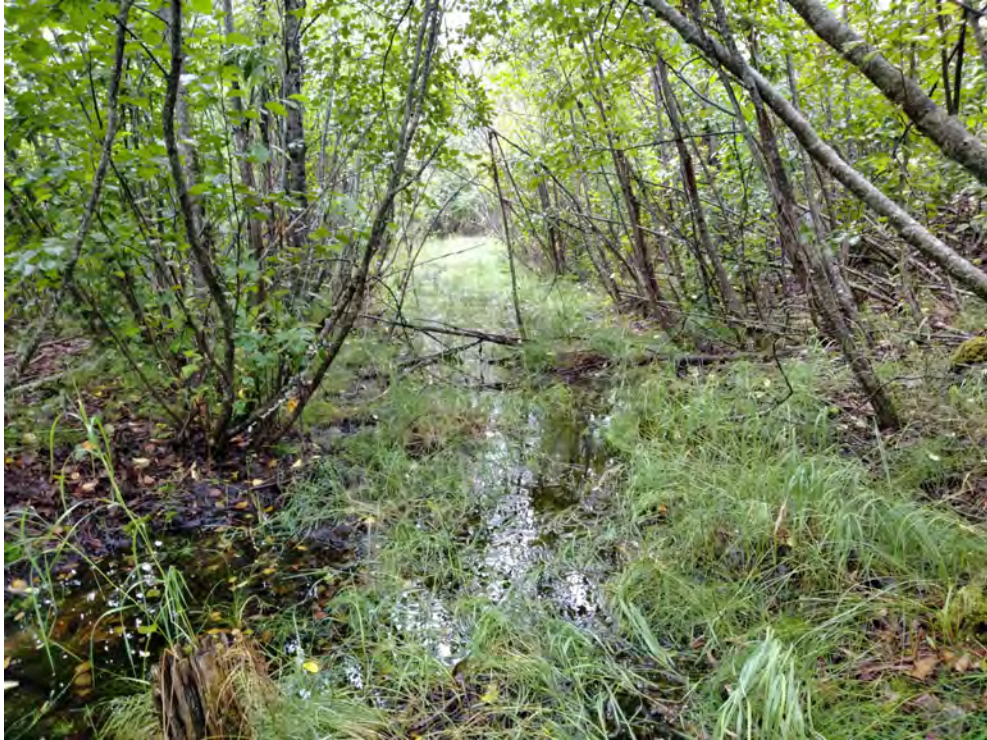
Sampling Point: eklutna-54

NWI classification: PEM1E

Hydric Soil Indicators: Other (explain in remarks)

Wetland Hydrology Indicators: Geomorphic Position (D2), Surface Water (A1)

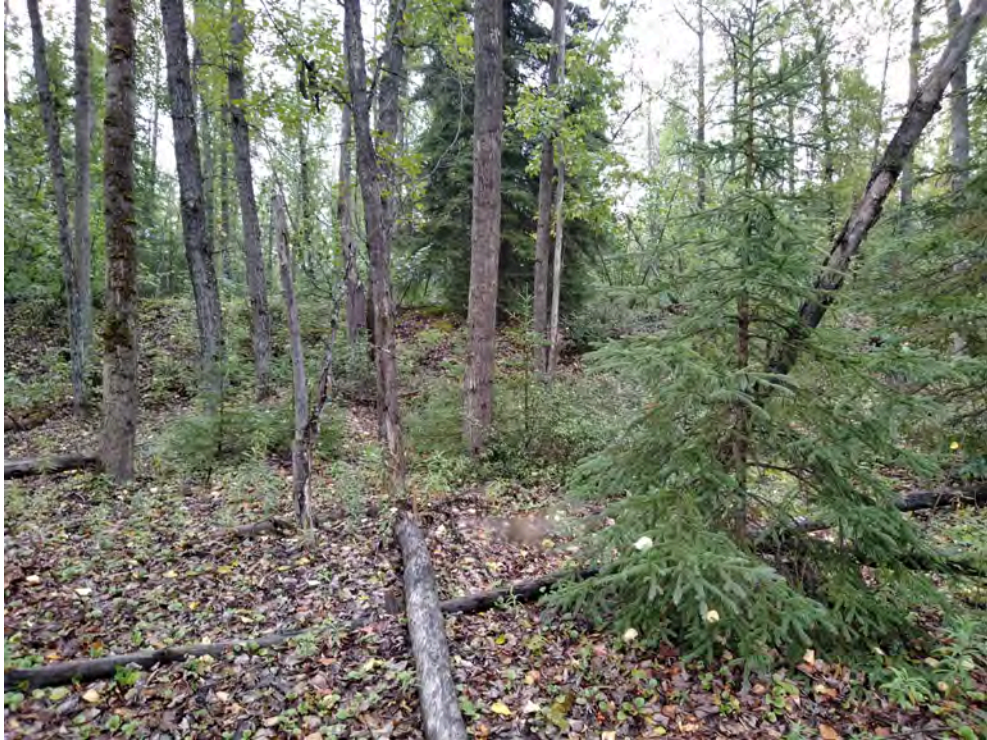
Sampling Point: eklutna-56

NWI classification: U

Hydric Soil Indicators: None

Wetland Hydrology Indicators: None

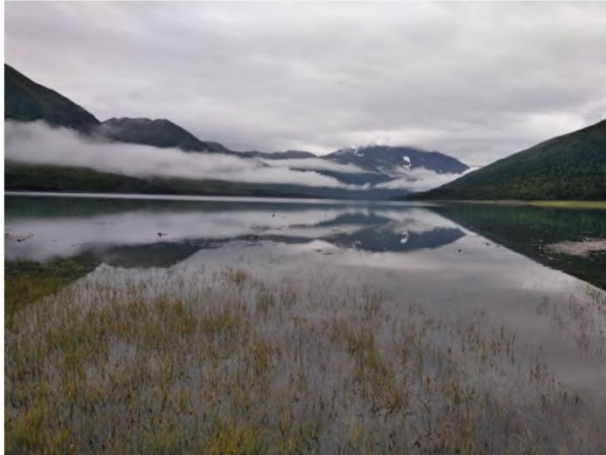
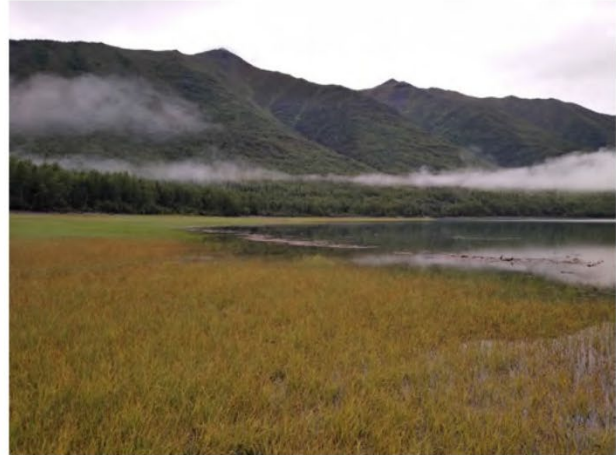
Sampling Point: eklutna-01
Site: Eklutna Hydro Wetlands
Date: 2022-08-09
NWI classification: L1UBH
Viereck code: Fresh Water
Species:

Notes: Eklutna Lake (L1UBH). Water high at time of site visit, flooded sedges along lake margin, grebes near shore. Clear water, EC 181 pH 6.14

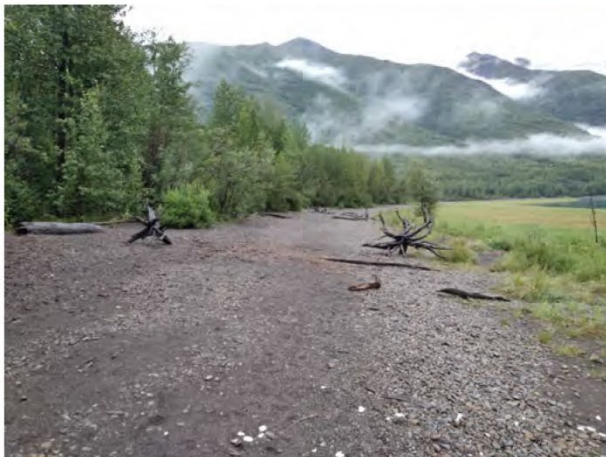
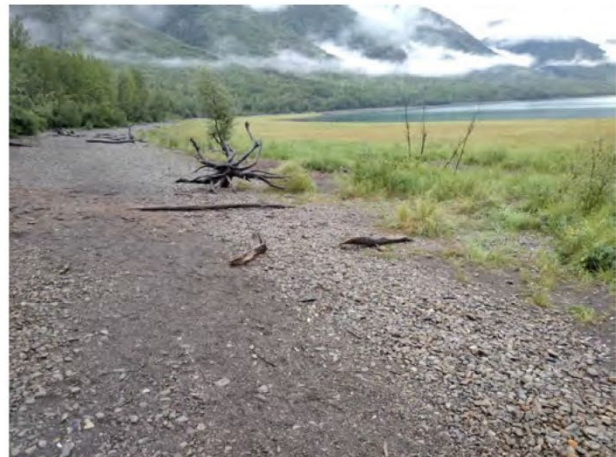
Sampling Point: eklutna-03
Site: Eklutna Hydro Wetlands
Date: 2022-08-09
NWI classification: L2US2C
Viereck code: Barren
Species:

Notes: Narrow band of unvegetated shoreline. Sand to coarse gravels with large driftwood along wrack line.

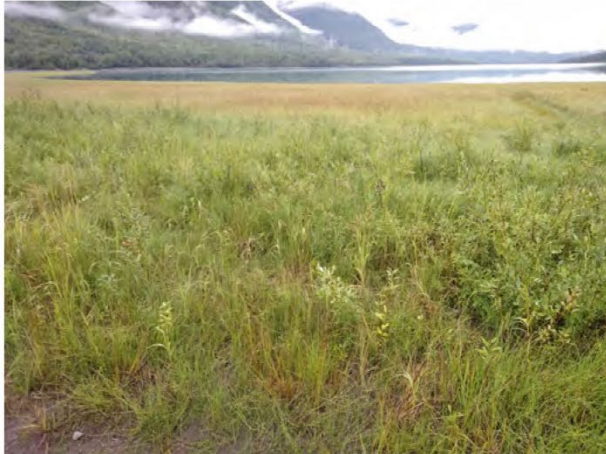
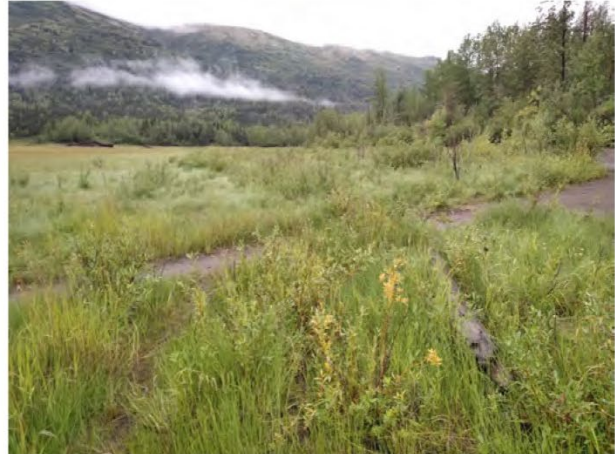
Sampling Point: eklutna-04

Species: *Salix barclayi*, *Salix alaxensis*, *Equisetum palustre*, *Calamagrostis canadensis*, *Trifolium hybridum*, *Juncus castaneus*, *Comarum palustre*

Notes: Narrow band of willows between lower and wetter sedges, higher and drier beach

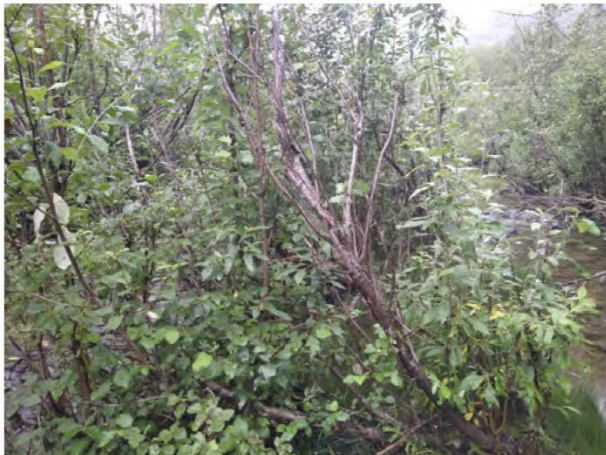
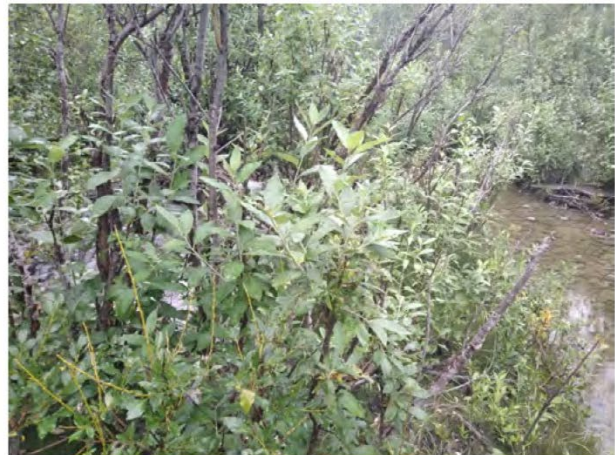
Sampling Point: eklutna-11

Species: *Alnus viridis*, *Salix alaxensis*, *Equisetum variegatum*, *Parnassia palustris*, *Juncus supiniformis*

Notes: Rafted debris and sediment deposits in stream-side willows. Active riparian zone is very narrow, limited to mid-channel islands and zone immediately adjacent to stream.

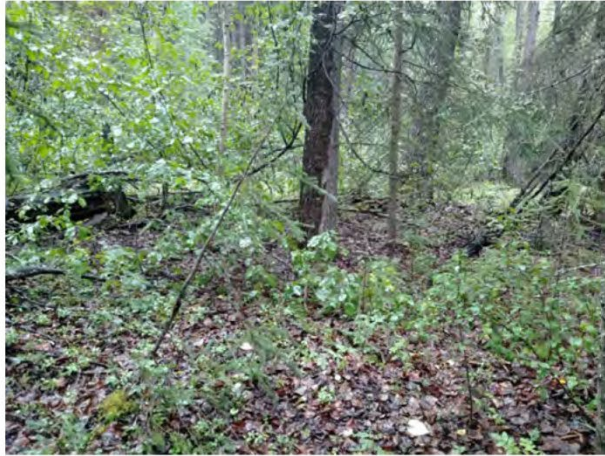
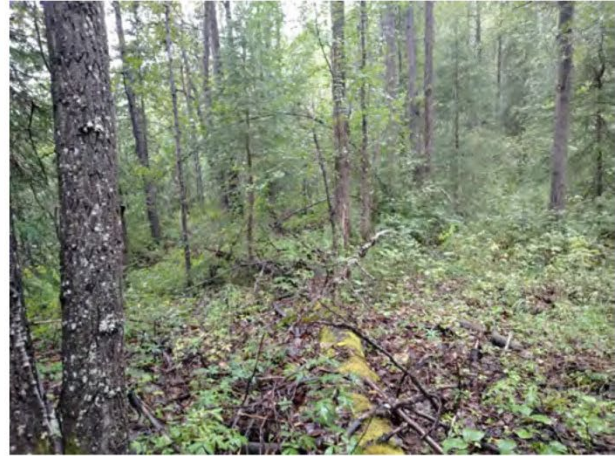
Sampling Point: eklutna-14

Species: *Picea glauca*, *Populus balsamifera*, *Alnus viridis*, *Rosa acicularis*, *Shepherdia canadensis*, *Juniperus communis*, *Linnaea borealis*, *Trientalis europaea*, *Orthilia secunda*, *Geocaulon lividum*, *Chamaenerion angustifolium*

Notes: Upland forest adjacent to Eklutna River. Open canopy cottonwood-white spruce forest several feet higher in elevation than Eklutna River.

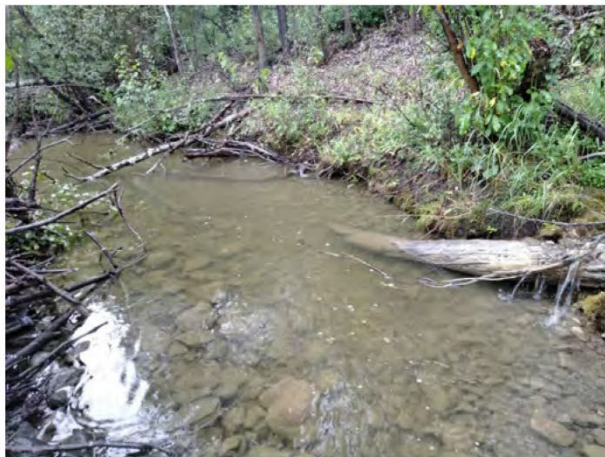
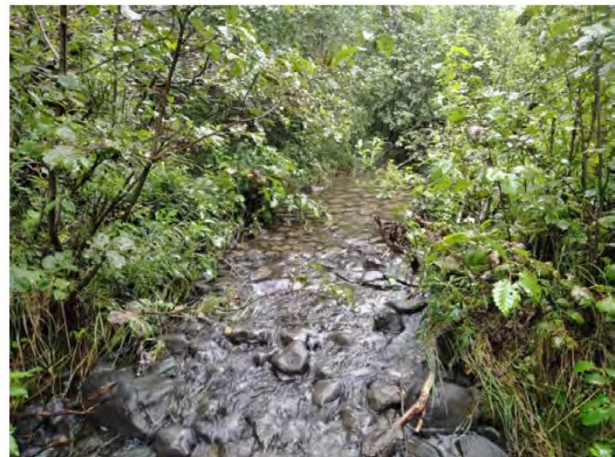
Sampling Point: eklutna-15

Notes: Eklutna River. Channel 7-10ft wide, water 3-12+in deep. Cobble substrate, clear water, large woody debris.

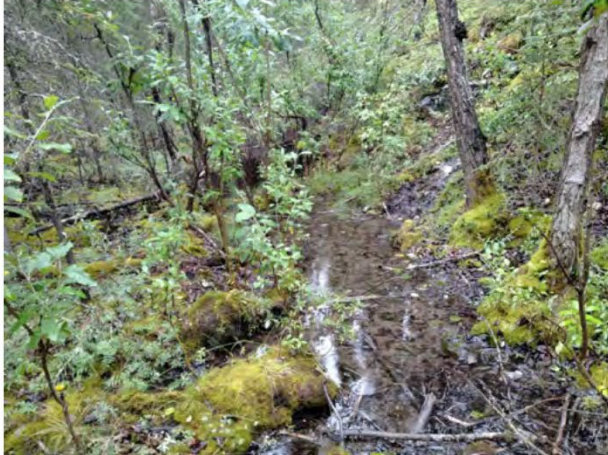
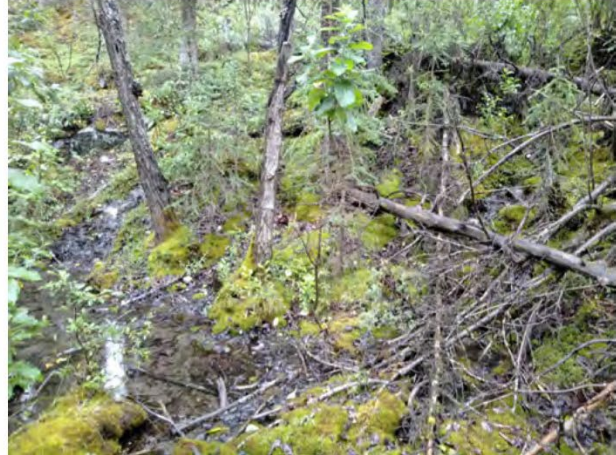
Sampling Point: eklutna-18
Site: Eklutna Hydro Wetlands
Date: 2022-08-09
NWI classification: R4SBC
Viereck code: Fresh Water
Species:

Notes: Small stream runs along toe of steep slope. Numerous seeps from hillside flow down into stream, will be unidentifiable on imagery. Shallow, less than 6 inches deep and 5 feet wide at this point. Clear water, leaves and detritus on bottom. This is likely a seasonal stream.

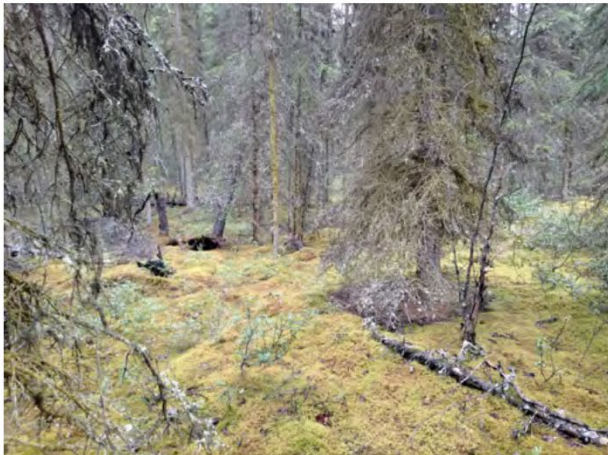
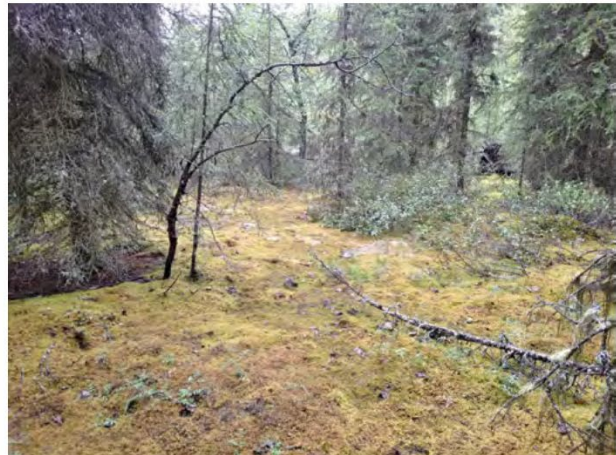
Sampling Point: eklutna-19
Site: Eklutna Hydro Wetlands
Date: 2022-08-09
NWI classification: U
Viereck code: Closed White Spruce
Species: *Picea glauca*, *Populus balsamifera*, *Shepherdia canadensis*, *Hedysarum mackenzii*, *Geocaulon lividum*

Notes: Upland forest in level terrain.

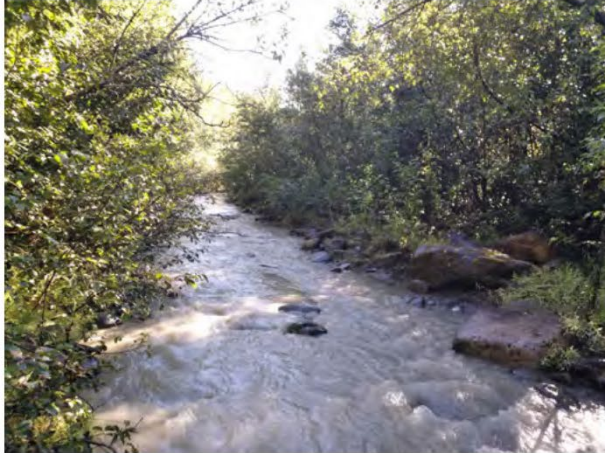
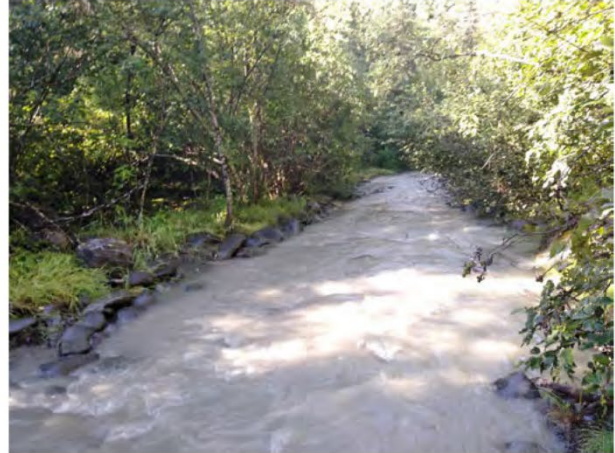
Notes: Active channel Eklutna River, visible in imagery. Stone to boulder substrate, turbid water. Very little riparian wetland. Tall *Salix alaxensis* along banks with rafted debris. The bank then transitions to upland white spruce forest.

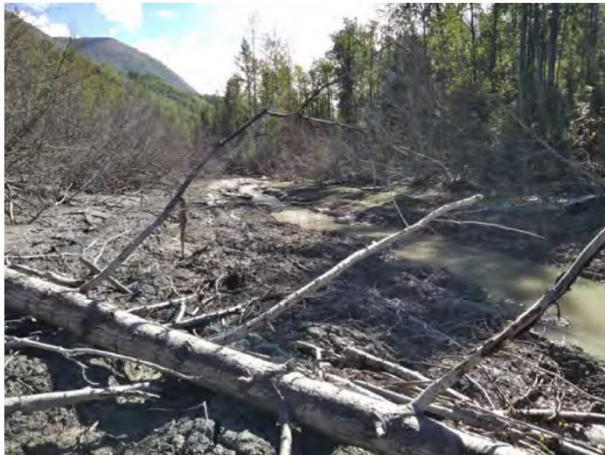
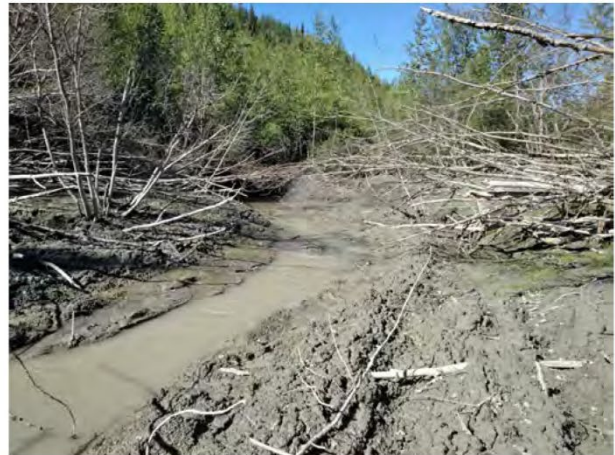
Sampling Point: eklutna-24
Site: Eklutna Hydro Wetlands
Date: 2022-08-10
NWI classification: R3UBH
Viereck code: Fresh Water
Species:

Notes: Active channel Eklutna River through drained beaver pond. Dam was breached this season, see plot 23 for drained beaver pond. Channel ca 5ft wide, silt substrates, turbid water. Extent of water in imagery presumably shows extent of seasonal flooding, which is more than current conditions. Atypical conditions present as this channel would become a PUBHb when beavers rebuild their dam.

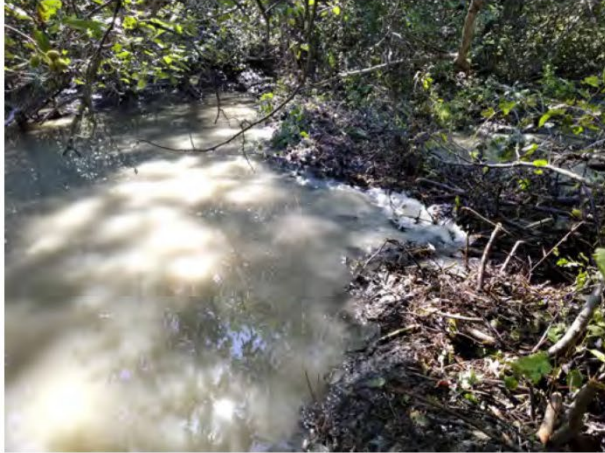
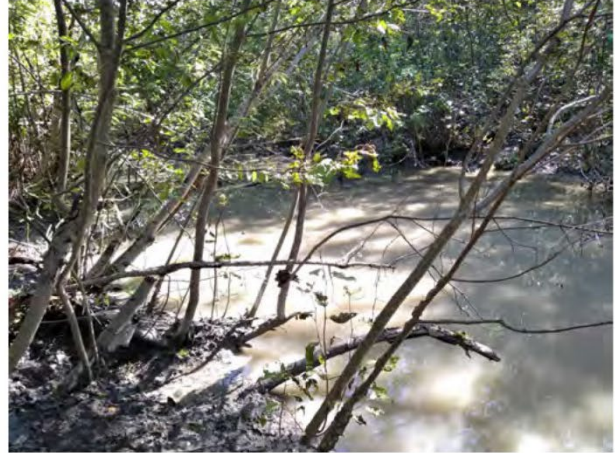
Sampling Point: eklutna-27
Site: Eklutna Hydro Wetlands
Date: 2022-08-10
NWI classification: PUBHb
Viereck code: Fresh Water
Species:

Notes: Recent beaver activity in Eklutna River. Dam has backed water up to adjacent uplands, over 3 feet deep at access trail.

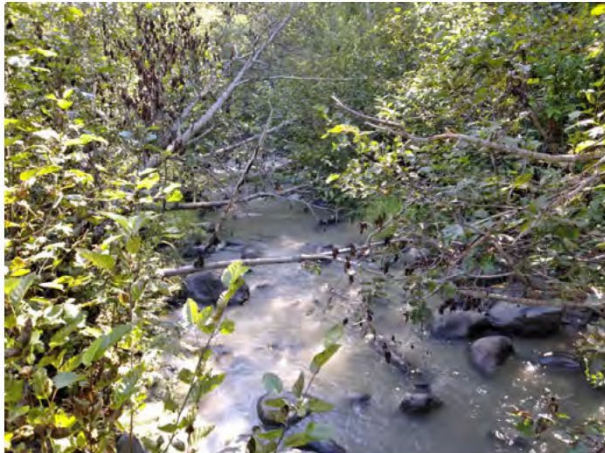
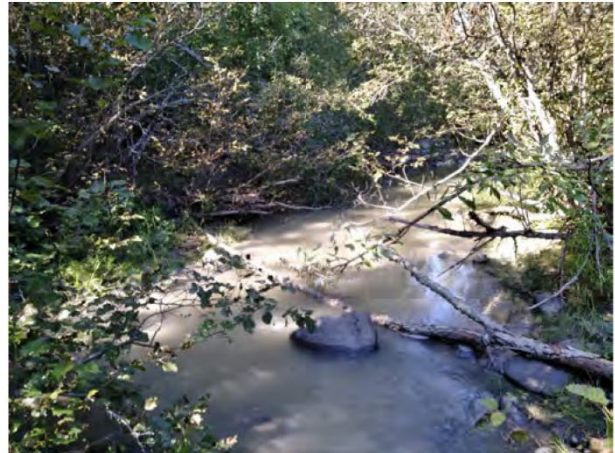
Sampling Point: eklutna-28
Site: Eklutna Hydro Wetlands
Date: 2022-08-10
NWI classification: R3UBH
Viereck code: Fresh Water
Species:

Notes: Active channel Eklutna River. Approximately 7 feet wide, with a stone to boulder substrate. Very little riparian wetland, confined to tall shrub within 5 feet of stream.

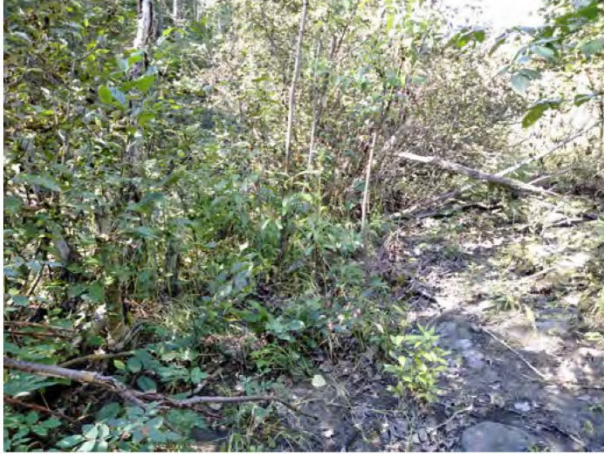
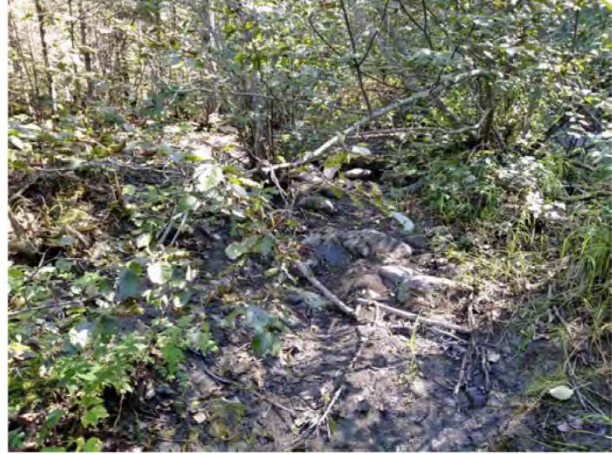
Sampling Point: eklutna-29

Species: *Alnus viridis*, *Salix alaxensis*, *Arctagrostis latifolia*

Notes: Narrow band of riparian wetlands. Sediment deposits and rafted debris observed. *Picea* and *Populus* trees mark transition to Upland forest. Includes small R3USC inactive channel.

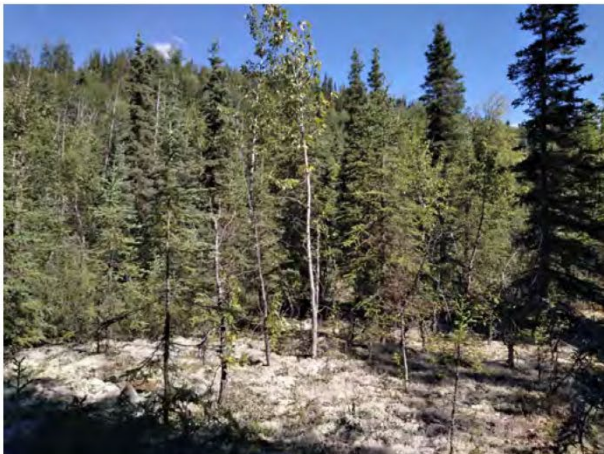
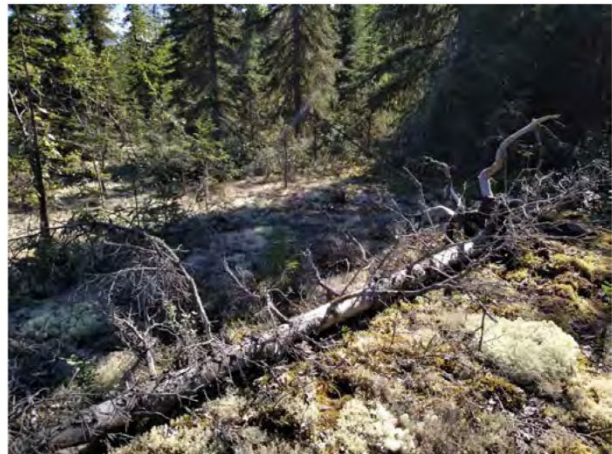
Sampling Point: eklutna-30

Species: *Populus balsamifera*, *Picea glauca*, *Shepherdia canadensis*, *Arctostaphylos uva-ursi*

Notes: Upland forest with mixed cottonwood-white spruce forest and sparse understory. Groundcover dominated by lichens (*Cladonia Stellaris*, *Cladonia uncialis*, *Flavoce-traria nivalis*, *Cladonia stygia*, *Cladonia rangiferina*).

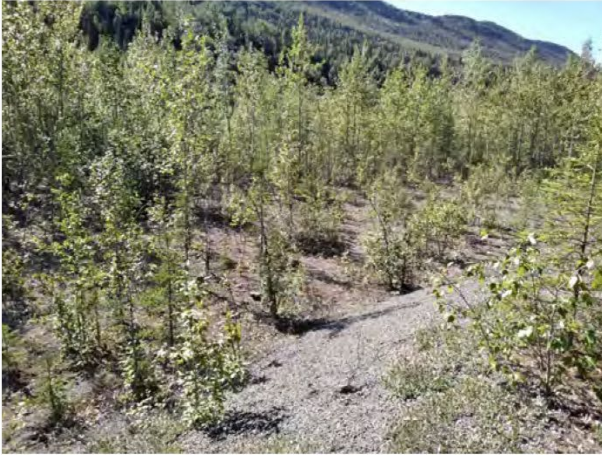
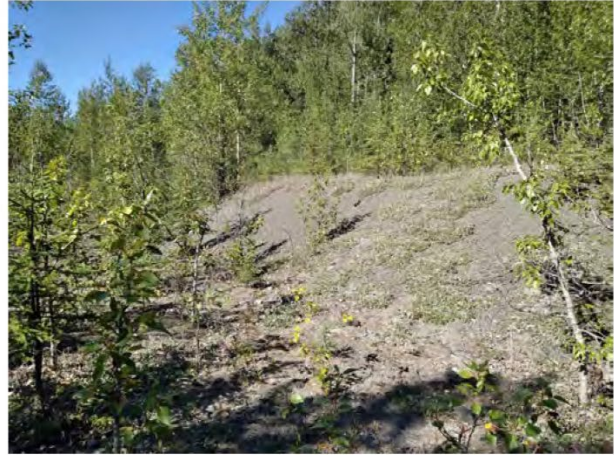
Sampling Point: eklutna-31

Species: *Populus balsamifera*, *Picea glauca*, *Dryas sp.*, *Chamaenerion angustifolium*

Notes: Uplands between access trail and this point. Raised mound in lidar is pushed up pile of gravel.

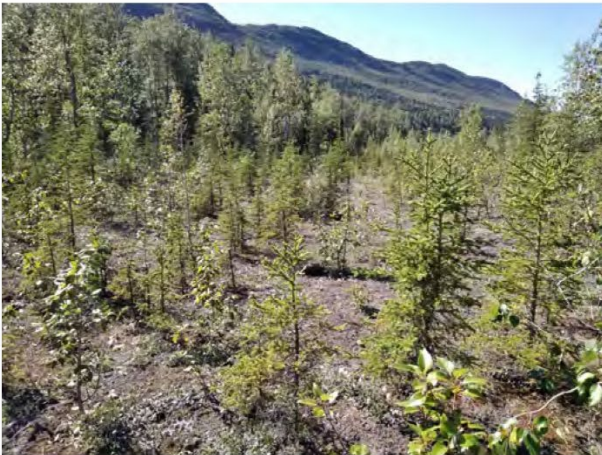
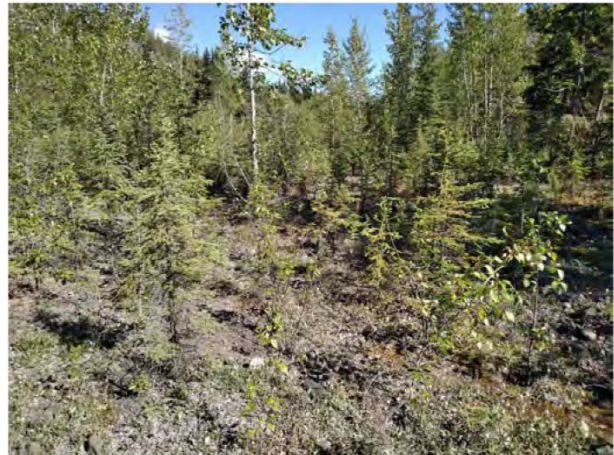
Sampling Point: eklutna-32

Species: *Dryas sp.*, *Picea glauca*, *Populus tremuloides*, *Shepherdia canadensis*, *Chamaenerion angustifolium*, *Taraxacum officinale*, *Orthilia secunda*

Notes: Previously cleared uplands.

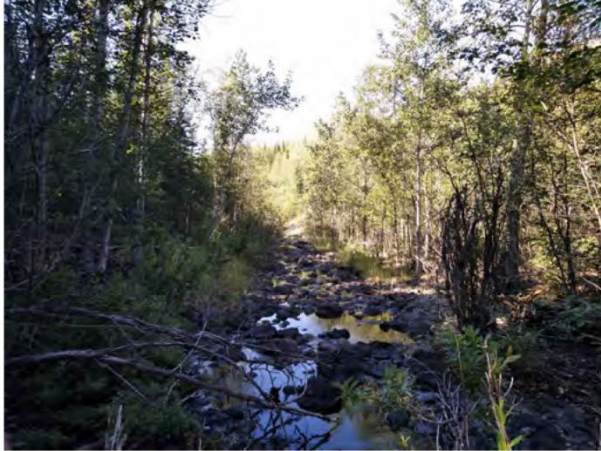
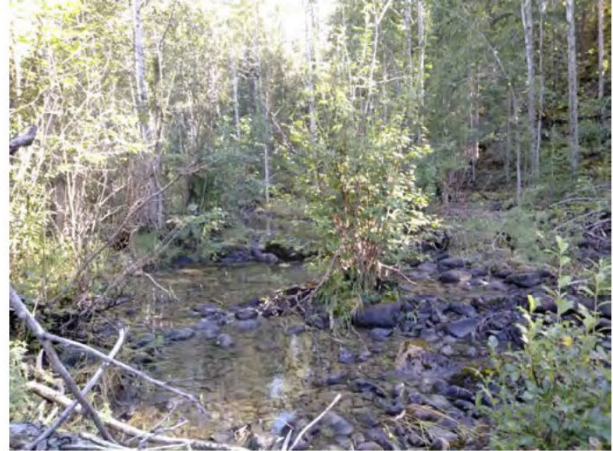
Sampling Point: eklutna-34
Site: Eklutna Hydro Wetlands
Date: 2022-08-10
NWI classification: R4SBC
Viereck code: Fresh Water
Species:

Notes: Active channel of Eklutna River. Channel approximately 15 feet wide, gravel to stone substrate. Rafted debris is about 2.5 feet above current water level, AJ Avitia (bear guard) states this likely related to high water he observed while minnow trapping here in June.

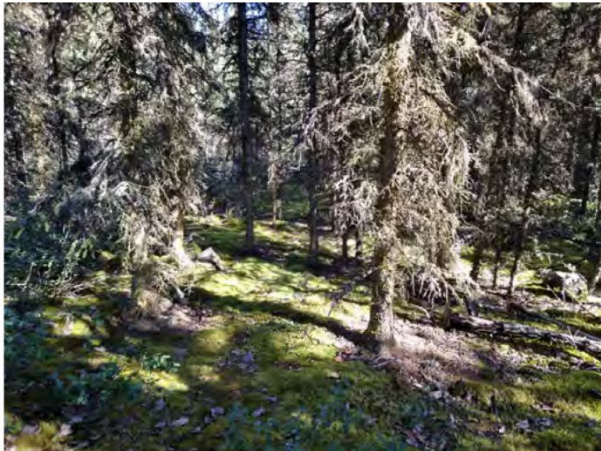
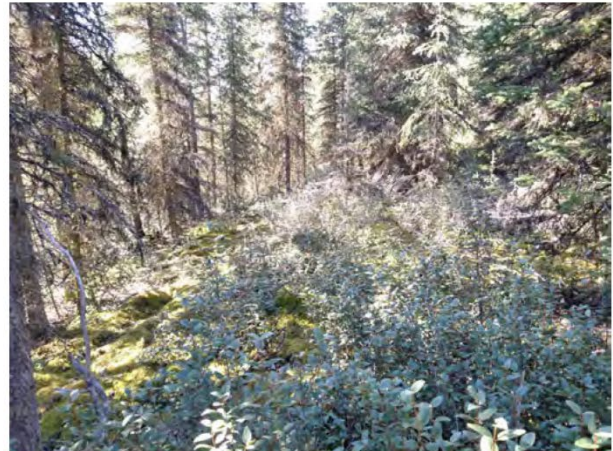
Sampling Point: eklutna-36
Site: Eklutna Hydro Wetlands
Date: 2022-08-10
NWI classification: U
Viereck code: Closed Black Cottonwood-White Spruce
Species: *Picea glauca*, *Populus balsamifera*, *Shepherdia canadensis*, *Geocaulon lividum*

Notes: Upland white spruce-cottonwood forest. Very thin non-vasculars over cobbles to stones.

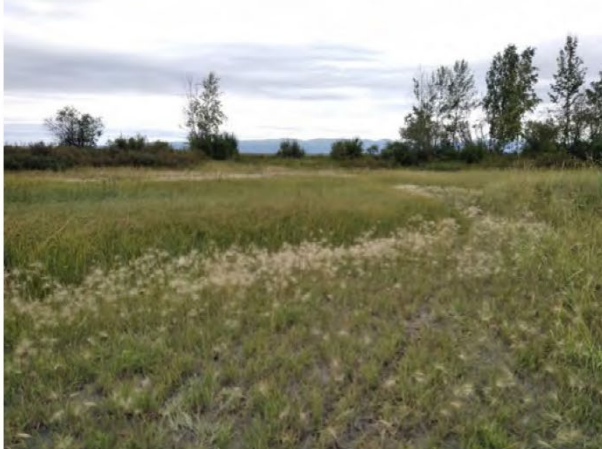
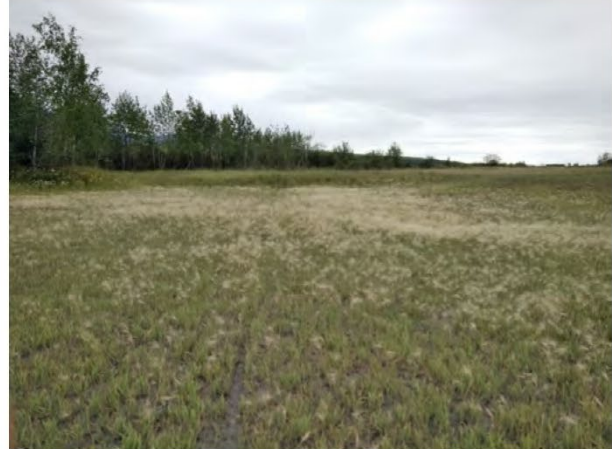
Sampling Point: eklutna-41

Species: *Carex lyngbyei*, *Plantago maritima*, *Potentilla egedii*, *Hordeum jubatum*, *Leymus mollis*, *Triglochin palustris*, *Schoenoplectus tabernaemontani*

Notes: *Scirpus* and *Carex lyngbyei* in wettest portion of this plot, *Plantago maritima* in portions with exposed sediments and no water at time of visit.

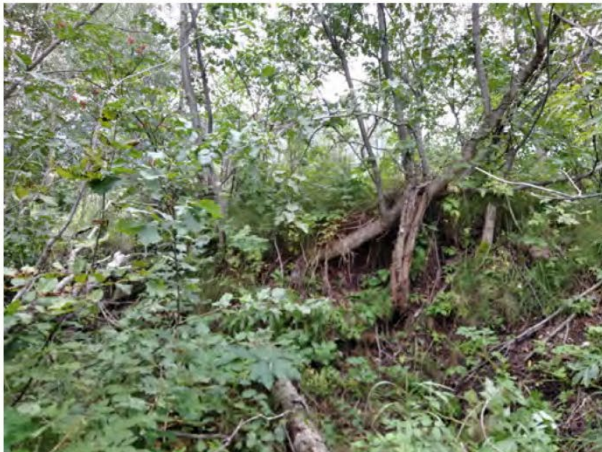
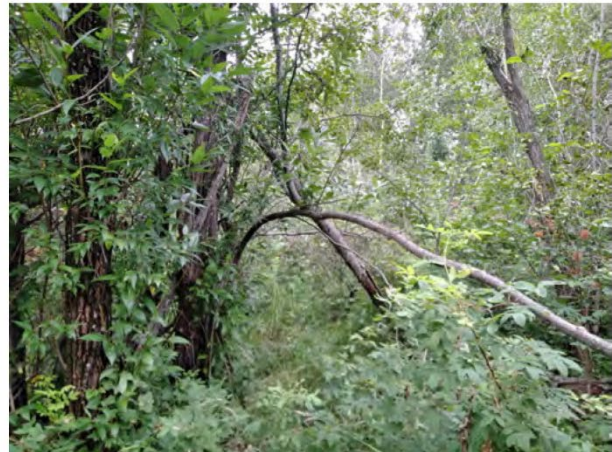
Sampling Point: eklutna-42

Species: *Salix lasiandra*, *Rosa acicularis*, *Alnus viridis*, *Sambucus racemosa*, *Calamagrostis canadensis*

Notes: Uplands with very tall tree-form *Salix lasiandra*, tall shrubs, and numerous dead/down trees. Possible old disturbance, with surface materials pushed into large mound

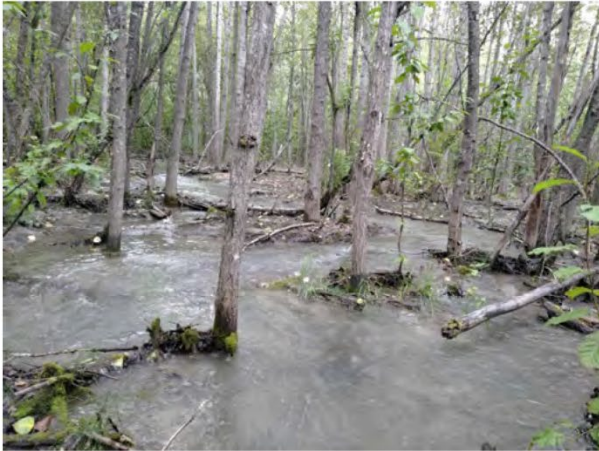
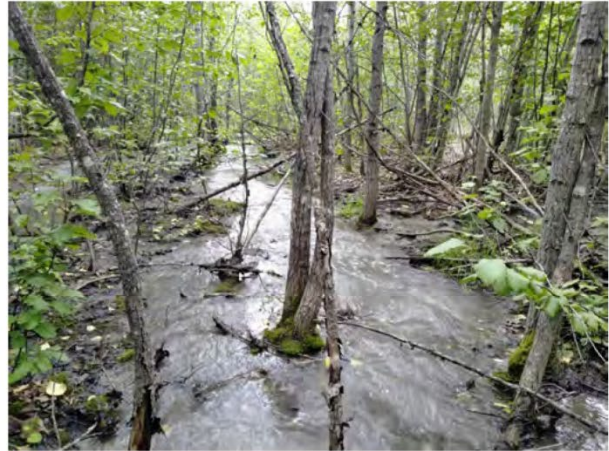
Sampling Point: eklutna-45
Site: Eklutna Hydro Wetlands
Date: 2022-08-11
NWI classification: R3UBH
Viereck code: Fresh Water
Species:

Notes: Eklutna River, braided section between Glen Highway and railroad tracks. Channels visible in lidar. Cottonwoods rooted in channels. Water level higher than ground surface in adjacent forest characterized by ek-46.

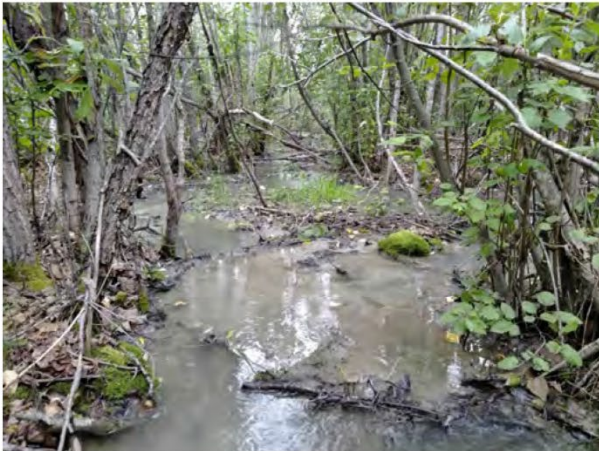
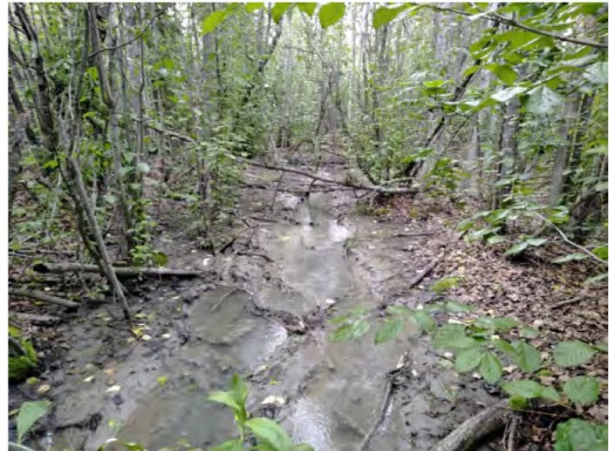
Sampling Point: eklutna-47
Site: Eklutna Hydro Wetlands
Date: 2022-08-11
NWI classification: R3UBH
Viereck code: Fresh Water
Species:

Notes: Small channel through forest. Eklutna still braided, but fewer braids/sheet flow through forest. Indications of flooding (sediment deposits in inactive channels) but less persistent than at 45 and 46.

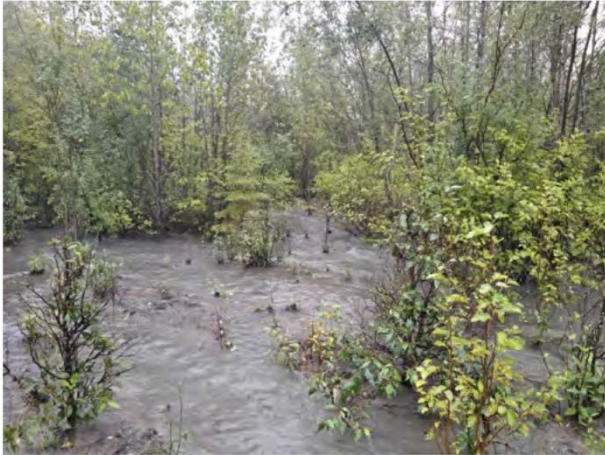
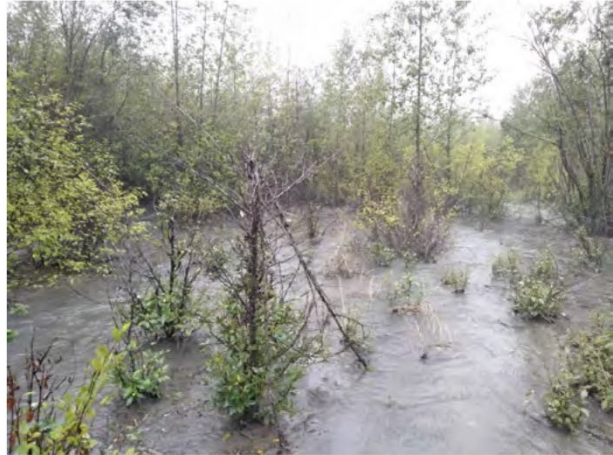
Sampling Point: eklutna-50
Site: Eklutna Hydro Wetlands
Date: 2022-08-12
NWI classification: PSS1C
Viereck code: Open Low Shrub
Species: *Populus balsamifera*, *Alnus viridis*

Notes: Gravels with open shrub in imagery, but sheet flow through shrubs at time of site visit. Water 4-6 inches deep, unvegetated silts and gravels beneath water.

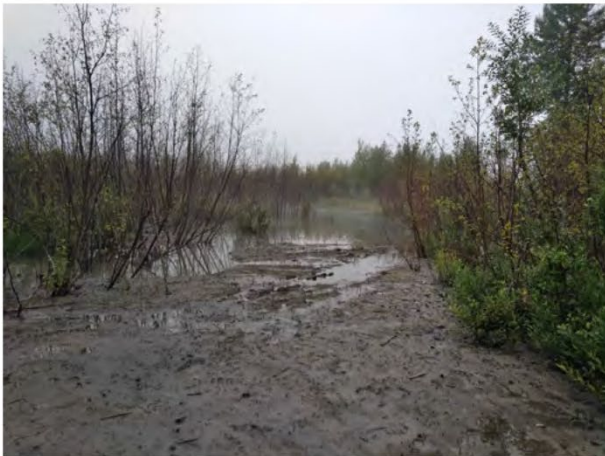
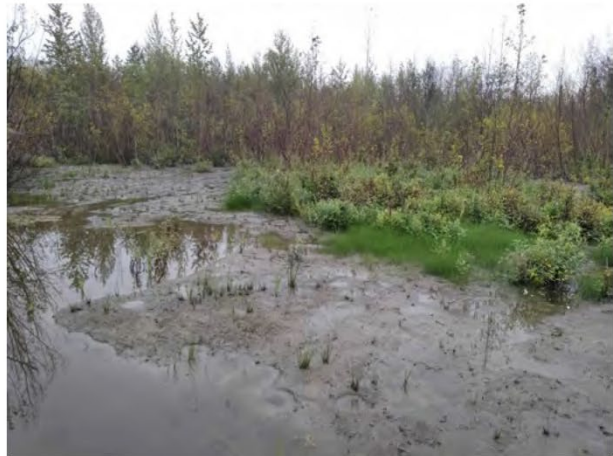
Sampling Point: eklutna-51
Site: Eklutna Hydro Wetlands
Date: 2022-08-12
NWI classification: PUSC
Viereck code: Open Tall Alder
Species:

Notes: Water in imagery, channel appears to have migrated. Sediment deposits throughout, bases of shrubs appear to be buried. Alders in poor condition, with chlorotic, sparse leaves.

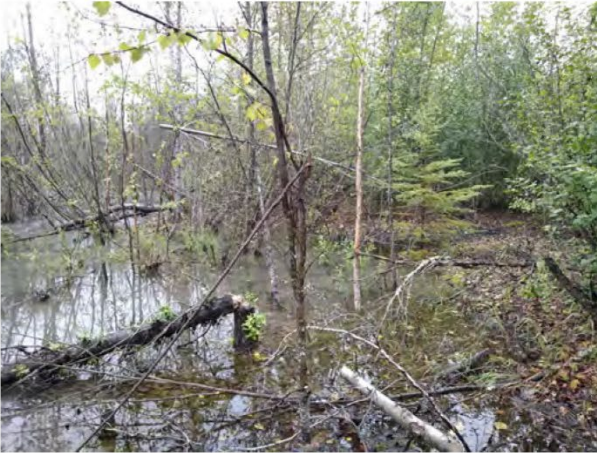
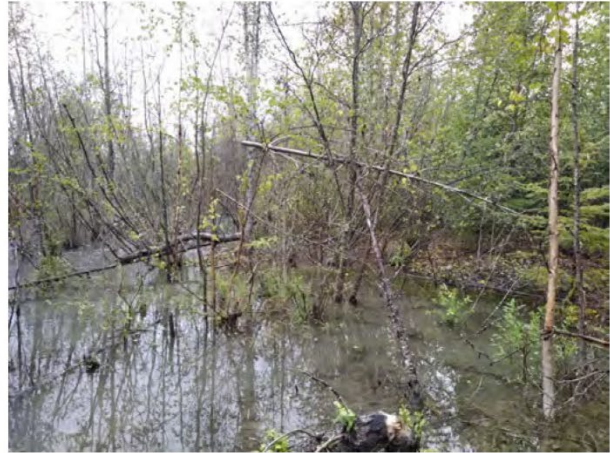
Species: *Populus balsamifera*, *Betula nealaskana*, *Alnus viridis*

Notes: Marking extent of current flooding from beavers. Extends a little further back on the trail, but this is the transition from flooded, presumably dying, broadleaf forest to well-drained upland broadleaf forest. See ek-52 for characteristic flooded area, and ek-53 for well-drained upland forest.

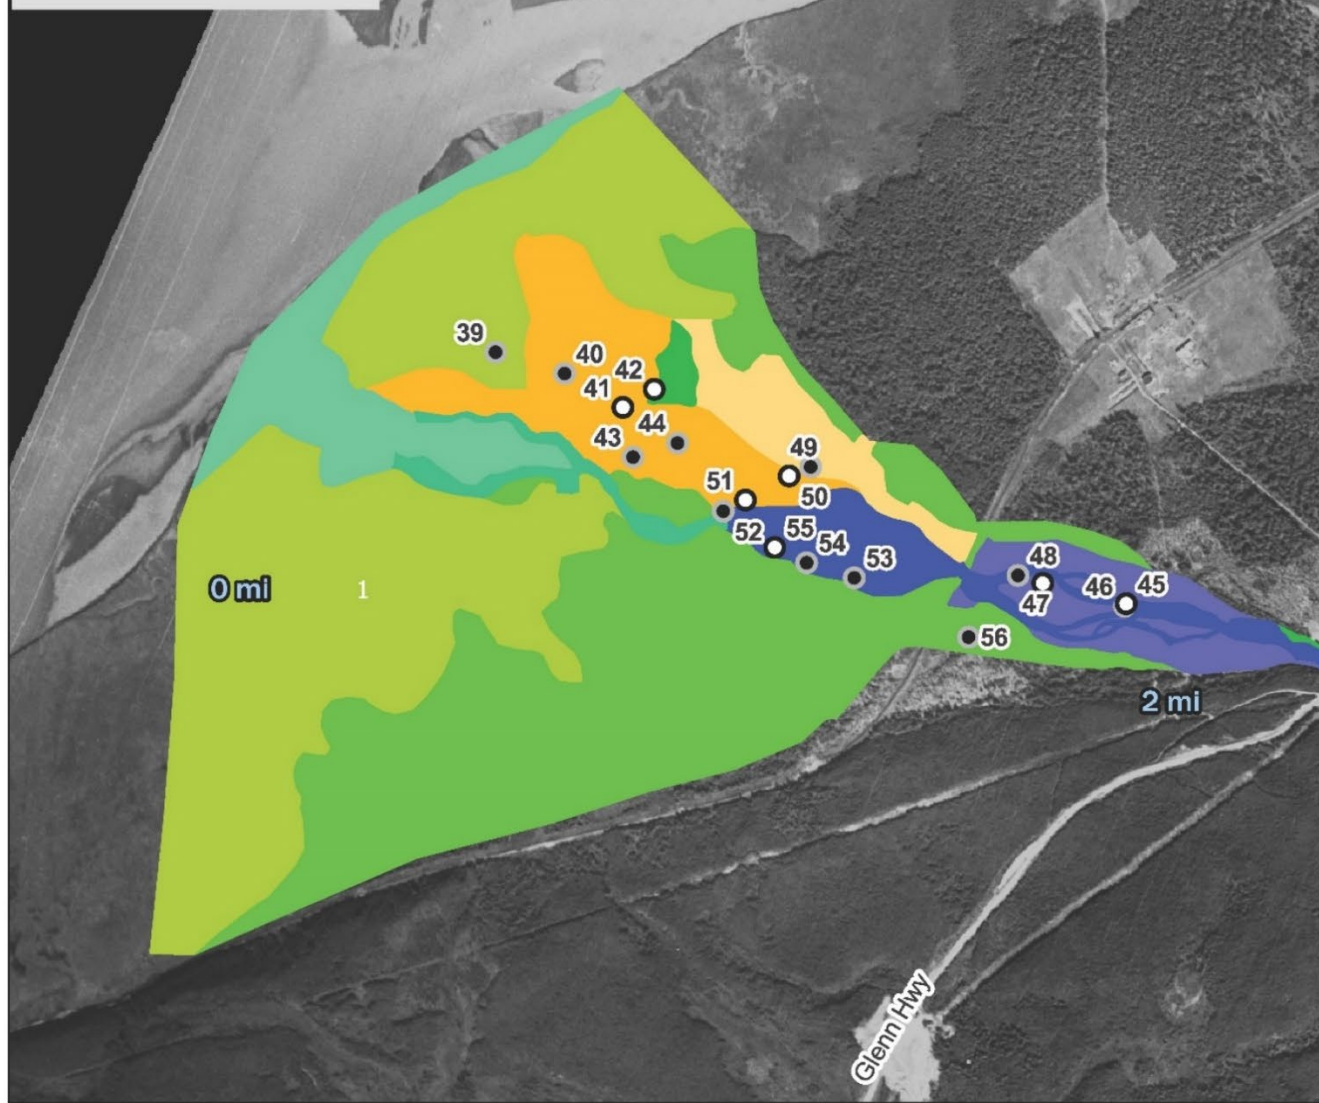
Tile 1. Historical

Appendix E: Wildlife habitats and wetland functional classes mapped from current (2022) and historical (1950) imagery in the Wetlands and Wildlife Habitat Study area, Eklutna Hydroelectric Project, 2022
