Eklutna Hydroelectric Project

Draft Summary of Study Results

October 2023

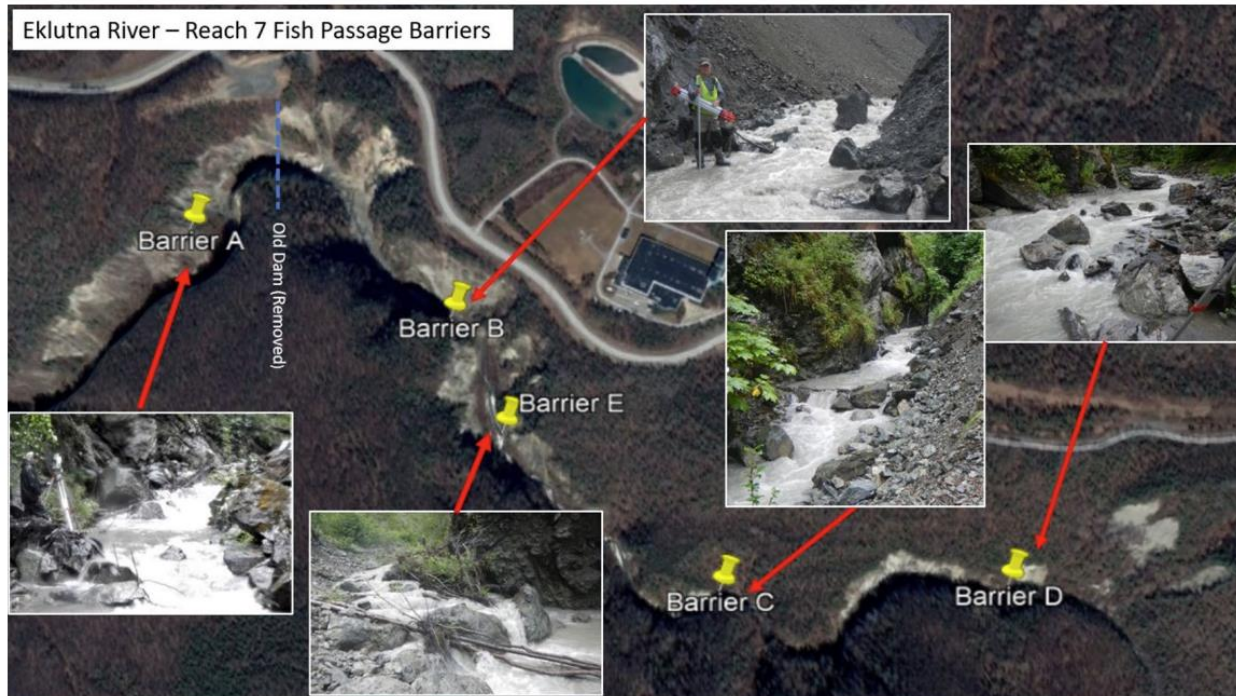
During field surveys, five potential passage barriers were identified within the canyon reach of the Eklutna River (Figure 2-4). Physical and hydraulic data were collected at each site in July 2022, and then a 1D hydraulic model was developed for each site. Depth and velocity criteria for Chinook, coho, and sockeye were applied to the hydraulic model outputs to define the minimum flows required for adult fish passage.

Figure 2-4. Potential passage barrier locations.

The analysis indicated that water depth (not velocity) is the major barrier issue at all five sites. The corresponding minimum flows to meet the fish passage requirements were determined at each site. Site B has the highest minimum flow requirement of 50 cfs. However, Site B is located within the sediment wedge (the remaining accumulated sediment behind the lower dam site) and is therefore very dynamic and likely to change. Sites A, D, and E have the next highest minimum flow requirement of 40 cfs.

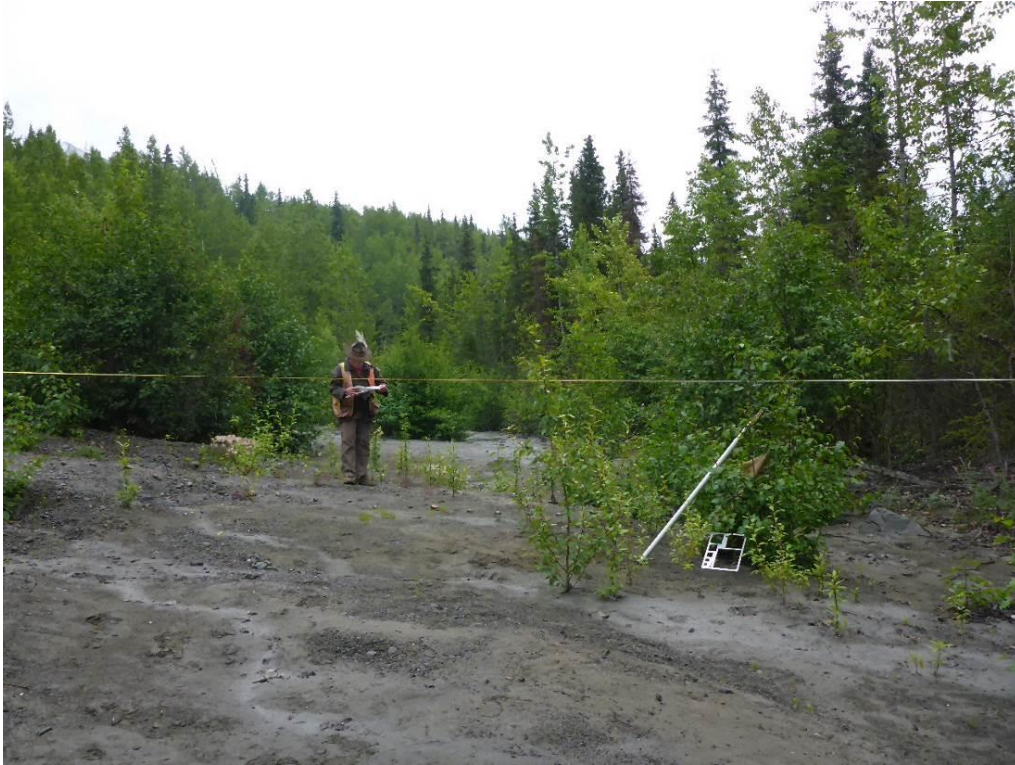
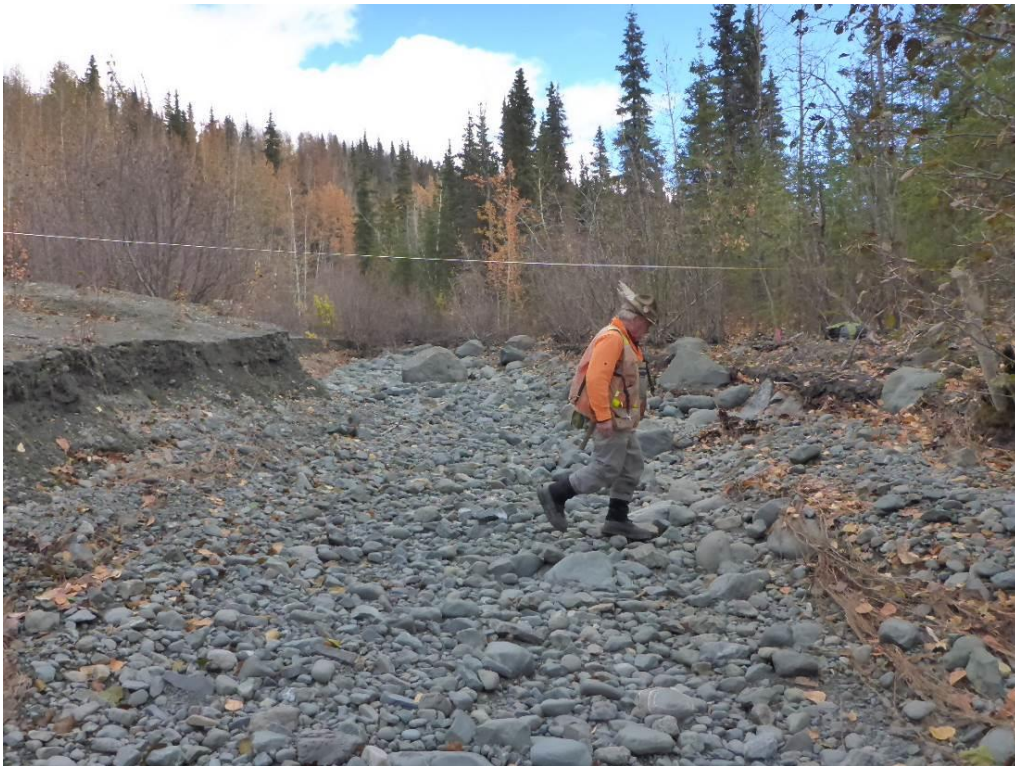
Figure 2-5. Geomorphic Monitoring Transect B before (top) and after (bottom) study flow release showing erosion of toe of alluvial fan deposits, re-establishment of river channel, and removal of accumulated fine sediment.

- Scour of accumulated fine-grained sediment and encroaching alluvial fan deposits to re-establish a stream channel (Figure 2-5);
- Changes in substrate from material too fine for anadromous fish spawning or rearing to substrate sizes suitable for anadromous fish use;
- Transport of up to 30,000 cubic yards of fine-grained material from behind the old lower dam site (RM 4) with up to 30 feet of downcutting;
- Erosion and deposition of up to 4 feet of sediment at other monitoring transects indicating bedload sediment was mobilized; and
- Transport of substrate particles up to 128 mm in diameter.

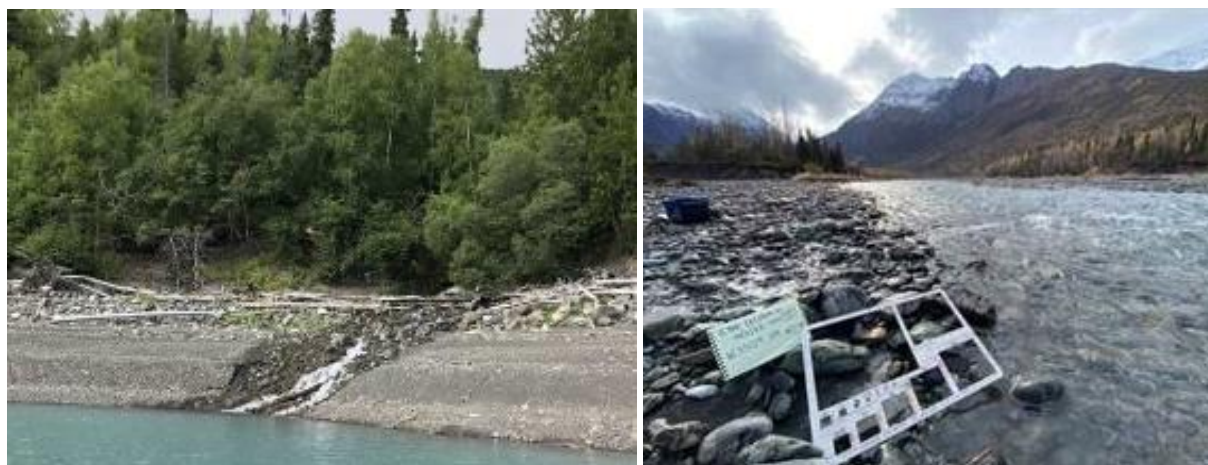
Most tributaries to Eklutna Lake are too steep to provide significant spawning or rearing habitat for ocean-run salmon or other large-bodied fishes (Figure 2-11, LEFT), though some of the lower reaches are used by small-bodied Dolly Varden for rearing.

Figure 2-11. (LEFT) Inaccessible entrance to a tributary on the northwest shoreline of Eklutna Lake. (RIGHT) Mainstem of the East Fork of Eklutna Creek.

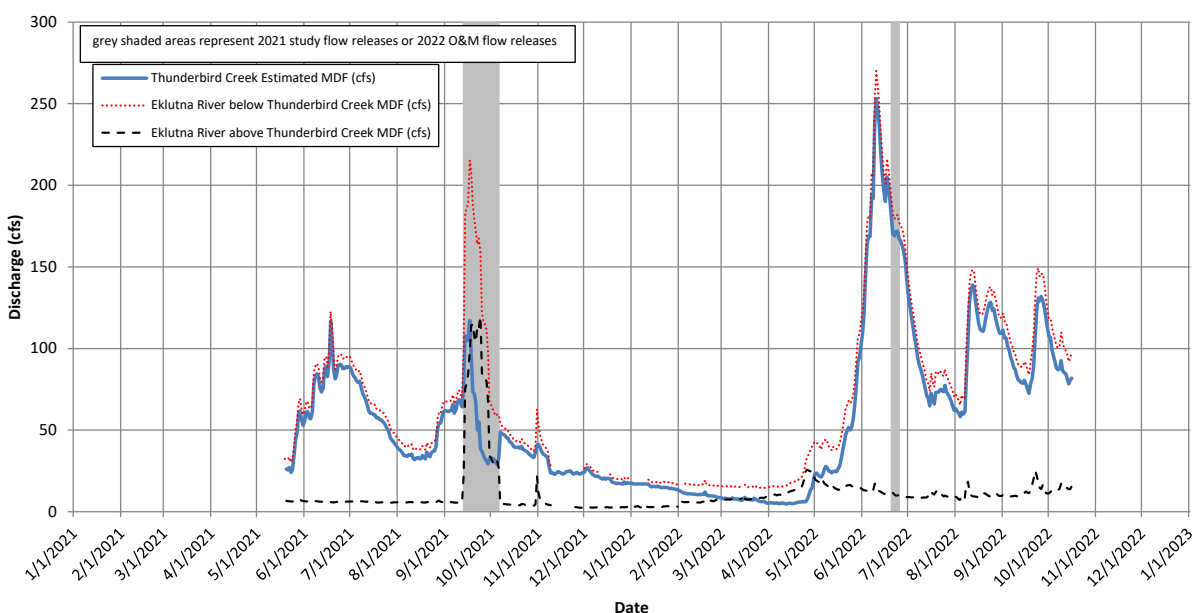
Thunderbird Creek flows were calculated by subtracting flows measured at the stream gage above Thunderbird Creek from the flows recorded at the stream gage below Thunderbird Creek. Figure 2-13 shows the daily mean discharge estimates for Thunderbird Creek in comparison to the two Eklutna River gaging stations. The grey shaded areas represent the 2021 study flow releases and the 2022 O&M flow release.

Figure 2-13. Thunderbird Creek estimated daily mean discharge vs Eklutna River stream gaging records, 2021-2022.

Overall, it is evident that Thunderbird Creek is the primary contributor of surface water discharge to the lower Eklutna River. Estimated mean daily flows for Thunderbird Creek are similar to those summarized by NVE in 2003 with peak mean daily flows occurring in the third week of June. Although the magnitude of peak Thunderbird Creek flows in 2022 are substantially greater than data from 2021 and NVE (2003), the time series hydrograph pattern

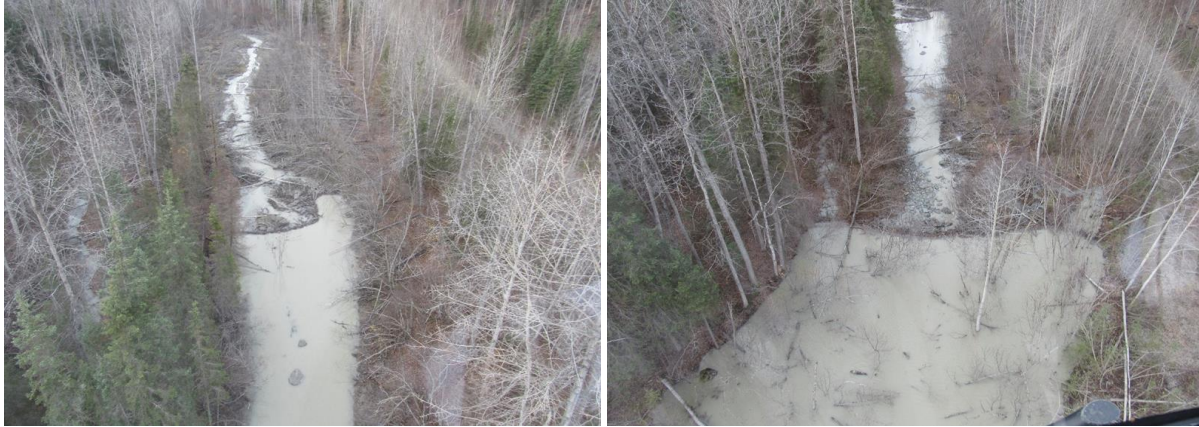
Figure 2-17. Active Dam-07 (LEFT) and Active Dam-08 (RIGHT) in the middle river colony.

During the ground-based survey, no beavers were observed at the middle river colony. The two dams farthest downriver were estimated at approximately six feet tall and looked like potential barriers to adult fish passage, though juveniles may be able to pass through. No signs of rehabilitation of the dam or lodge were evident at the former upper river colony.

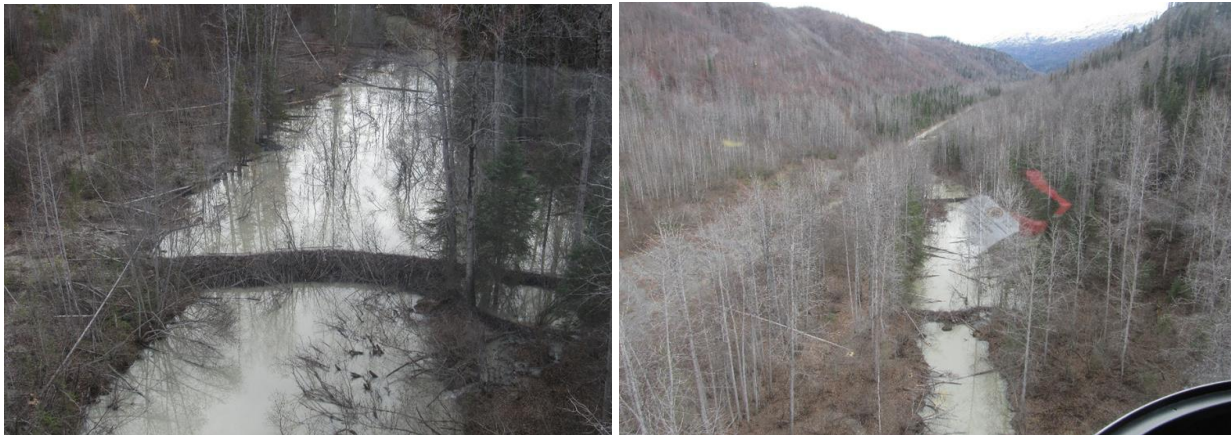
Figure 2-18. Active Dam-09 (LEFT) and Active Dam-10 (RIGHT) in the middle river colony.

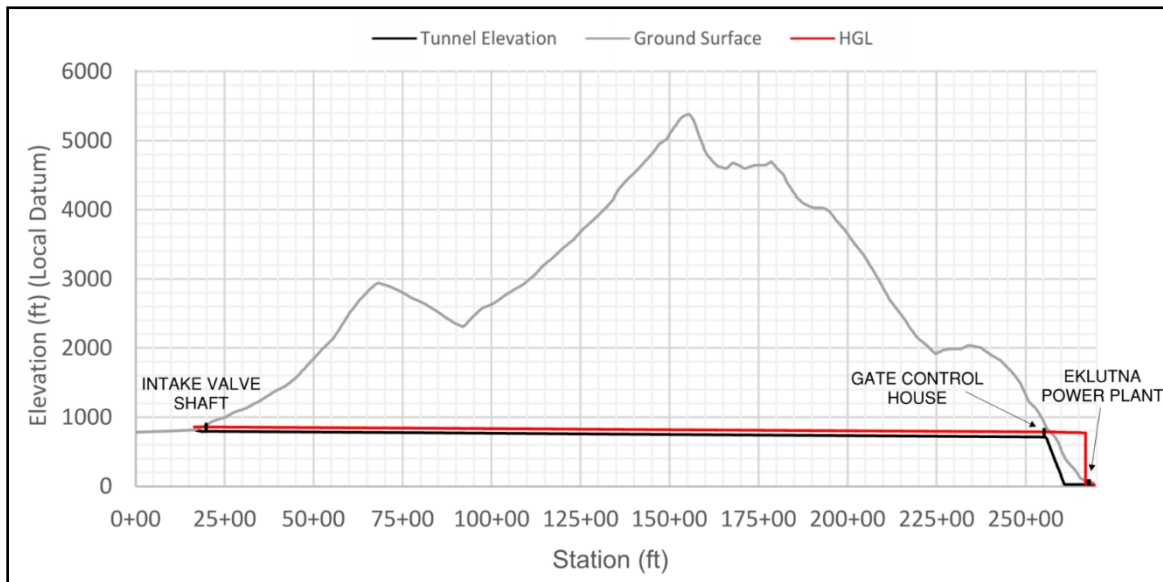
A hydraulic model was developed of the intake and power conduit to determine friction losses as a function of flow rate through the conveyance. Minor losses were included at the trashrack, each pipeline bend, each reduction in conveyance diameter, at the turbine bifurcation, valve, and turbine draft tube. Major friction losses were determined throughout the power tunnel and penstock. The hydraulic grade line represented on the tunnel elevations throughout the power conduit is presented in Figure 2-23.

Figure 2-23. Eklutna Power Conduit Hydraulic Grade Line (HGL).
