REHABILITATION OF EKLUTNA PROJECT FEATURES FOLLOWING EARTHQUAKE OF MARCH 1964

EKLUTNA DAM, TUNNEL AND POWERPLANT
TECHNICAL RECORD OF DESIGN AND CONSTRUCTION, MARCH 1958

Constructed 1951-1955
Rehabilitated 1964-1965

Eklutna Project
Alaska

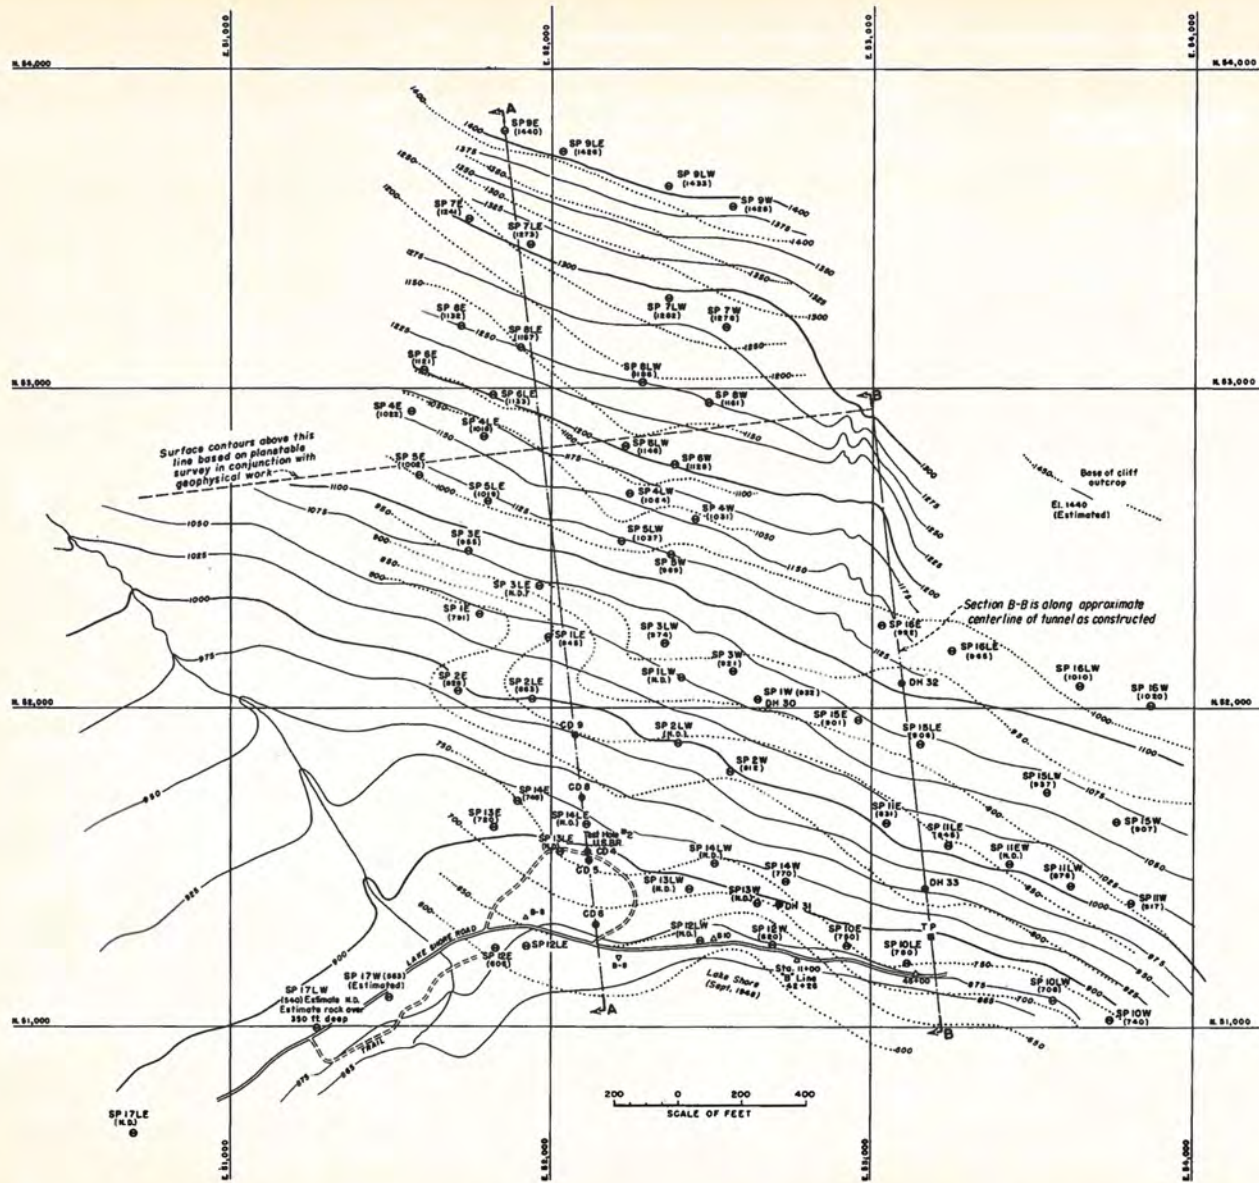
(a) *Intake Structure.* --Surface topography and bedrock contours obtained in 1951 from seismic data in the vicinity of the intake structure are shown on figure 10. Although foundation conditions in the area of the intake structure and conduit were well documented during the original investigations in 1951, three additional holes (DHI-10, -11, and -12, see fig. 11) were drilled along the conduit line in September and October 1964 in an effort to detect possible fracturing or shattering of the compact glacial till as a result of the earthquake. This exploration revealed no significant changes in the till foundation, and no evidence of foundation failure was observed during excavation for the new structure. Absence of structural damage to the existing intake structure and conduit segments is indicative that the glacial till foundation itself did not fail during the earthquake, but consolidation of the bedding material under these structures resulted in a horizontal movement toward the lake accompanied by a lesser amount of vertical displacement.

Figure 10. --Bedrock contours from seismic data for intake area, as obtained in 1951. From drawing No. 783-908-3.

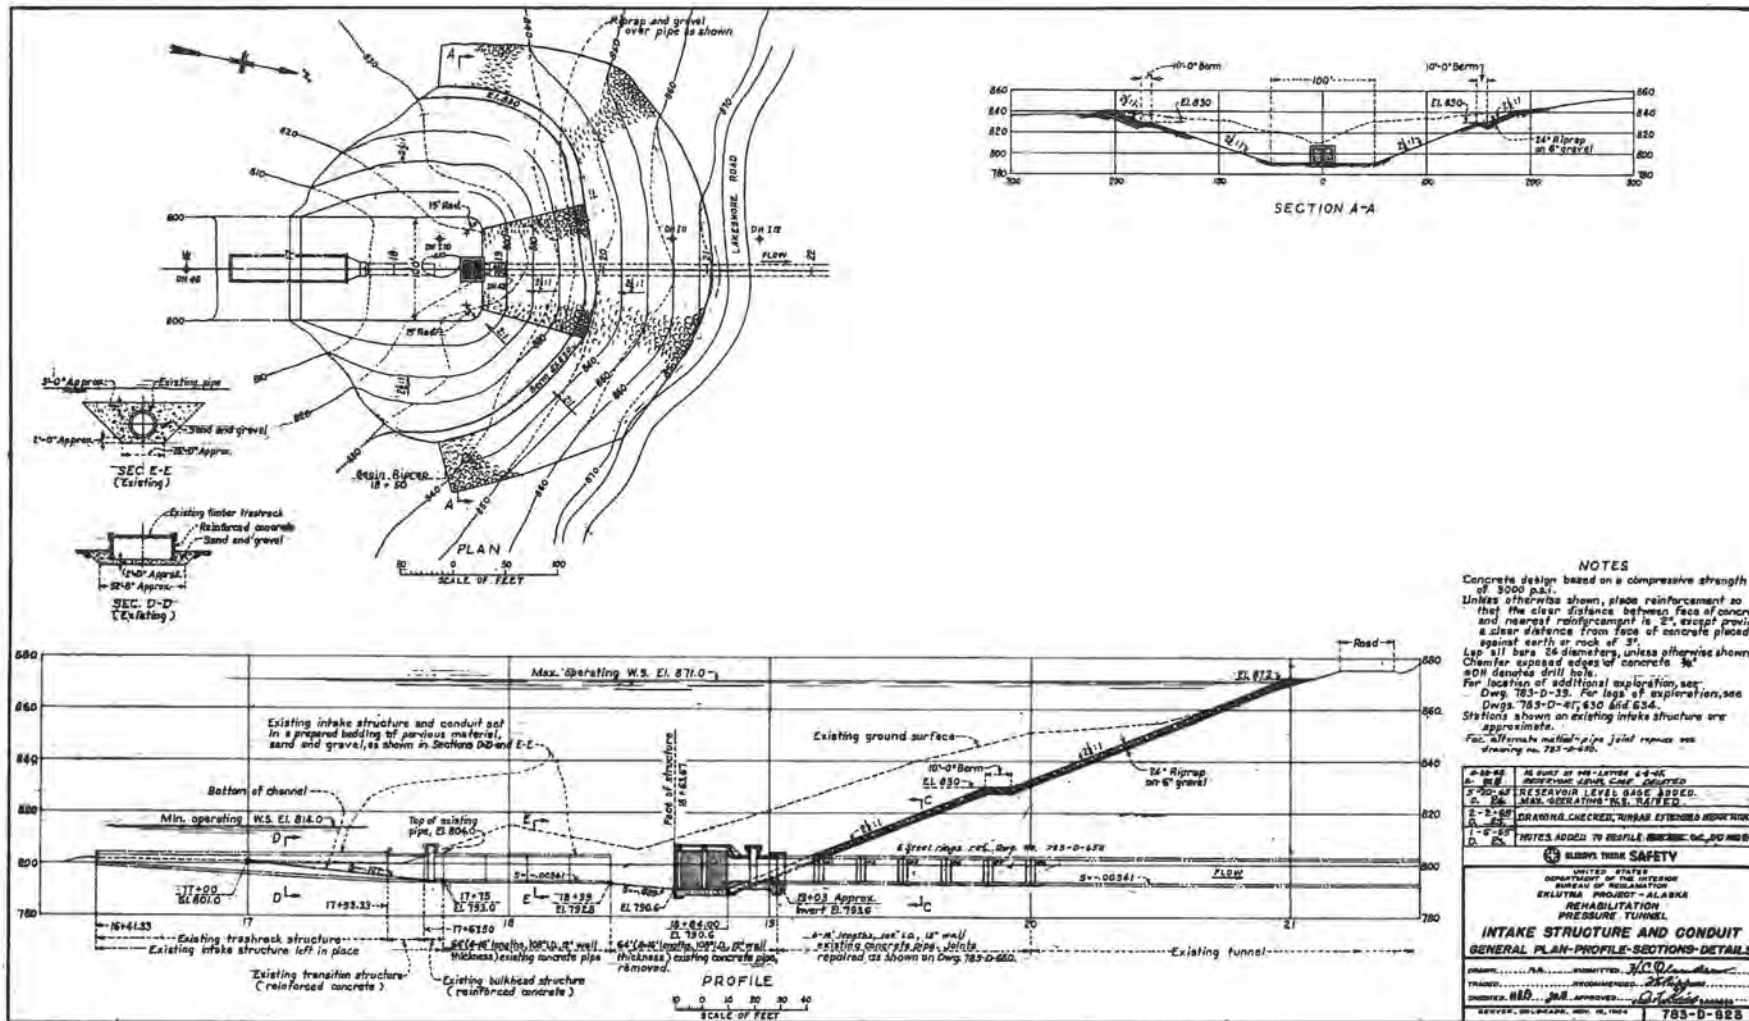
Figure 15. -- Plan and elevation of new intake structure and rehabilitated conduit. From drawing No. 783-D-623, revised June 30, 1965.

The specifications contemplated that the joints would be repaired by encasement in concrete collars, and a sketch illustrating the proposed repair of these joints by this method is shown as figure 19. Subsequent to preparation of specifications No. DC-6212, however, an alternative method was approved for repair of the conduit joints as discussed below. This method was permitted because it was believed to be more economical and would require less time than the originally specified method, and time was a very important consideration.

The alternative method consisted of the installation of expandable stainless steel rings inside the pipe at the joints. The rings were 1/2 inch thick and 20 inches wide. One-inch bolts with four nuts and beveled washers were provided to expand the ring against the inside of the pipe; and after expansion the rings would be welded in place. Irregularities between the rings and the inside of the pipe were to be filled with dry-pack mortar. The alternative method is illustrated in figure 20. Specifications for repair by this method were issued concurrently with specifications No. DC-6212 as supplemental notice No. 1. The contractor elected to use this alternative method as discussed in section 60.

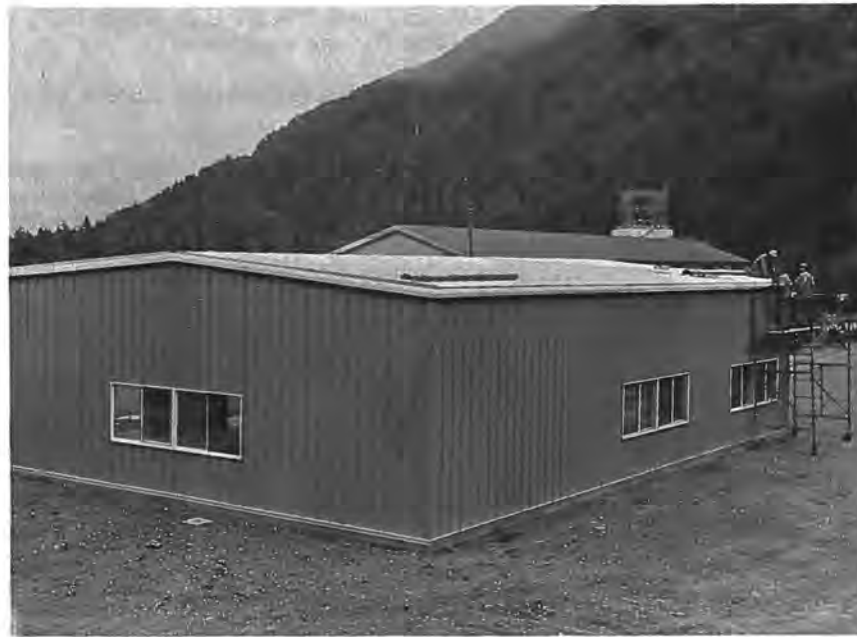
The garage which the new automotive repair shop replaced, spanned a subsidence crack and incurred major damage in the earthquake. The new structure (fig. 31) was therefore moved away from this crack and rotated in a direction similar to that of the warehouse. Work under the contract started June 2 with excavation for the sewerline. The excavated materials were moved to the building site area. The concrete footings were placed and after a delay due to late receipt of the heating cable the floor was constructed. Progress was very sporadic due to delays in receiving materials. The prefabricated steel building was received early in August and erected promptly. Other materials including overhead lights and interior partitions were received late in October, but installation was slow. Interior painting and installation of the overhead doors were delayed and there was a rush to complete all work during the remaining days of the contract period. All work under the contract was accepted as complete on November 10, 1965.

Figure 31. --New automotive repair shop. P783-908 C&R-192A, September 3, 1965.

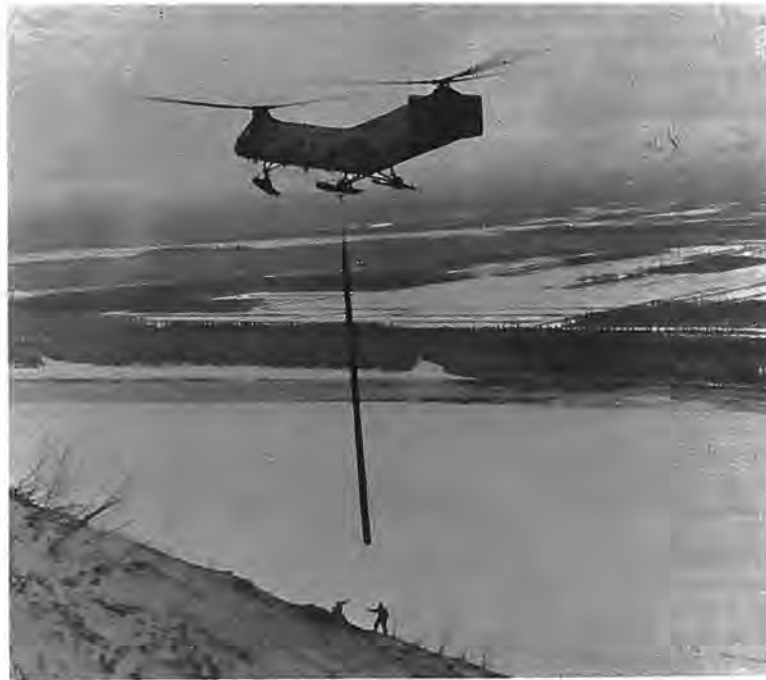
Figure 34. --View of helicopter assisting in reconstruction of 115-kilovolt transmission line. An Army helicopter crew cooperated with Bureau of Reclamation and Matanuska Electric Association line crews in rebuilding a section of the 115-kilovolt line which was swept away by a snowslide released during the earthquake. P783-906-2312, April 3, 1964.

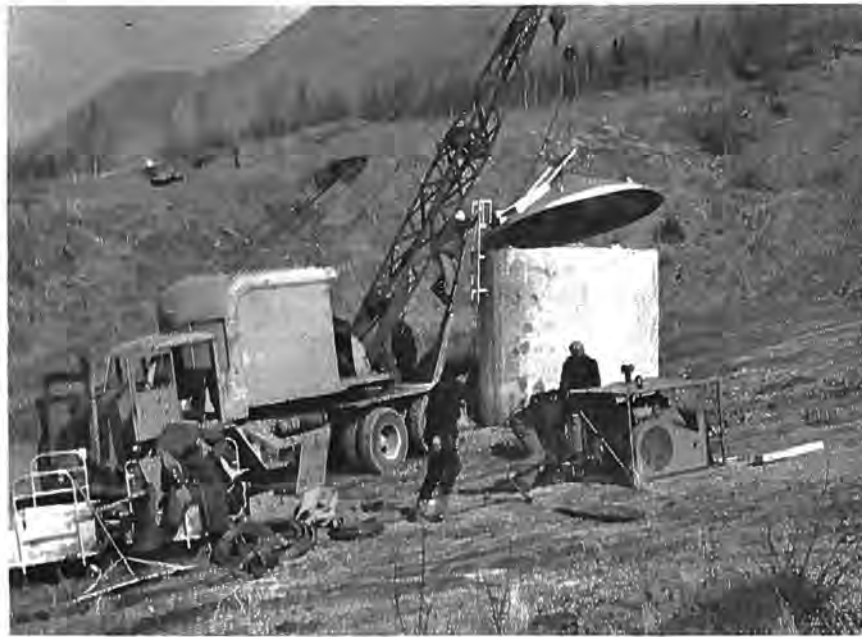
On May 9, 1964, the Eklutna Powerplant was shut down and preparations for unwatering of the tunnel began. Divers were sent into the headgate shaft before the gate was lowered to determine the condition of the gate slot (see fig. 35). The divers found deposits of sand and rock, 1 to 2 feet in depth, both upstream and downstream of the gate as well as at the gate pocket. Divers working in 40 feet of water required approximately 12 hours to clear the gate so it could be seated.

Figure 35. --Bureau and contractor personnel lowering diving gear into headgate shaft in preparation for investigation of conditions in and around the headgate seat prior to unwatering tunnel. P783-906-2319, May 9, 1964.

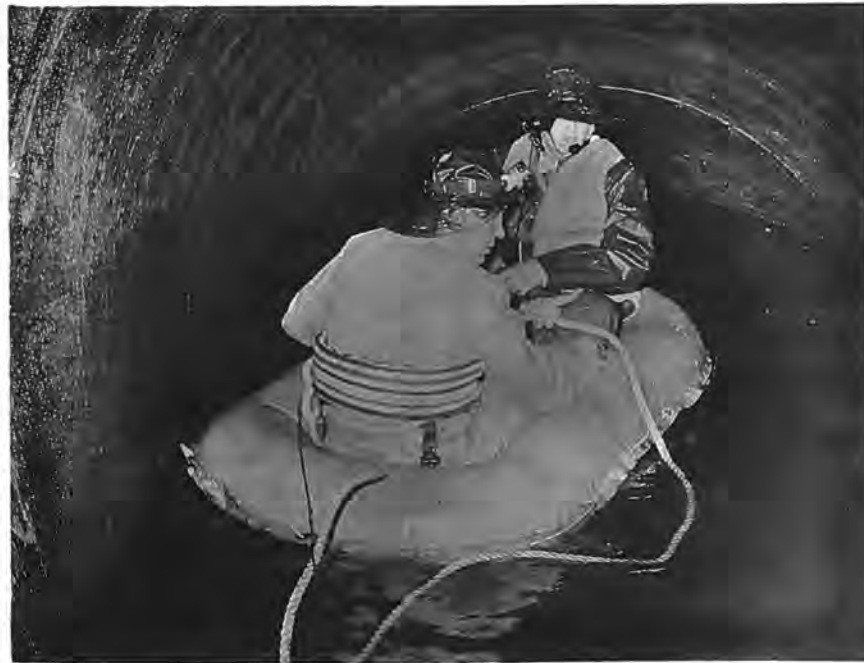
(b) *Inspection of Penstocks.* --On May 18 a representative from the Denver office and the Alaska District Manager made an inspection of the penstock from the base of the surge tank, elevation 716.67, to the powerplant at elevation 24.0. This 863-foot length of penstock slopes at an angle of 53° with the horizontal making an inspection difficult. A rather unique method of descending through this 6-foot-diameter pipe was devised. The penstock was filled with water, using the tunnel leakage water, and after it was filled, the leakage was diverted out through the adit tunnel door and a two-man liferaft was floated down the penstock (see fig. 36). The desired rate of descent of the raft was controlled by releasing water from the penstock by use of the butterfly valves, wicket gates, and drainlines. Instructions to obtain the desired water discharge were given from the raft to the plant by a combination of telephone and radio. The entire penstock from the tunnel to the generating units appeared to have been free from any permanent deformation caused by the earthquake. Fineline cracks in the overlapped painted surfaces at the coupled sleeve joints did, however, indicate that unusual pipe vibration had occurred.

Figure 36. --A two-man rubber raft being used for internal inspection of the 863-foot-long penstock which slopes at an angle of 53° with the horizontal. Descent of the raft was controlled by releasing water from the penstock drainlines. P783-906-2315, May 18, 1964.

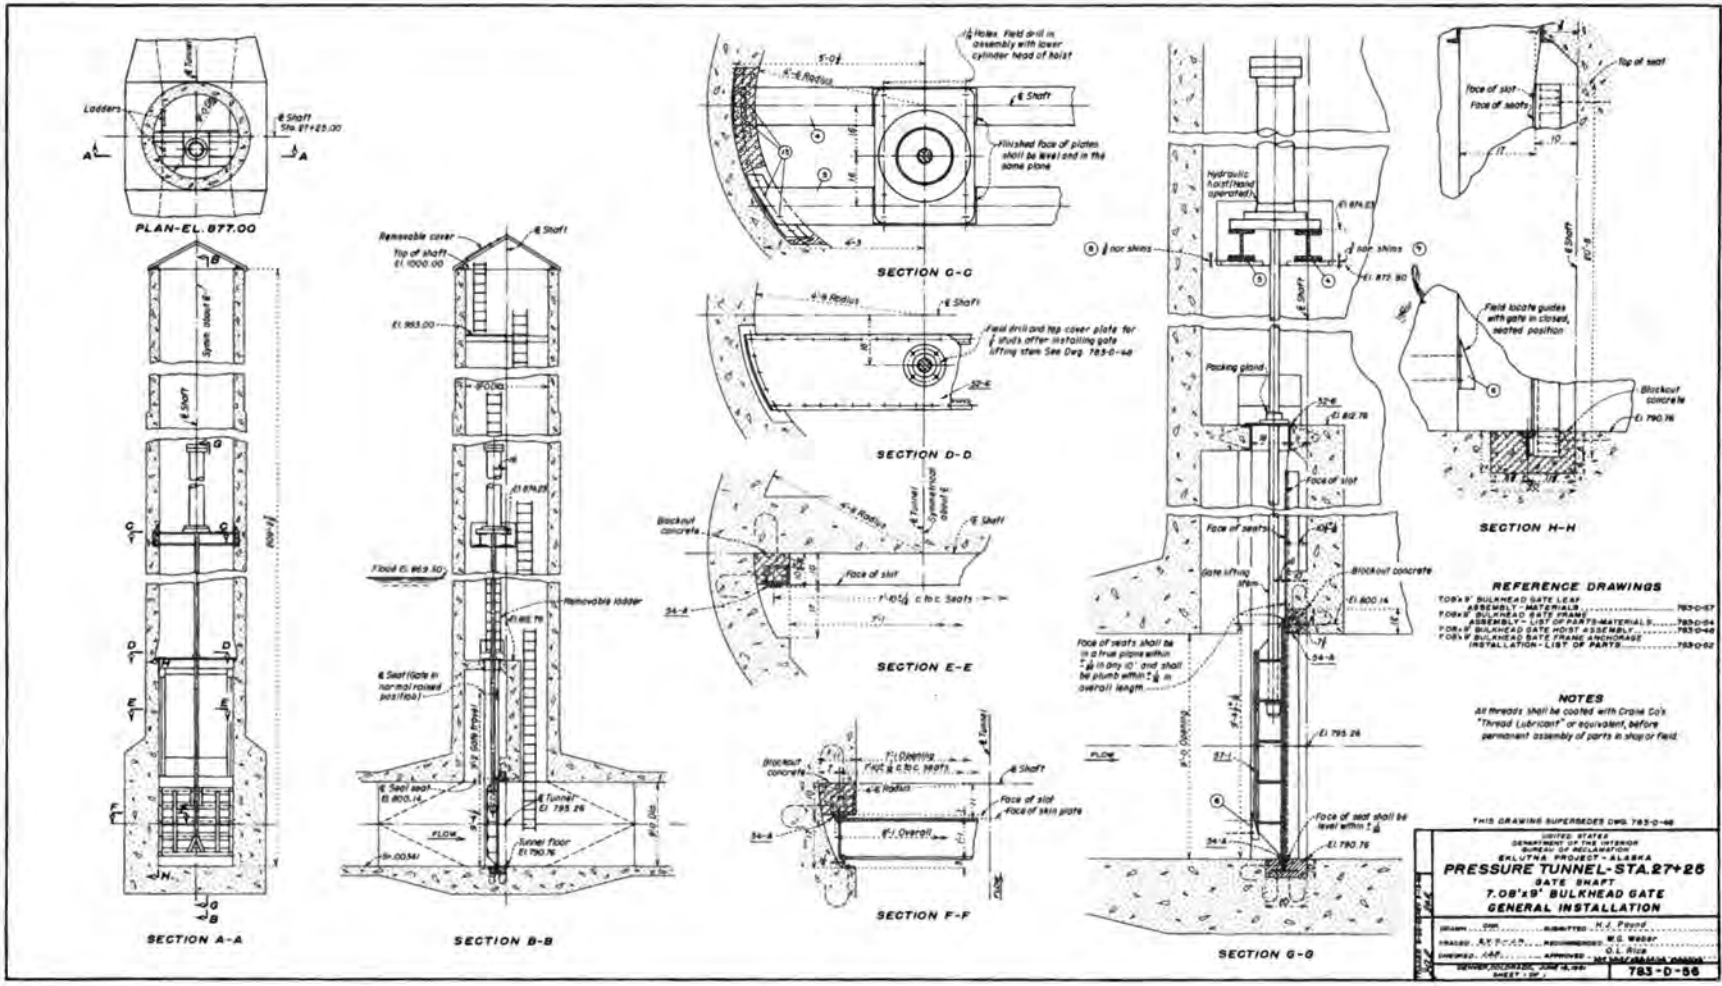
Figure 39. --General installation of bulkhead gate in pressure tunnel--Station 27+25 (gate shaft).

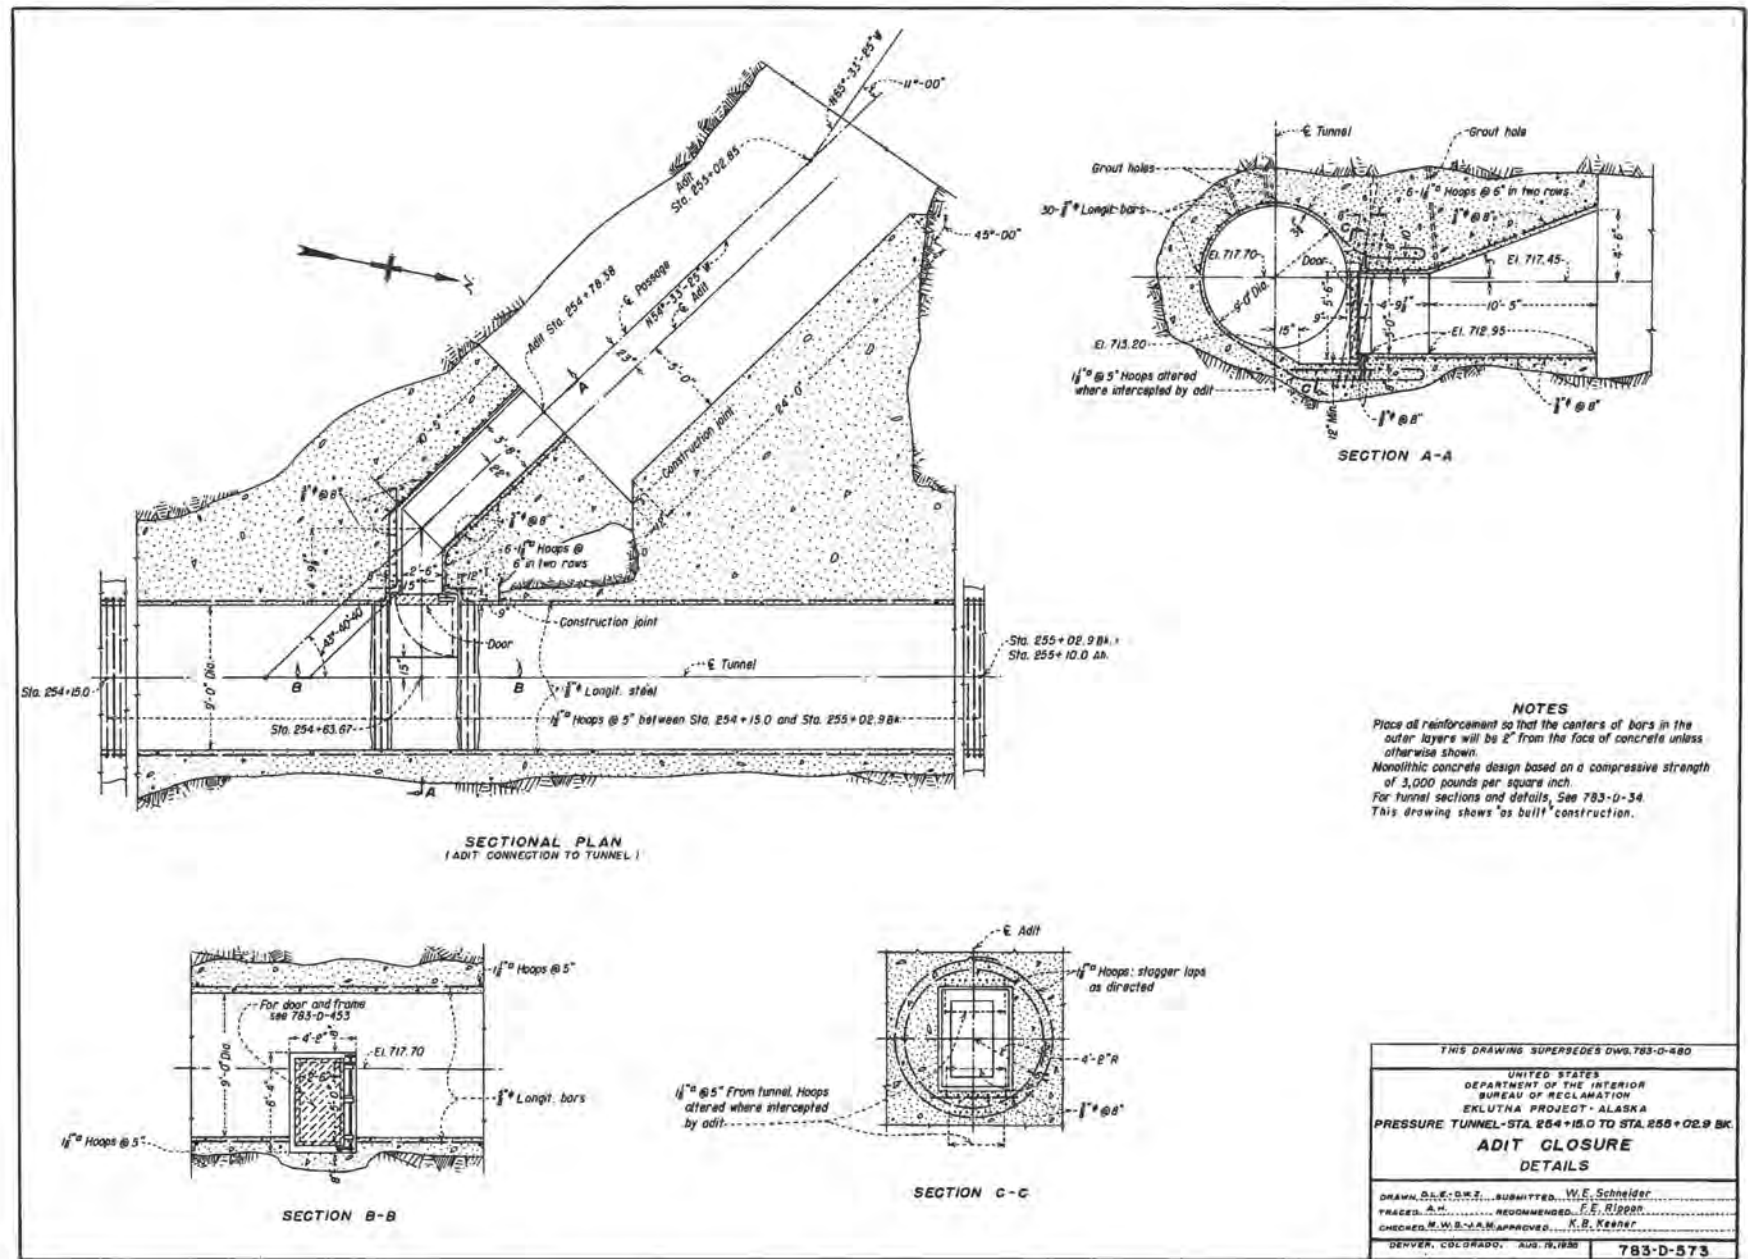
Figure 40. --Details of adit closure for pressure tunnel--Station 254.15 to station 255.02.9 Bk.

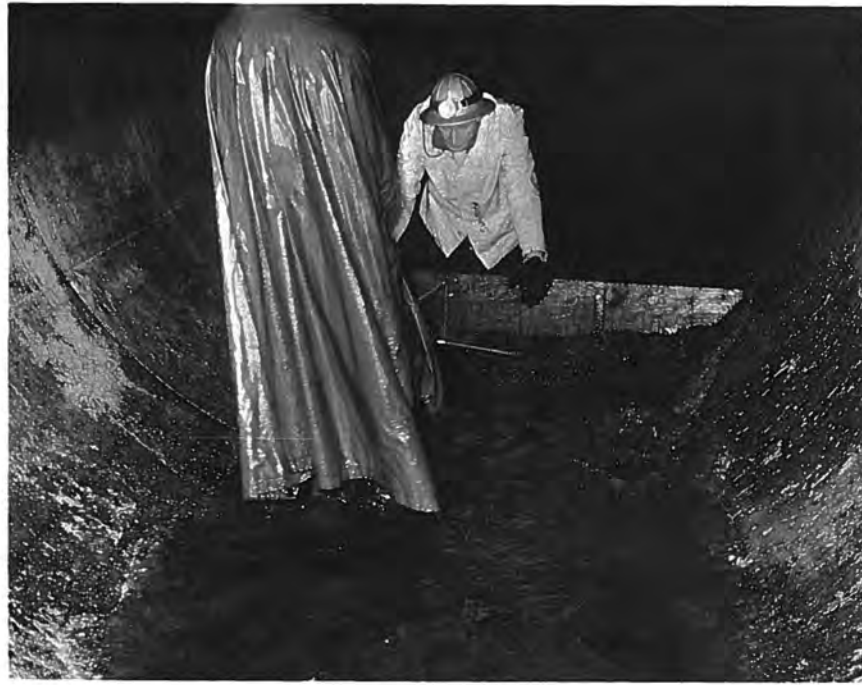
Figure 41 shows a movable plywood dam being used to cause the head developed by the leakage water to move debris toward the adit.

Figure 41. --View of tunnel mucking operation by Bureau force-account employees. Sand and rock is being moved toward the adit tunnel by means of a movable plywood dam utilizing the head developed by the leakage water to assist motivation. P783-906-2326, May 1964.

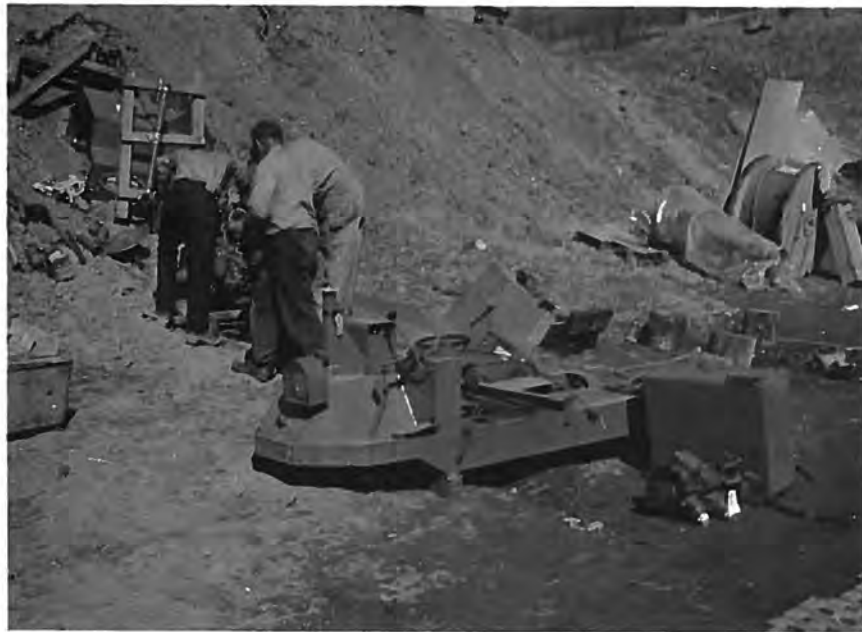
Figure 42. --View of diesel-powered 1-1/2-cubic-yard haul unit being dismantled prior to lowering it into the tunnel through the headgate shaft. P783-906-2343, June 1964.

which could be passed through the narrow space at the bottom of the headgate shaft (see figs. 42 and 43). Bureau force-account crews were withdrawn for work in the tailrace and other critical areas after having reached station 32+00 from the headgate end and station 189+00 from the adit door end of the tunnel. (See fig. 4.)

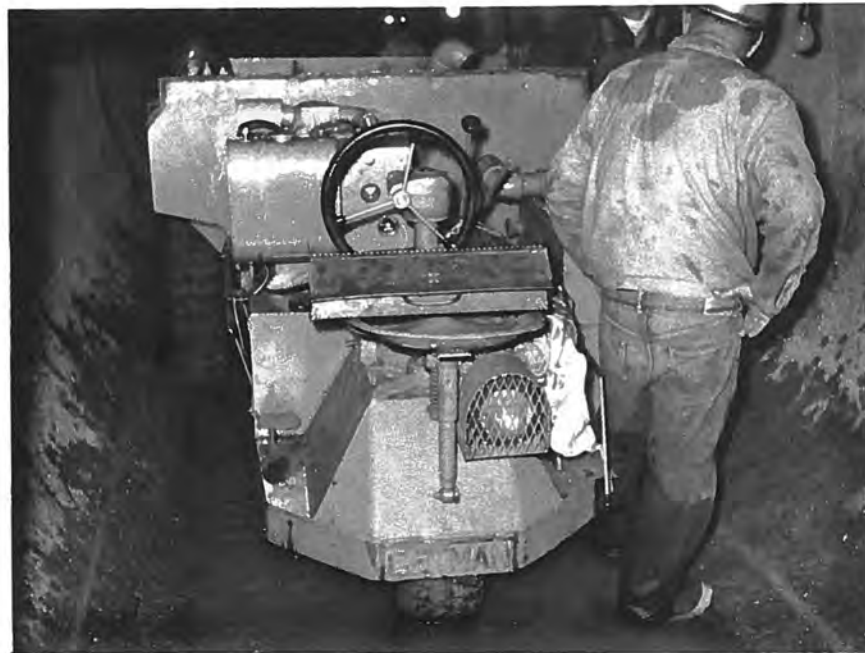
Figure 43. --View of the haul unit being reassembled in the 9-foot-diameter tunnel.
P783-906-2344, June 1964.

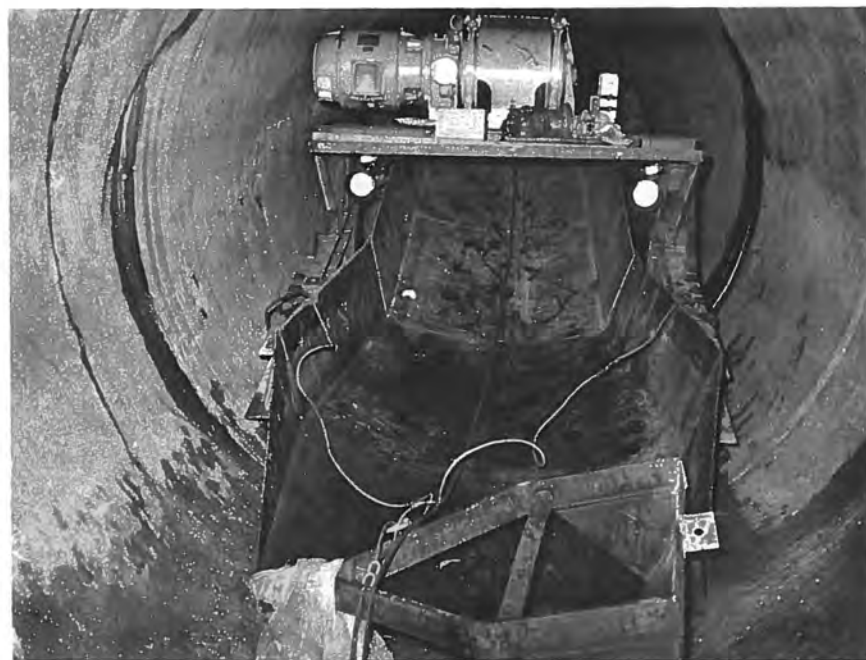
Figure 44. --View of loading chute and drag bucket of the 15-horsepower electric slusher unit used by the contractor to remove accumulated gravel from the pressure tunnel.
P783-906-2349, June 1964.

The contractor's mechanical mucking operations were accomplished using a diesel-powered 1-1/2-cubic-yard haul unit and a slusher and drag-bucket combination (see figs. 44 and 45). The empty drag bucket was drawn into the gravel debris by a cable attached to a gin pole which was jacked against the sides of the tunnel. The loaded drag bucket was drawn into the loading chute of the slusher unit, which discharged the material into the haul unit. The haul unit then delivered its load upstream to the headgate shaft where the rock was lifted to the surface in a 3/4-cubic-yard bucket by a 45-ton motor crane.

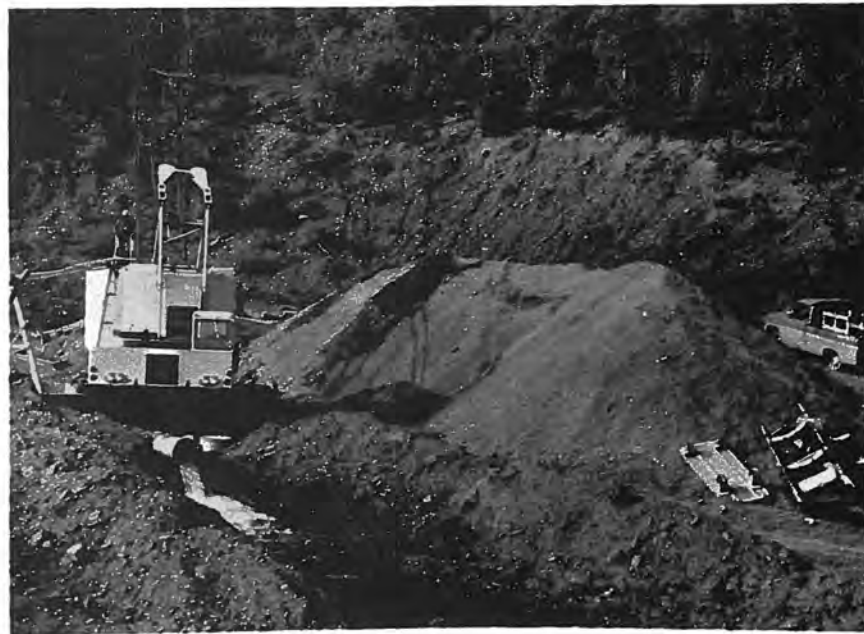
Figure 46. --View showing the second of two approximately equal piles of sand and rock removed through the headgate shaft during tunnel mucking operations. The water spilling from the pipe at the left is the discharge from a high-lift pump installed behind the gate shaft and represents the leakage through the headgate seals. P783-906-2355, June 1964.

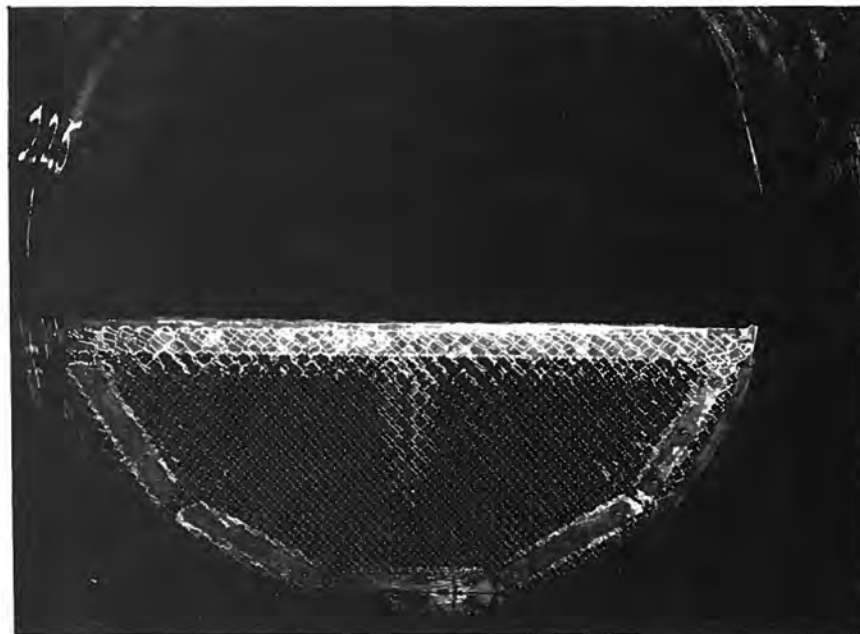
Figure 47. --View of the second of three 4-foot-high screens installed at intervals of approximately 100 feet below the headgate. The screens were installed by the contractor after the sand and rock was removed from the 4-1/2-mile tunnel. They were designed to stop the rock which remained in the tunnel between the headgate and the trashrack and which could not be readily removed by divers. P783-906-2356, June 1964.

Following final cleanup and demobilization of the mucking equipment, three heavy chain link screens 4 feet high were installed at approximately 100-foot intervals downstream from the headgate. Each screen was made up of 2-inch mesh wire with an additional strand interwoven to reduce the effective opening to 1 inch. (See fig. 47.) The headgate was partially opened until the tunnel and penstock were filled and then immediately closed and the tunnel dewatered sufficiently to permit examination of the screens. No rock had collected at the first screen at station 28+50, although the wire mesh was bulged somewhat, indicating there had been some impact. One to two cubic yards of rock were found deposited behind the second screen at station 29+50, but nothing was found to have lodged on the third screen at station 30+50.

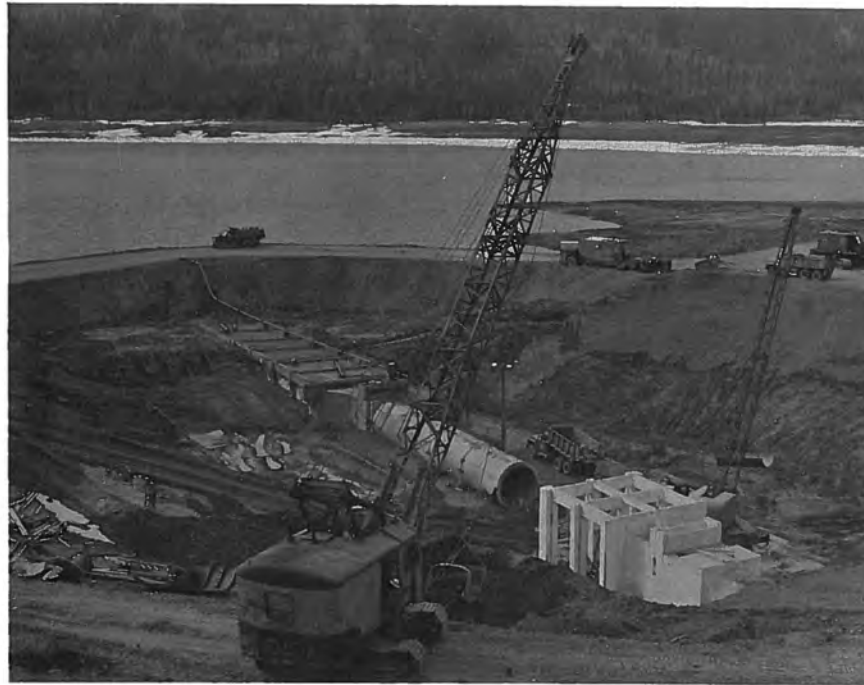
Figure 51. --General view of abandoned intake structure and conduit in the background and new intake structure nearing completion in the foreground. P783-908 C&R-54A, April 28, 1965.

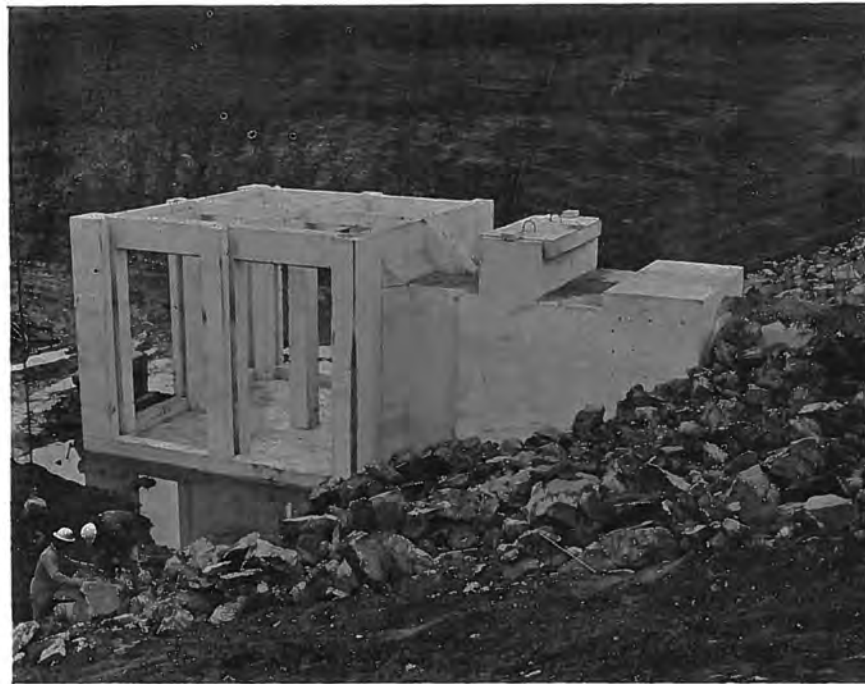
Figure 53. --New intake structure with concrete work completed and ready for installation of trashracks on the top, sides, and front. P783-908 C&R-65A, April 30, 1965.

Concurrently with the work on the conduit, forms for the intake structure were prefabricated and were set in place on April 12. Also, the reinforcing steel was erected and concrete was placed in the base and the remainder of the intake structure (fig. 53). The trashracks arrived and were installed by April 30. Figure 54 shows the completed intake structure in front of the abandoned portion of conduit and the original intake structure.

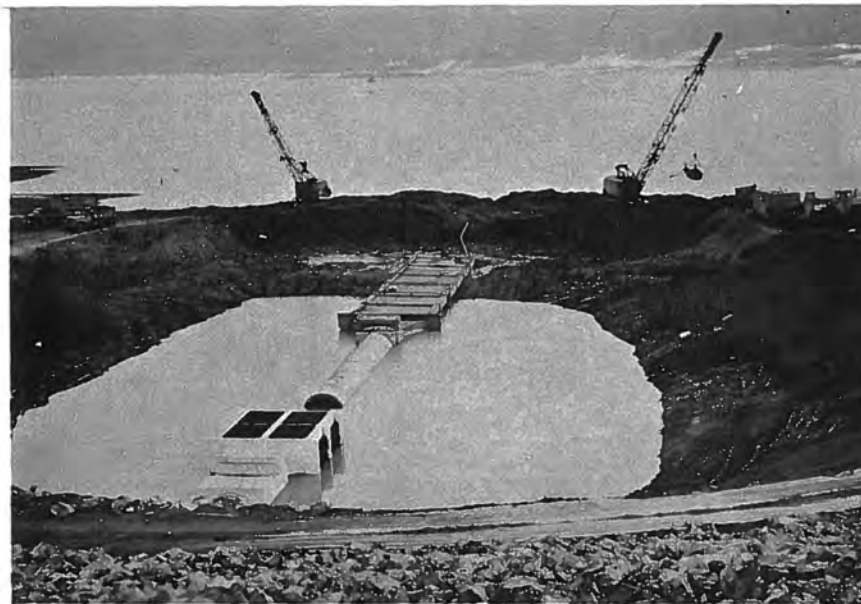
Figure 54. --Completed new intake structure in front of abandoned portion of conduit and old intake structure. P783-D-48322NA, May 3, 1965.

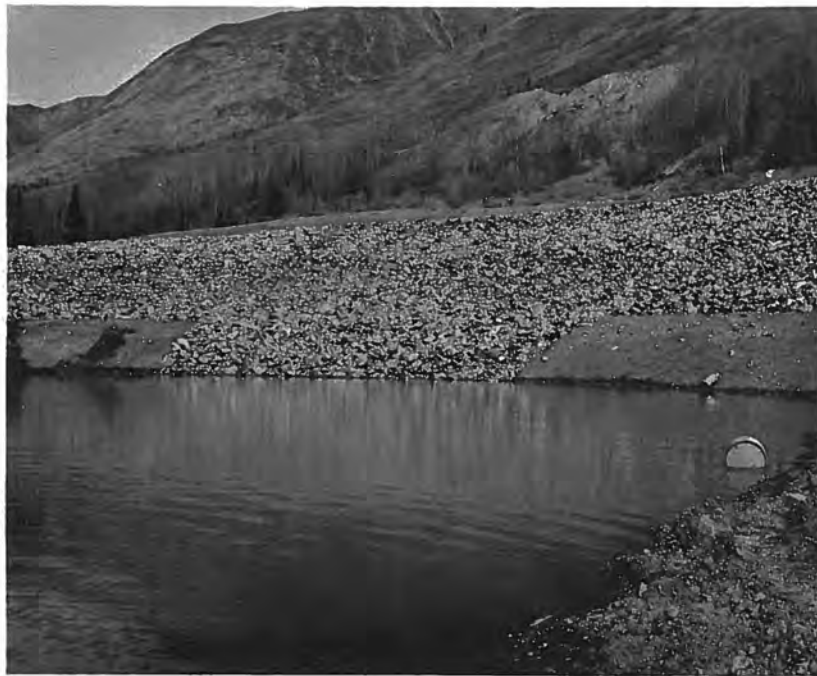
Figure 55. --Completed riprap in place on the backslope to the new intake structure. P783-908 C&R-83A, May 18, 1965.

Final grading and placement of bedding and riprap below elevation 820 (along the slope of the bank above the inlet as seen on figure 55) was accomplished concurrently with the concrete work for the intake structure. The bedding material was obtained from a pit located about 900 feet to the right, or southeast of the tunnel centerline along the lakeshore road. Riprap rock was obtained from a source about 1 mile east of the intake along the lakeshore road.

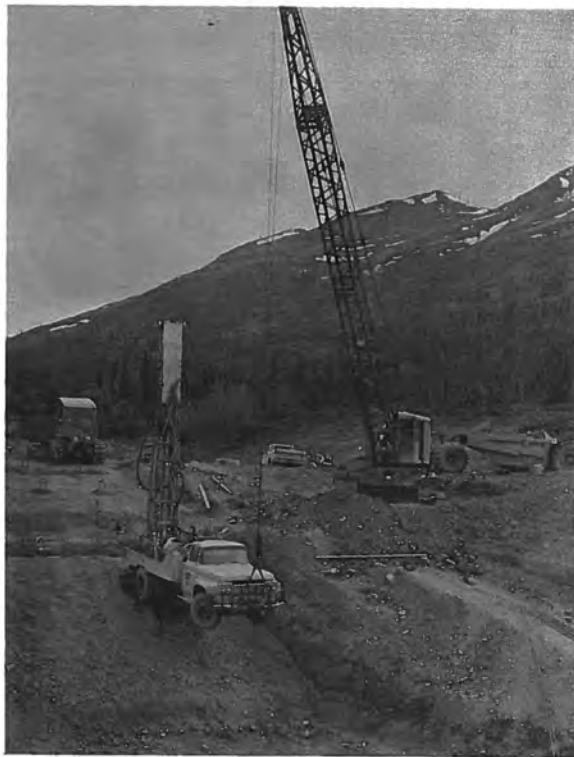
Figure 61. --Drill rig supported by motor crane while drilling holes for anchor bars on the spillway. P783-908 C&R-142NA, June 25, 1965.

at drilling the anchor bar holes with a piledriver, the contractor subcontracted this work to United Geophysical Co., who performed the work with a truck-mounted rig using a rotary bit. Work began on June 7 and was completed by June 30, 1965. To expedite the work, a crane was used to support the rig while drilling holes on the slope. (See fig 61.) Since only a short period of time was needed to drill each hole, this procedure saved considerable time which might otherwise have been required for blocking up the rig before each drilling operation. The prime contractor installed the 130 anchor bars and performed the grouting operation. The bars were 1-3/8 inches in diameter and ranged from 13 to 16 feet in length. (See fig. 62.)

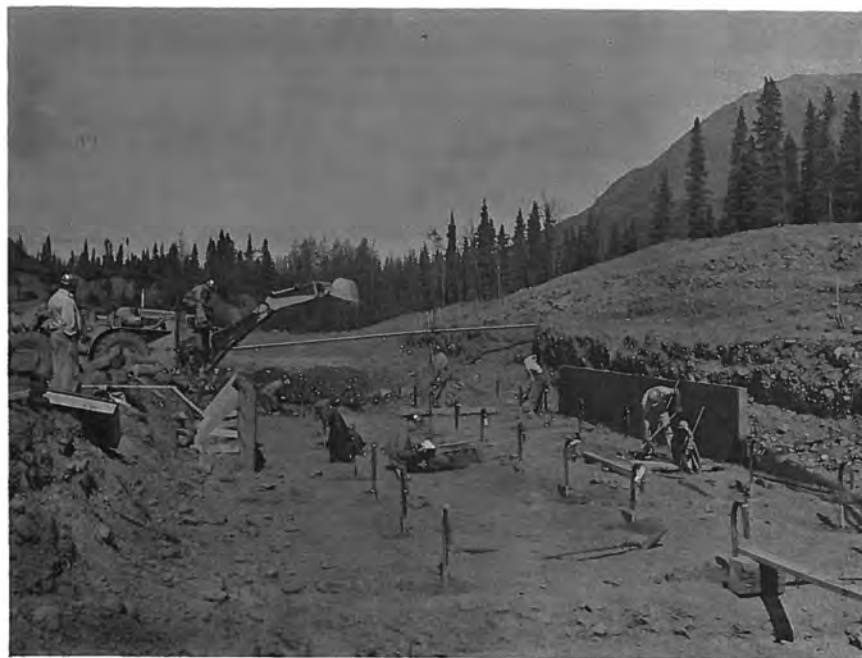
Figure 62. --Anchor bars in place on the spillway structure subgrade. P783-908 C&R-113A, June 10, 1965.

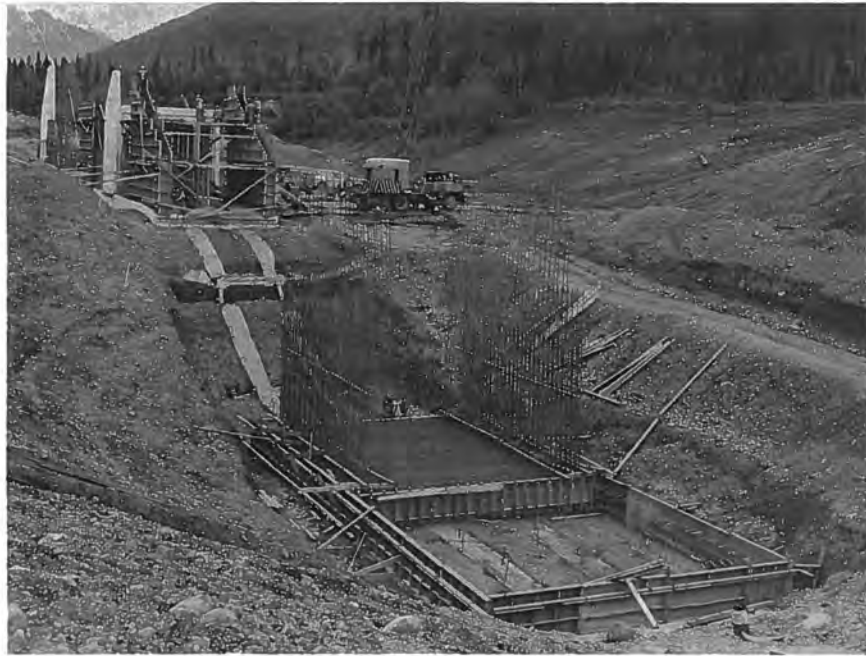
Figure 63. --Forming and steel reinforcement in the spillway stilling basin. P783-908 C&R-158NA, July 23, 1965.

72. Forms and Reinforcing Steel. Forms for the spillway were constructed using 4- by 8-foot panels constructed of 2- by 6-inch studs placed on 16-inch centers with 3/4-inch plywood facing. (See fig. 63.) Carpenters placed sections of these forms by nailing them to each other. Walers were then applied to line up and strengthen the forms. This practice did not require the continuous use of a crane during construction of the forms, as carpenters could move small panels into place manually except on the higher portions of the structure. Erection of forms for the first placement of concrete on the spillway began on June 10, 1965, in the first upstream floor section.

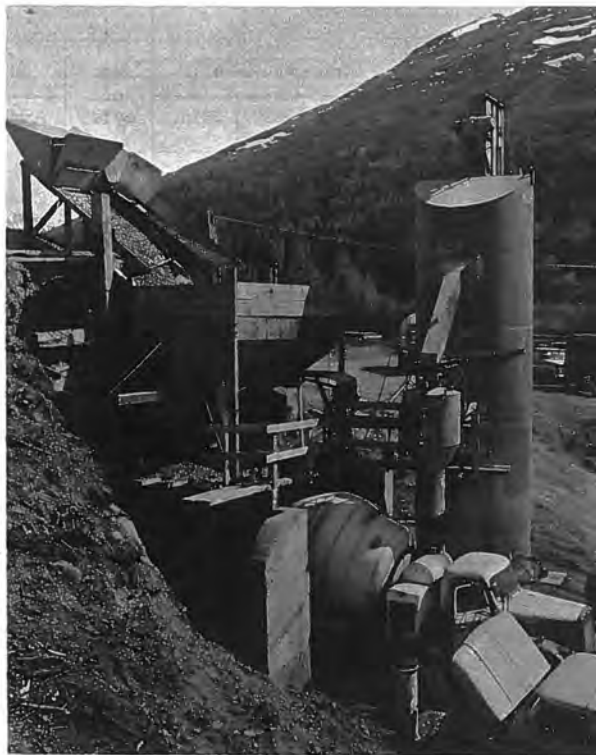
Figure 64. --Contractor's batching plant located at the damsite. P783-908 C&R-130A, June 16, 1965.

73. Concrete Control. (a) Aggregates.--The contractor set up a batching plant on the right abutment upstream from the new damsite. The plant consisted of a three-bin unit with a total capacity of 24 cubic yards for two sizes of coarse aggregate and sand (see fig. 64). The coarse aggregate was separated into No. 4 to 3/4-inch and 3/4- to 1-1/2-inch sizes.

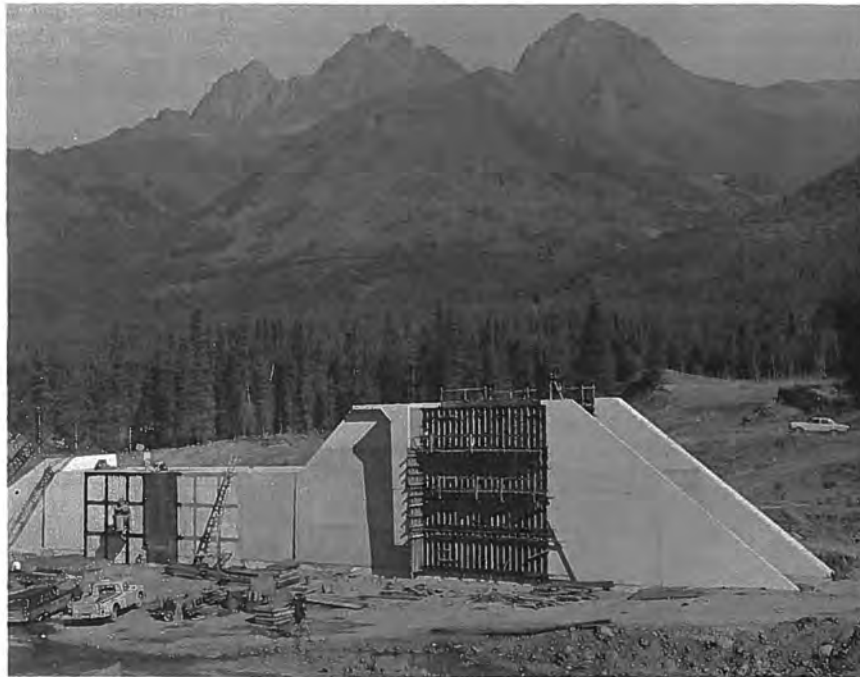
Figure 65. --Concrete placements on the inlet and conduit sections of the spillway nearing completion. P783-908 C&R-172NA, August 19, 1965.

(e) *Curing.*--The concrete was cured with a white-pigmented curing compound sprayed on immediately after the forms were stripped. (See fig. 65.) The curing compound was manufactured by the Hunt Process Co., Los Angeles, Calif.

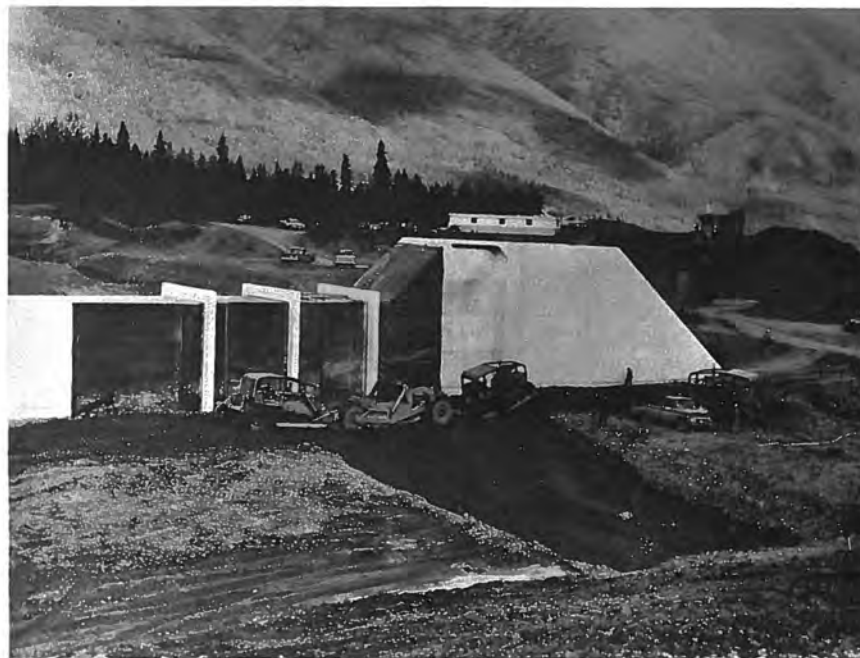
Figure 66. --Butyl-rubber covering in place on the conduit section of the spillway. P783-908 C&R-184A. September 2, 1965.

74. *Watertight Protection for Spillway Conduit.* The specifications required that the concrete spillway conduit be covered with a 3/32-inch-thick butyl-rubber covering to produce a continuous watertight protection along the barrel section from station 4+59.86 to station 5+41.54 (see fig. 66).
