Eklutna River Aquatic Ecosystem Restoration Technical Report

Eklutna River Eklutna, Alaska

November 2011

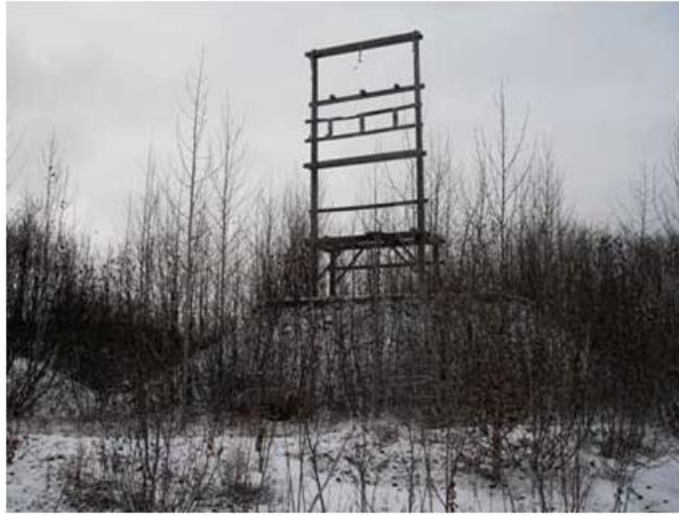
Figure 6. The remains of an electrical substation perched above existing ground level after approximately 20 vertical feet of aggregate was removed by mining operations.

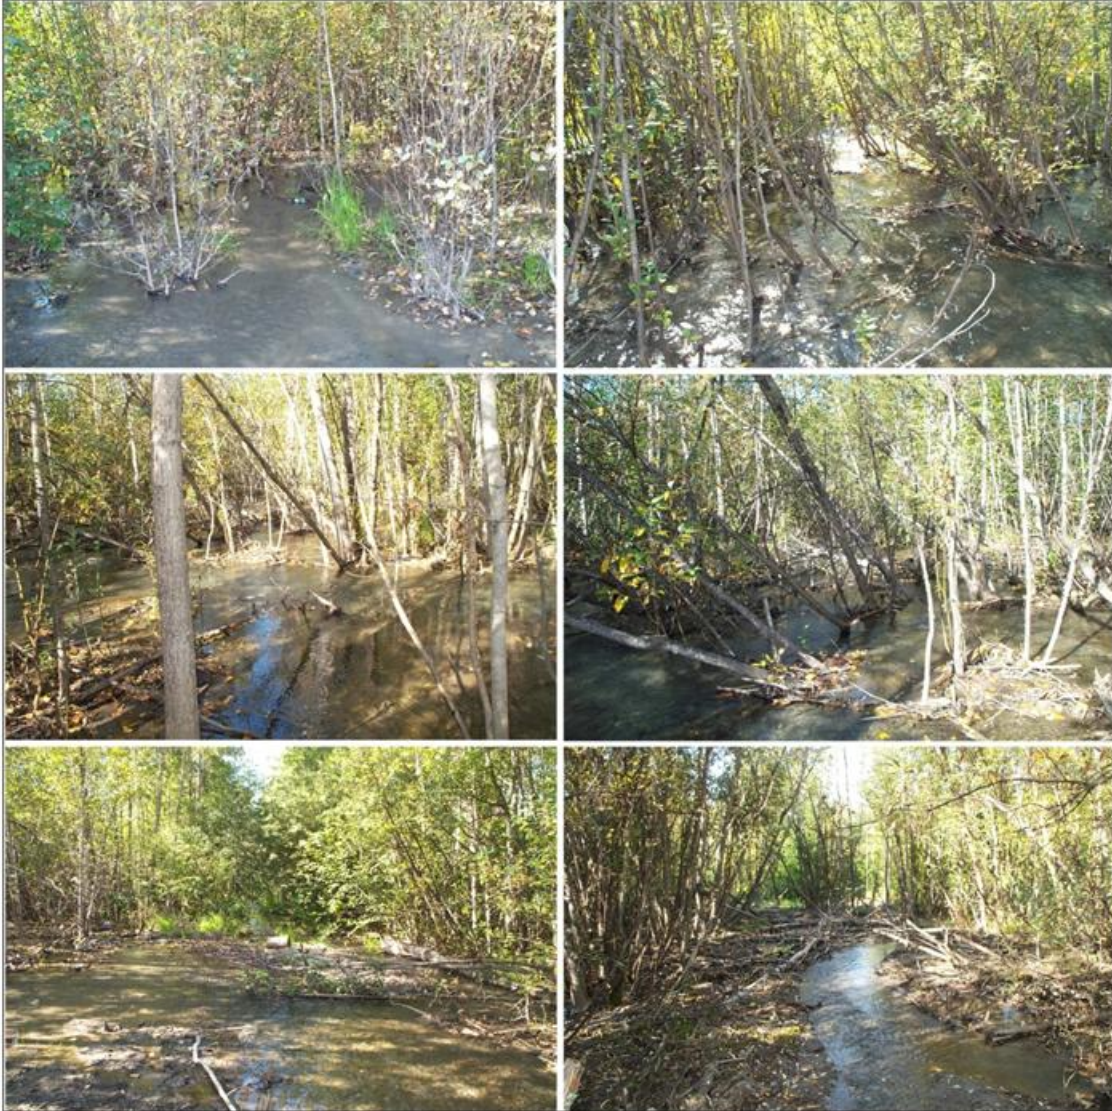
Figure 8. Errant channels of the Eklutna River flowing downstream into heavily wooded areas between the Glenn Highway and the Alaska Railroad bridges.

Ecosystem damage from aggregate mining is complicated by natural bedload that accumulates between the highway and railroad bridges. Much of the bedload deposited between the bridges appears to have been caused by a relatively narrow railroad bridge that restricted flow and an elevated rail bed that acted like a dam during a 100-year flood event on October 12, 1986 (USGS 2005). This 100-year event flooded the ecosystem behind the elevated railbed to where a massive volume of bedload being carried from the canyon dropped out and superimposed a fresh alluvial deposit on the existing deposits.

This massive bedload deposit and additional bedload transported in subsequent but smaller events has elevated the river bed between the bridges to where it has become highly braided and subject to frequent channel changes within and between summer seasons. These small, braided channels change course within and between open water periods. Some of these channels dewater as they flow downstream. Conversely, when viewed from the downstream end of the reach, some of the channels braid into small and often impassable branches moving upstream. These small, shallow braided channels pictured in Figure 8 often run through heavily wooded areas that can dewater, strand fish, and make passage for salmon difficult or impossible. In addition to

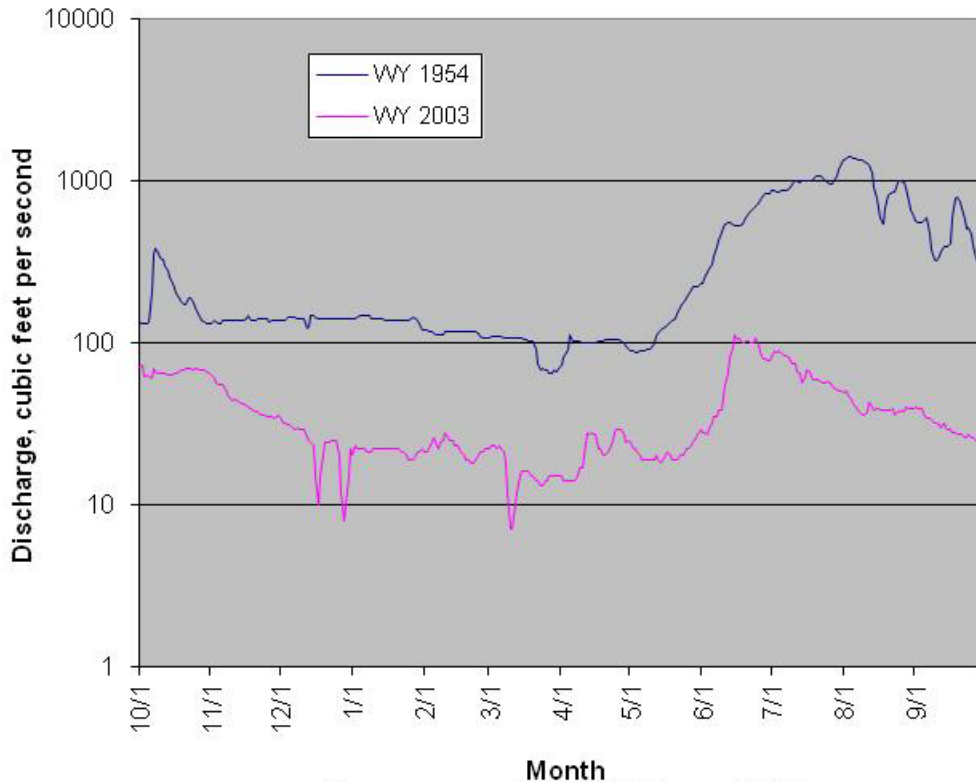
Figure 10. Eklutna River at Old Glenn Highway Discharge Comparison for Water Years 1954 and 2003

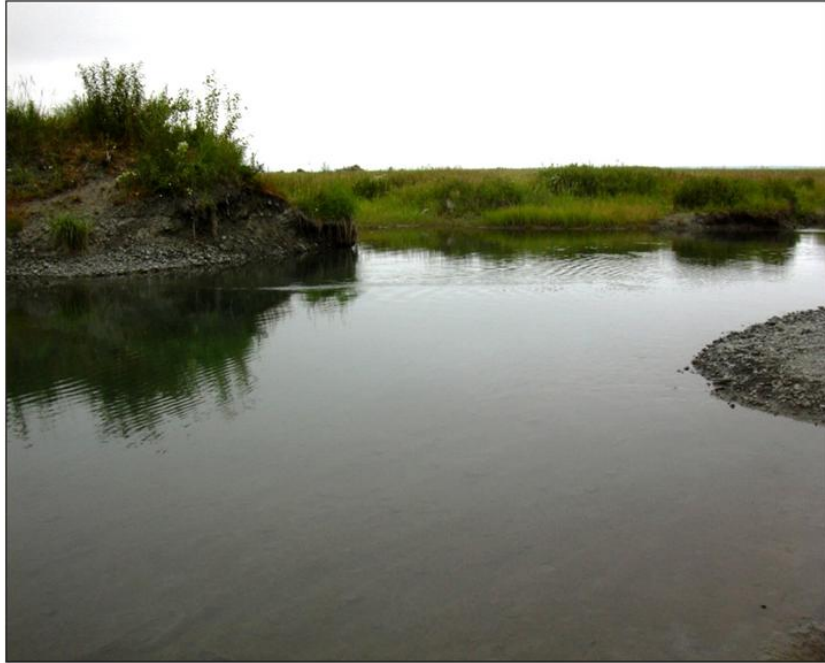
Figure 11. A pool at the mouth of a man-made pond in which adult salmon hold and acclimate to river water before moving upstream to spawn in the Eklutna River

Most adult Eklutna River salmon enter the river on the flood tides. Chinook, chum, and coho salmon will typically hold for a few days in deeper water at the edge of a pond that was excavated near the upper tidal influence during mining operations before moving upstream to spawning reaches. Figure 11 shows such a pool. Pink salmon have a relatively short stream life compared with the other species, and will typically move directly to the spawning areas.
