UNITED STATES
DEPARTMENT OF THE INTERIOR
BUREAU OF RECLAMATION

EKLUTNA PROJECT
ANNUAL PROJECT HISTORY

CALENDAR YEAR 1959

VOLUME IX

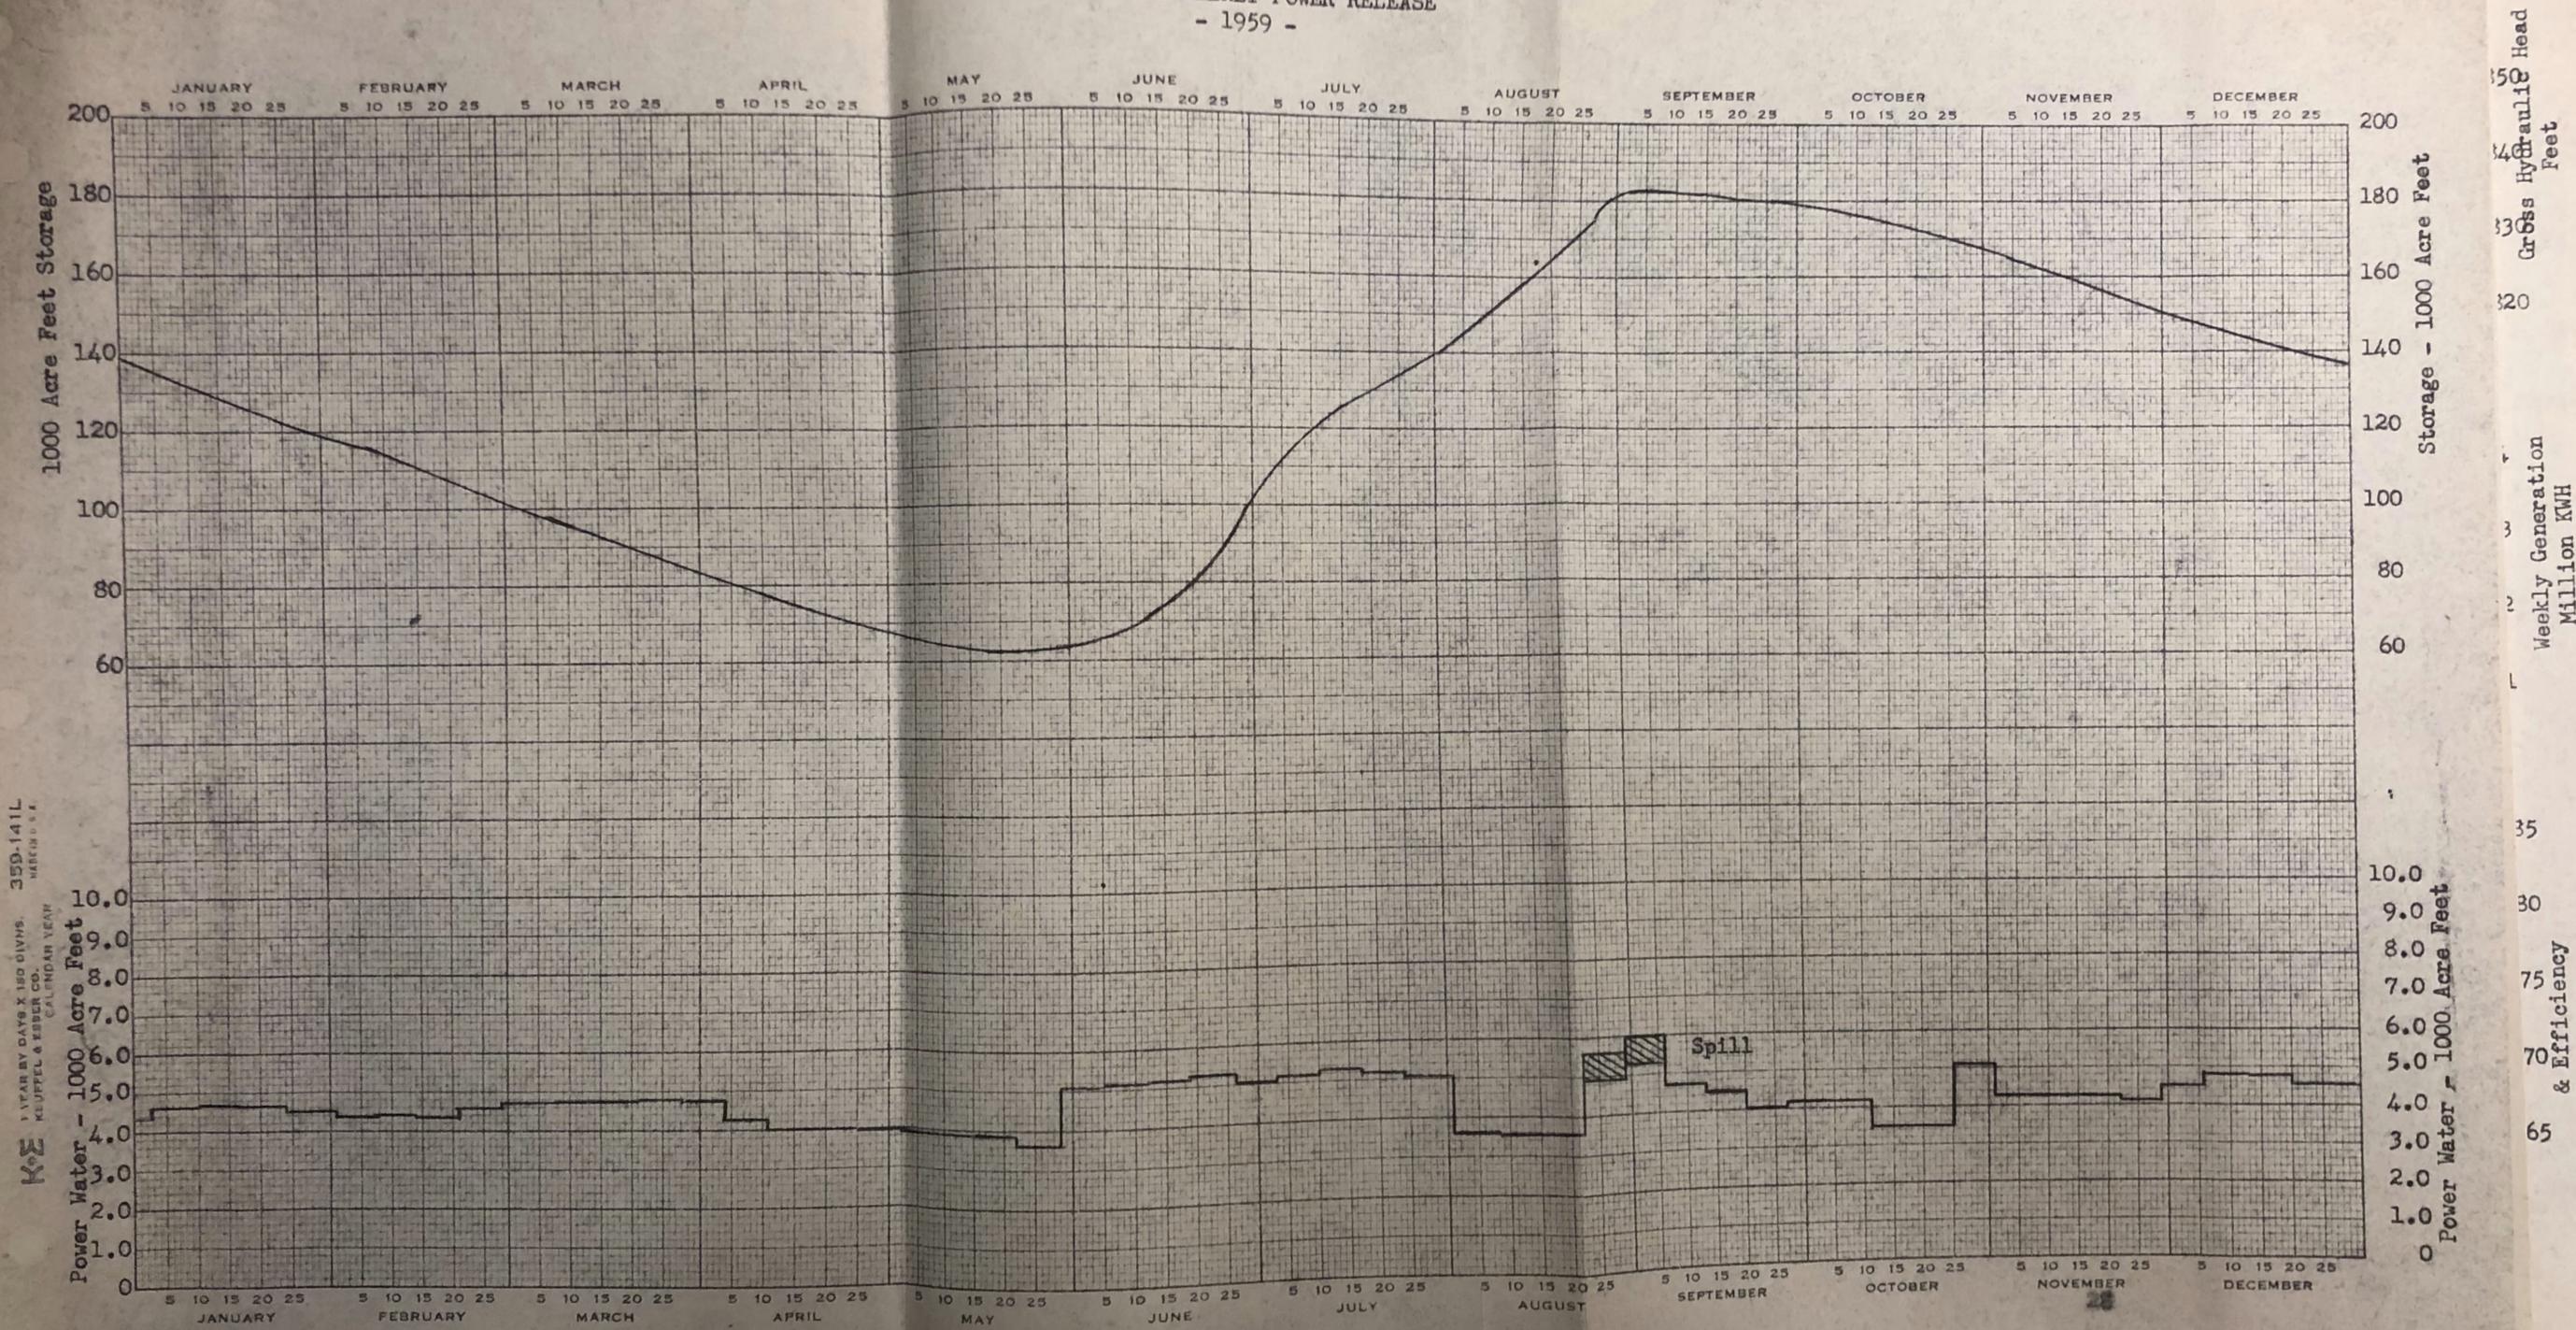
UNITED STATES
 DEPARTMENT OF THE INTERIOR
 BUREAU OF RECLAMATION - ALASKA DISTRICT
 EKLUTNA POWERPLANT
 STORAGE AND WEEKLY POWER RELEASE
 - 1959 -

231,441 A.F. of water was used through the turbines during the year and 1504 A.F. were spilled or leaked under the dam. This gives a water factor of 99.4%.
