TECHNICAL RECORD
of
DESIGN AND CONSTRUCTION

**EKLUTNA DAM, POWERPLANT
AND TUNNEL**

Eklutna Project
Alaska

Denver, Colorado
March 1958

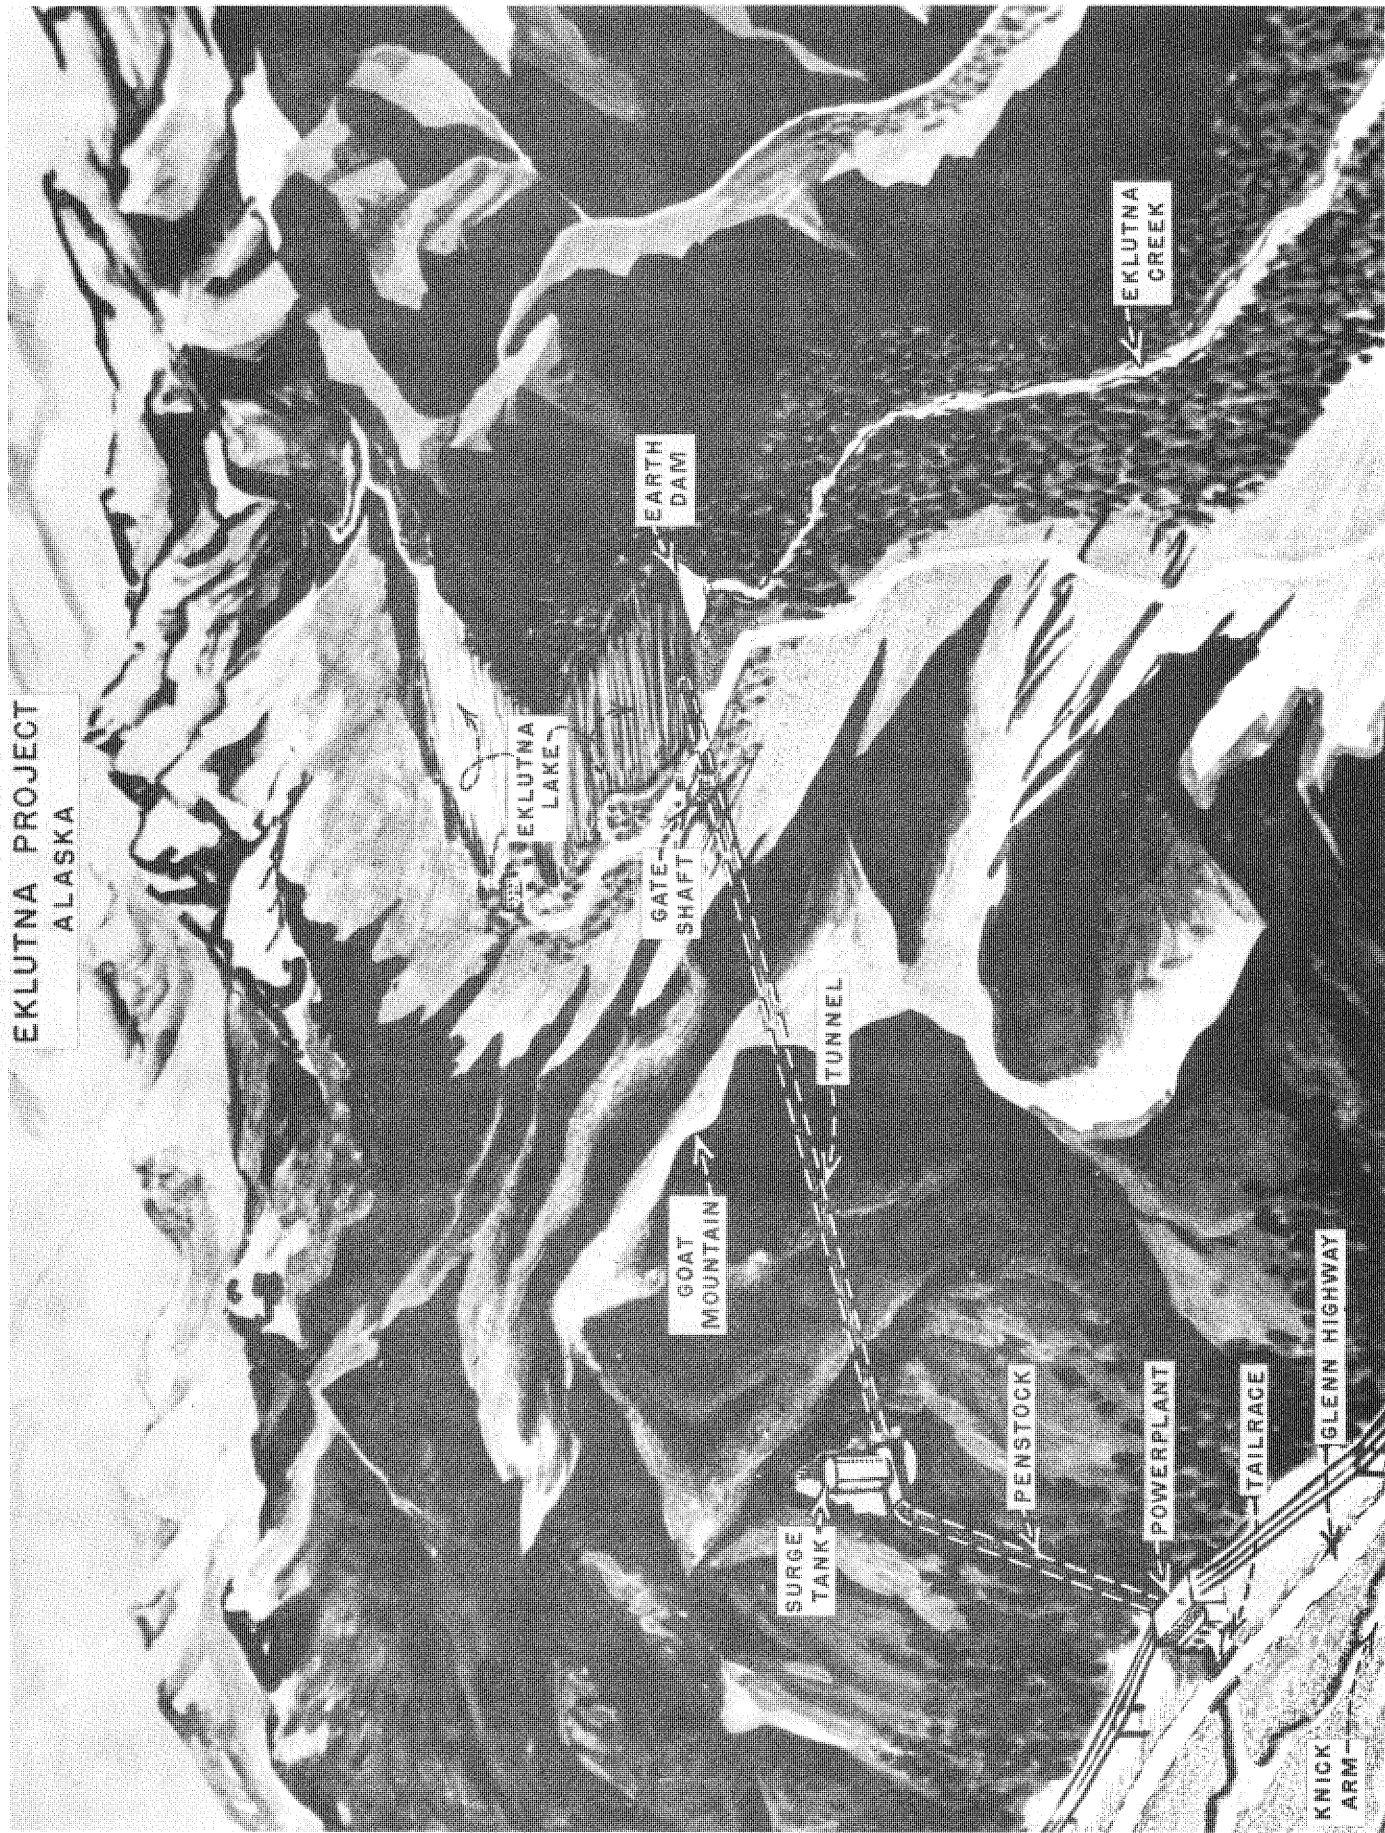
Figure 1.--Artist's conception of Eklutna project.

1. Location and Purpose. - The Eklutna project (fig. 1) is a 30,000-kilowatt hydroelectric power development designed and constructed by the Bureau of Reclamation, United States Department of the Interior, to bring urgently needed electric power to the rapidly expanding area at Anchorage, Alaska. The project, the first major development by the Bureau of Reclamation outside the continental United States, was constructed during the 4-year period between 1951 and 1955.

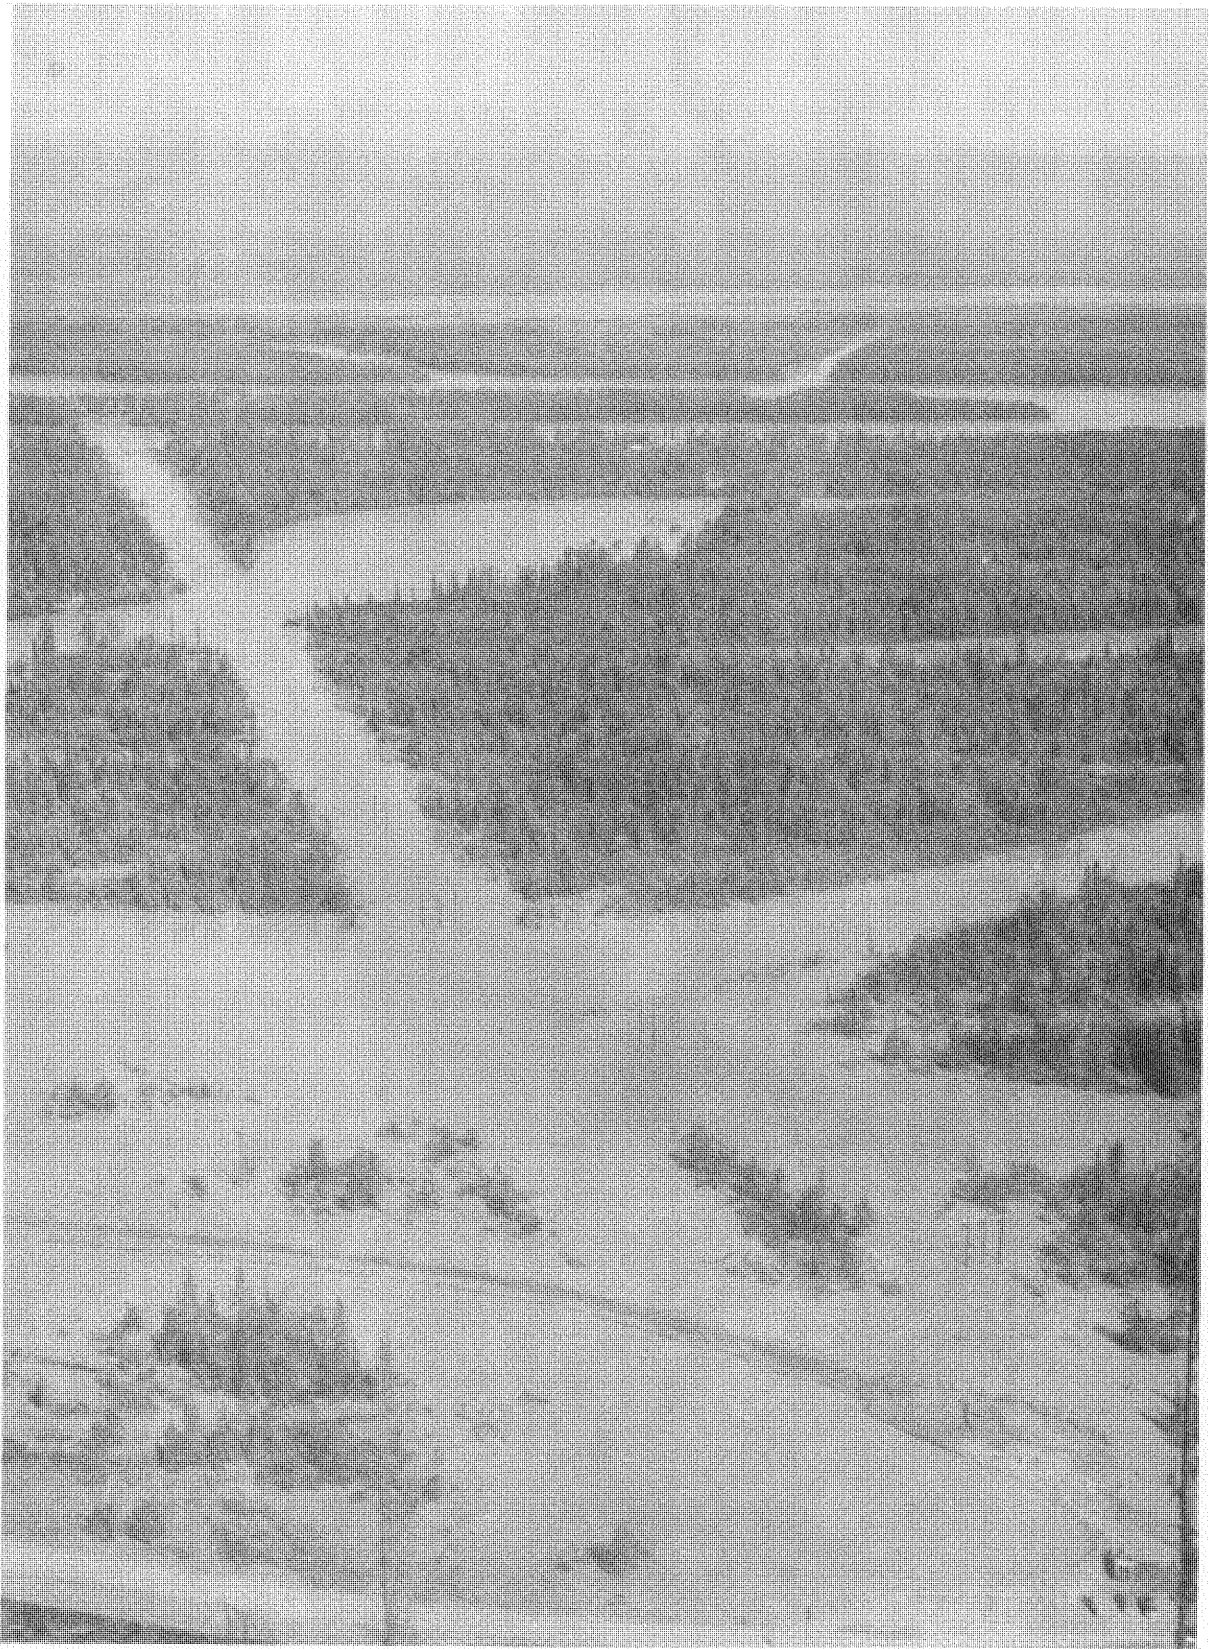
Figure 16. --General view from tunnel adit portal showing conditions at height of Knik River flood during the Lake George breakup. Note powerplant and tailrace embankment in foreground. P783-908-1665, July 26, 1954.

14. Tailrace. - Throughout the entire length of the tailrace, the upper 4 to 6 feet of material is silt and sandy silt, underlain by a layer of sand and fine gravel approximately 2 feet thick. Beneath the sand and fine gravel is sand and coarse gravel. During extremely high tides the water backed up in the channel and added to the water from the tunnel, during the pumping out of the powerhouse and penstock area, some sloughing of the sand and gravel layer occurred. Also during the period of extremely high water during the Lake George breakup, there was some sloughing of the banks of the channel-deposited material in the bottom of the channel (fig. 16).

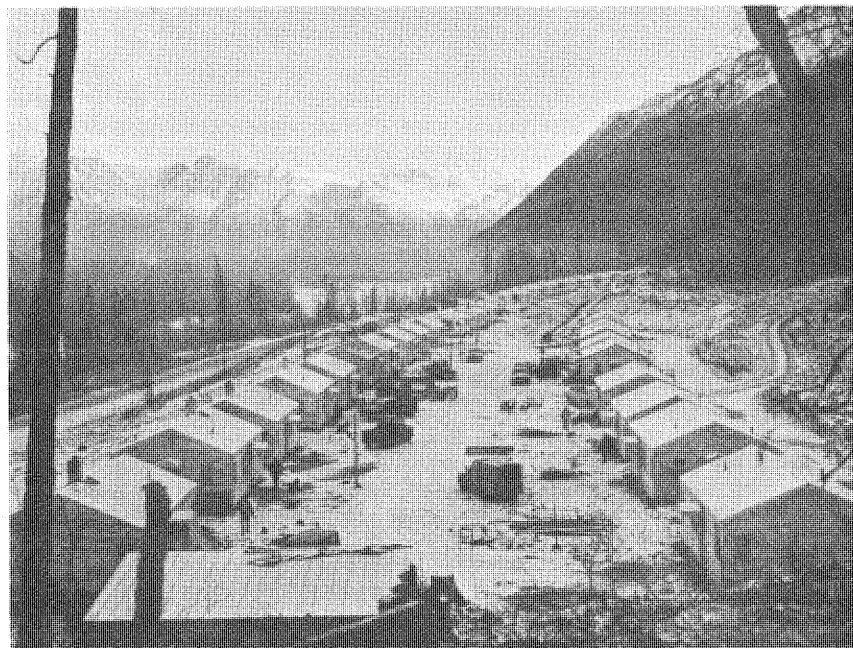
Figure 102. --Temporary and permanent houses under construction at Eklutna Government camp. P783-908-459. November 27, 1951.

Six small 2-bedroom prefabricated portable houses in Palmer were completed and occupied in January 1951. Thirty temporary 2-bedroom houses, 10 in Palmer and 20 at the permanent Government camp site near Eklutna Powerplant, were completed and occupied by January 1952 (fig. 102). The 12 permanent houses at the Government camp were completed and occupied in March 1952, and one permanent house at the Anchorage substation site was completed in December 1952. The occupancy rate was 100 percent during most of the major construction period.

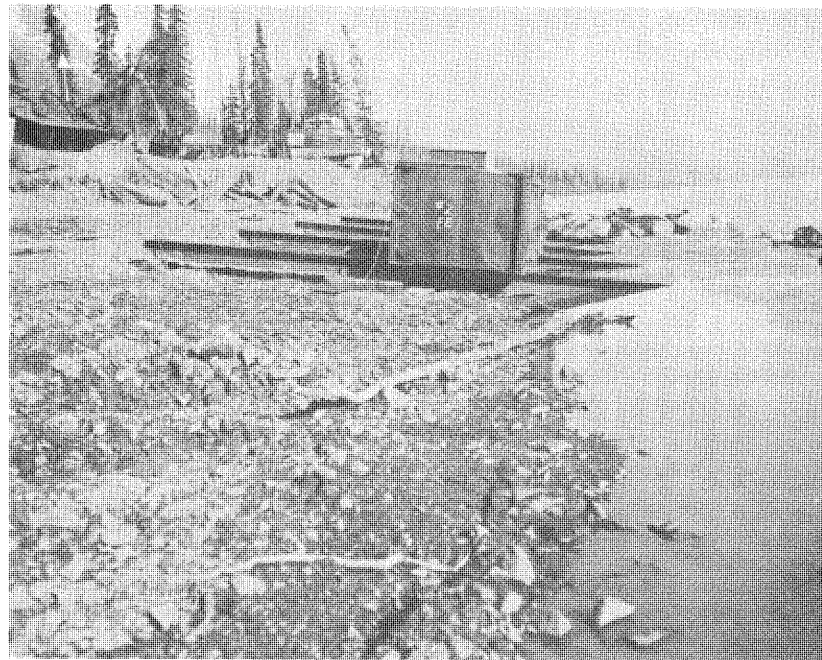
Figure 104. --View of assembly area for dredge at Eklutna Lake showing one steel pontoon and steel skids on which assembled dredge will slide into lake. P783-908-788, May 2, 1952.

Ben C. Gerwick Inc., in a joint venture with Hydraulic Dredging Inc., as a subcontractor under Palmer Constructors, solved this problem by designing and building a relatively small 14-inch suction dredge that could be broken down to truck loads. The assembled dredge is shown in figures 103 and 105. The size of hulk was reduced by using a floating support for the ladder. Traverse motion of the cutter head was provided by swinging the entire dredge rather than by use of swinging the boom. The stern was used as the pivot point and its position was maintained by two winch-powered "off" lines and a stern line connected to buoys and anchors. Forward motion and swing were gained from quartering aft lines similarly powered and anchored. Mobility was more than ample. Operation revealed no fundamental errors in the design of the dredge and only the usual maintenance problems of replacing worn cutter heads, rock wipers, etc., were experienced.

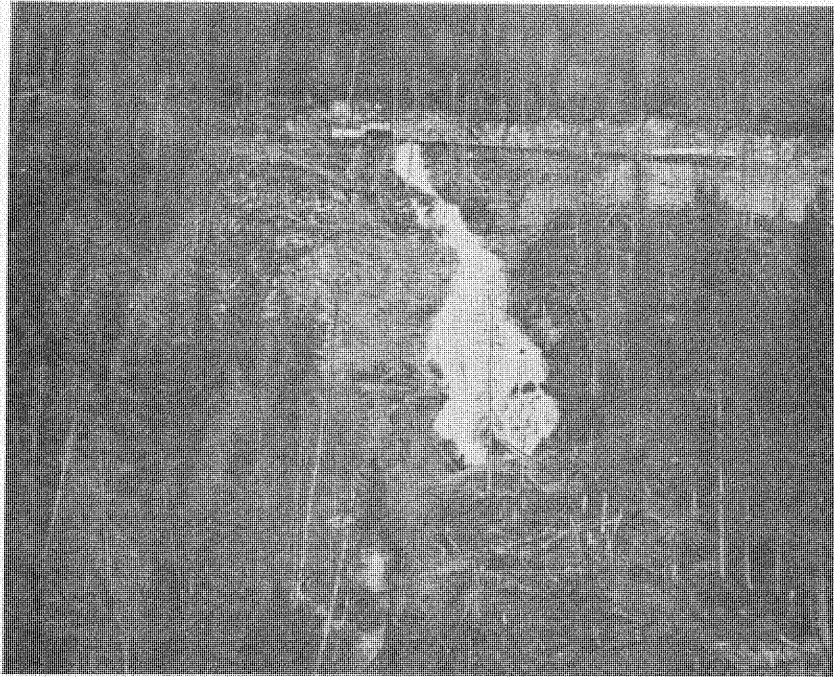
Figure 111. --Tunnel drainage from fault at station 208+70, cascading down slope toward highway. Flow was estimated at 7,800 gallons per minute. P783-908-1153, November 10, 1952.

The first mile of tunnel driven from the north portal passed through complexly folded and faulted rock with numerous water bearing channels. Progress was slow as a result of frequent caving and water flows. A major cave-in and loss of the heading occurred November 9, 1952, at station 208+70 at which time the water flow was estimated at 10,000 gallons per minute. (Figs. 111 and 112.) Work was suspended at this heading for 2 months to permit installation of unwatering equipment. Two 22-inch-diameter pipelines, one 10-inch and three 6-inch electric pumps, were installed to pump the water from the tunnel. During the heading shutdown, a change in tunnel design was made to handle the water during driving. The contractor was instructed by order for changes No. 4 (sec. 84(c)) to proceed with an enlarged section that would allow for "under the track drainage" in a steel flume section. Excavation of the enlarged section was started at station 207+50 and discontinued at station 150+13, without encountering further serious water problems. No flume steel was installed. Maximum flow of water from the north portal was approximately 16,000 gallons per minute. Eventually the flow of water stabilized at approximately 1,300 gallons per minute. During this period the contractor was advancing the heading from the gate shaft, and the two headings were "holed through" on October 15, 1953, at station 118+20.

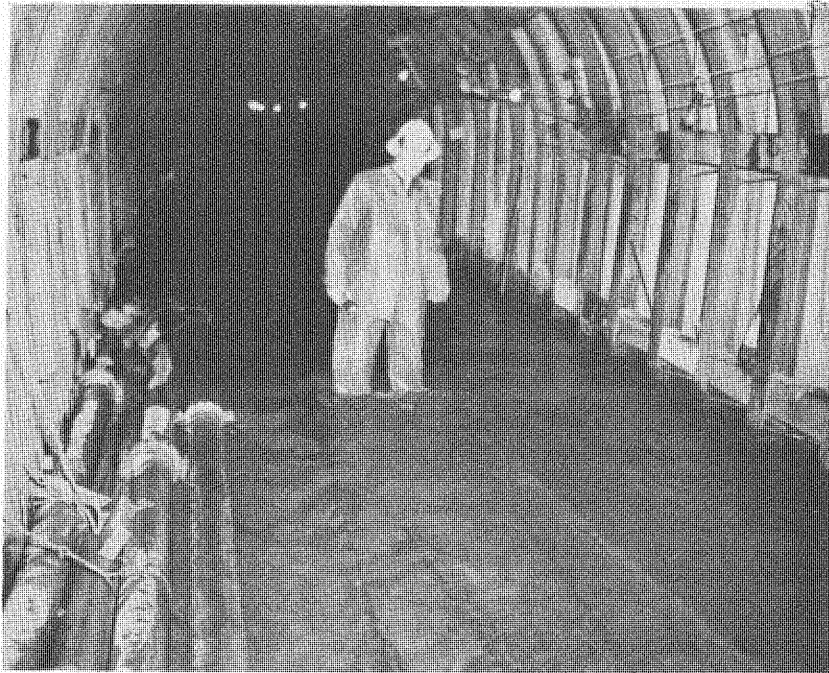
Figure 112. --Water flowing through tunnel from fault at station 208+70. P783-908-1163, November 15, 1952.

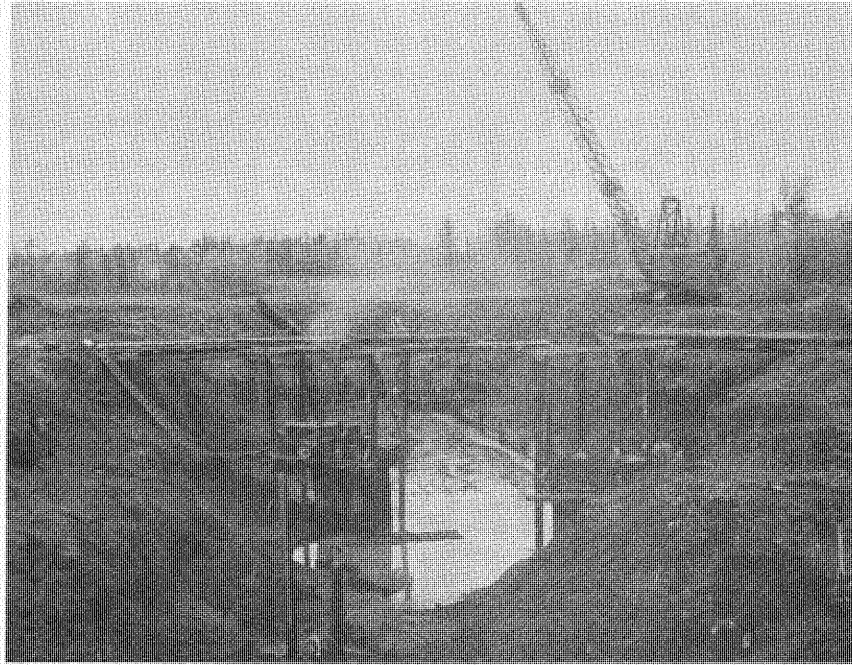
Figure 123.--General view of powerhouse and tailrace excavation showing pumps necessary to unwater foundation excavation. Shown are two 10-inch and three 6-inch pumps. P783-908-1084, September 19, 1952.

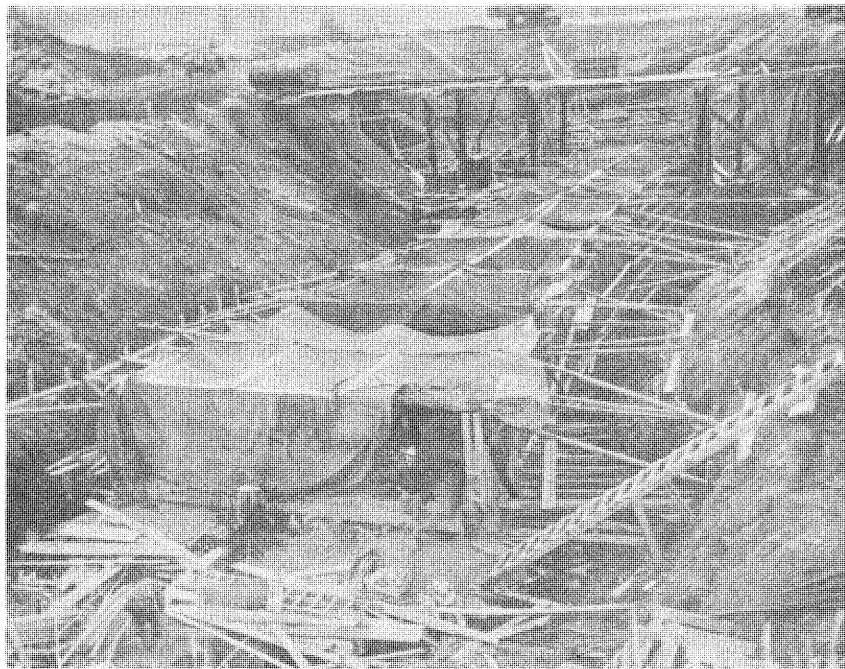
Figure 133. --Construction view of tailrace conduit, showing method of protecting newly placed concrete from freezing temperatures. P783-908-1118, October 18, 1952.

A crane, equipped with a 1/2-cubic-yard bucket, was used to transport the concrete from the mixer to the point of placement. After sandblast cleanup of the construction joint, concrete was placed in the invert and 6-inch stub walls, followed by placement of the wall and deck. Immersion-type vibrators were used to consolidate the concrete in the forms. Membrane curing compound was applied with a portable hand spray immediately after form stripping, and the concrete was protected from freezing by covering with tarpaulins and heating with heaters (fig. 133).
